AIRCRAFT ACCIDENT REPORT 1/2007

**Civil Aviation Department
Hong Kong**

**Report on the accident to
Robinson R44 helicopter, B-HJS,
operated by Topjet Aviation Limited at Pak A, Sai Kung, Hong Kong
on 11 June 2005**

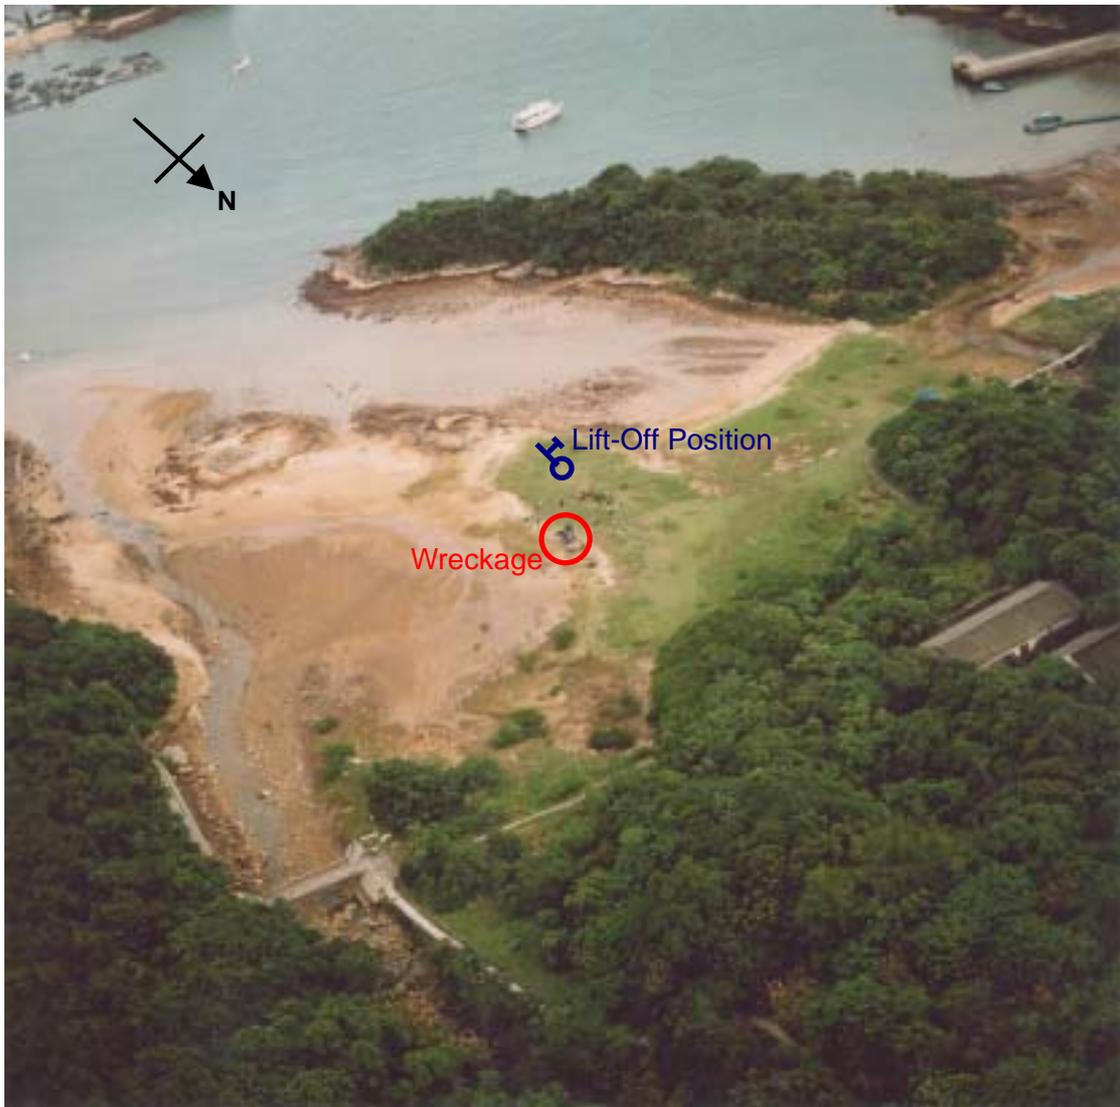
Photograph 1 Helicopter Lift-Off and Wreckage Positions at Pak A

1.1.3 The helicopter lifted off at 0610 hrs (1410 hrs) from a sandy-grassed area at Pak A (see Photograph 1). Whilst the helicopter was in a hover on a northerly heading, the pilot made a yaw turn to the right with the intention that the spot turn would stop at 180° (half a revolution) so that the helicopter could be stabilized in a hover facing the sea before transitioning

to forward flight over the water. This subsequently developed into a continuous uncontrolled yaw turn, drifting to the left. The helicopter then impacted with the ground on a southerly heading at approximately 10 m to the northeast of the lift-off position. The helicopter eventually came to rest on its left side. The left skid was substantially damaged. The main rotor blades remained attached to the helicopter but were significantly bent and twisted. Both blades of the tail rotor were severed. The tail boom was severely fractured, locally twisted and bent to the starboard near the damper bearing of the tail rotor drive shaft. There was no post-impact fire.

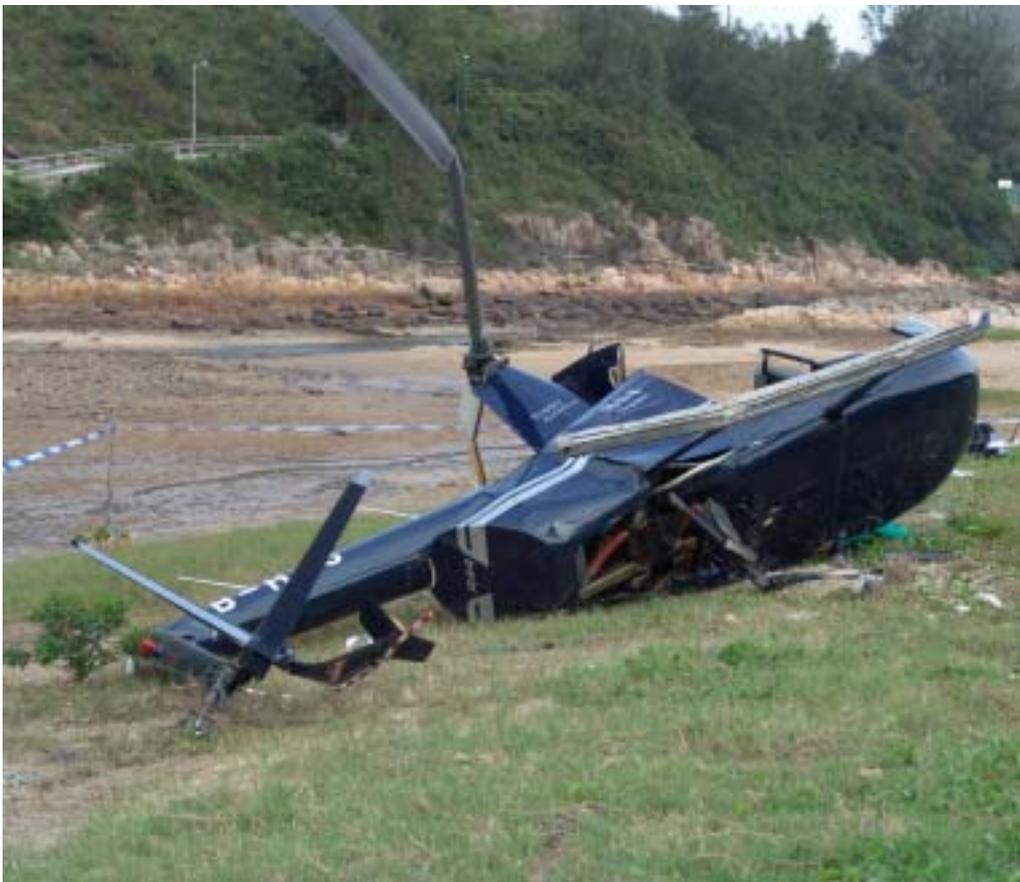
Photograph 2 Helicopter Wreckage

1.12.3 Damage to the helicopter as a result of the impact was as follows (see Photograph 2). Additional photographs showing the damage to the helicopter are included in Appendix C.

(a) The left skid was substantially damaged.

(b) The main rotor blades remained attached to the helicopter but were significantly bent and twisted.

- (c) Both blades of the tail rotor were severed. One of the two tail rotor blades was subsequently recovered at approximately 2 m from the tail rotor hub whereas the other piece could not be located despite extensive search of the accident site.
- (d) The tail boom was severely fractured, locally twisted and bent to the starboard near the tail rotor drive shaft damper bearing.
- (e) The perspex canopy was extensively damaged.

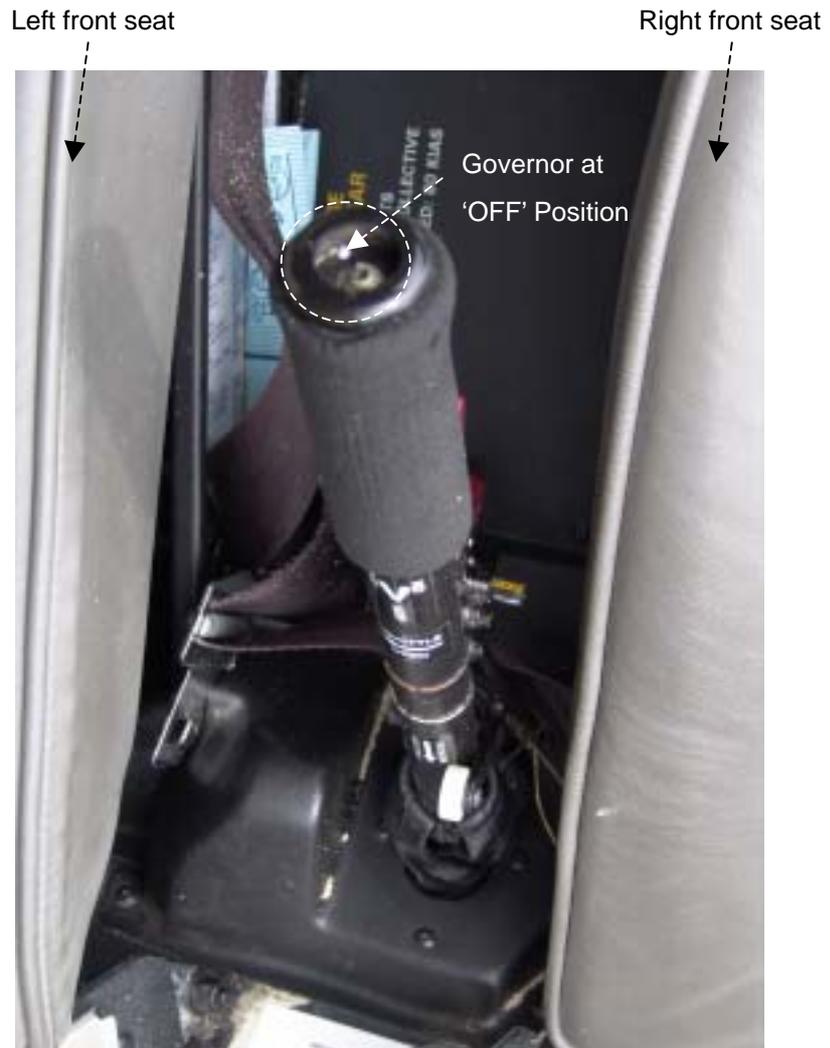
Photograph 3 Governor Switch at 'OFF' Position

2.1.2.1.2 The governor switch, located at the end of collective control, was found at the 'OFF' position (see Photograph 3).

preflight checks by reciting the checklist on each take-off. The Preflight Checks as stated in the R44 POH require the governor to be selected 'ON' and verified operative before flight. As stated in Paragraph 2.1.1, the pilot did not report noticing illumination of 'GOV OFF' (indicating governor disabled). The pilot also confirmed in his statement that the helicopter had entered into a steady hover, and this was supported by the left rear seat passenger in her statement. The warning light bulb of the governor was tested after the accident and was found to be serviceable. The right magneto, governor controller and governor motor were returned to the aircraft manufacturer for functional testing and these components were found to be operating normally. All the above indicated that the governor was selected 'ON' from the moment of lift-off until the steady hover. It was reasonably believed that the governor switch was inadvertently knocked into the 'OFF' position after the accident, most probably during the evacuation of the occupants from the helicopter.

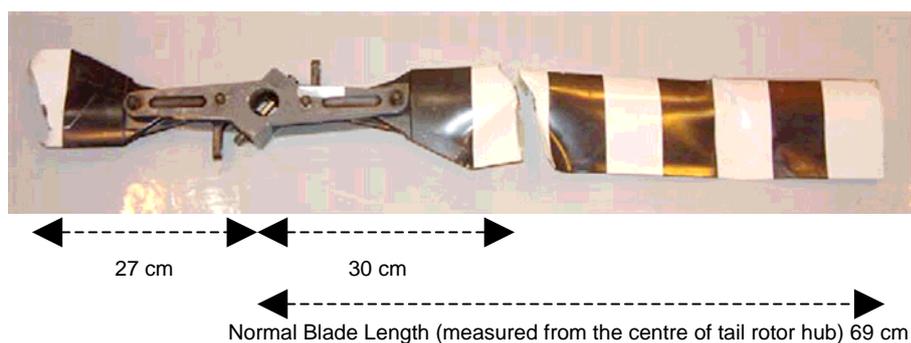
Photograph 4 Tail Rotor Hub and Broken Blade

2.1.3.1 The tail rotor blades were severed by impact with the ground. Both ends were fractured at approximately the same distance from the centre of the tail rotor hub assembly (see Photograph 4) and found to have sustained similar breakage, indicating that the tail rotor was still running when it hit the ground. Judging from the breakage of tail rotor blades, the damage to both blades was likely to be symmetrical, i.e. each of the two blades was severed into two pieces.

2.1.3.3 An independent metallurgical laboratory conducted an analysis of the tail rotor hub and the blade of the tail rotor of the helicopter. The results indicated that the tail rotor hub and the tail rotor blades did not have any pre-impact damage. In addition, the fracture surfaces of the blades did not indicate any signs of metal fatigue. The fracture of blades was most probably caused by a combination of tearing, bending and twisting forces acting on the rotating blades when they struck the ground. Had the breakage

of the tail rotor blades occurred during the hover manoeuvre, the pilot would have experienced extreme vibration. Since none of the occupants reported noticing any extreme vibration or significant noise during the hover manoeuvre, it could be concluded that the tail rotor did not suffer from any damage until it hit the ground.

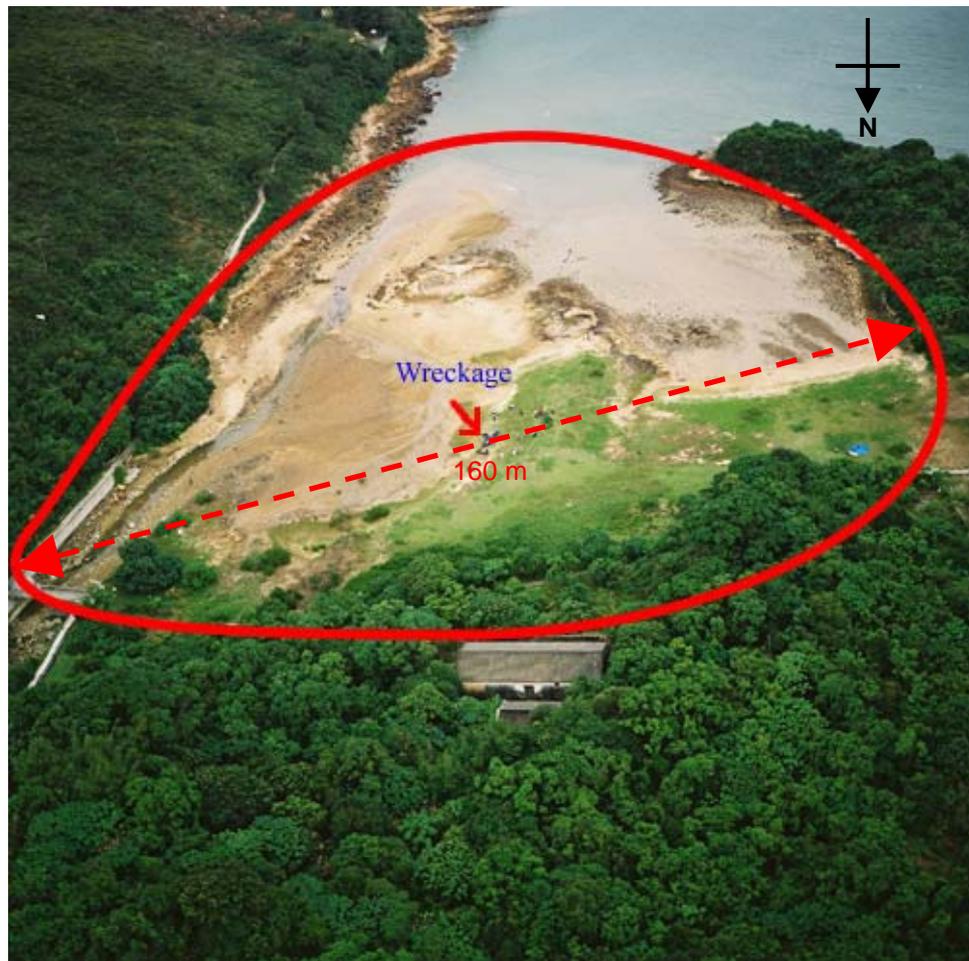
Photograph 5 Search Area for Missing Part of Broken Tail Rotor Blade

2.1.3.2 Comprehensive search over an extensive area of approximately 160 m in diameter as shown in Photograph 5 was conducted in an attempt to recover the missing part of the broken tail rotor blade

but it could not be located.

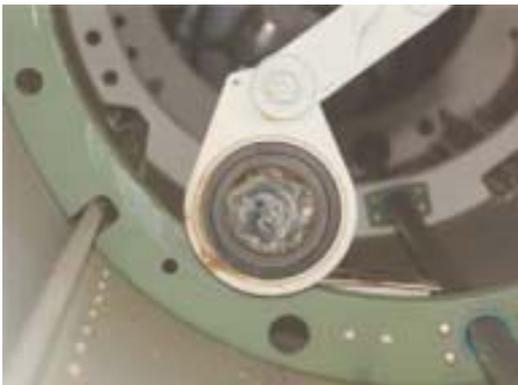
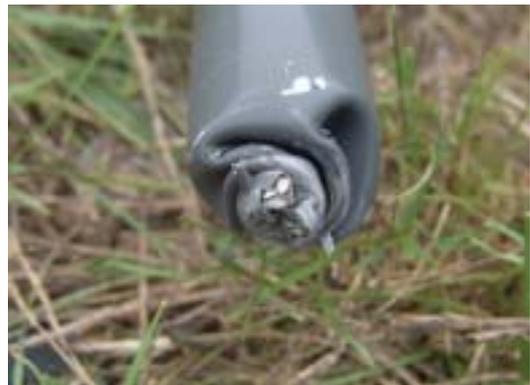
The laboratory examination on the breakage of the broken ends of the tail rotor drive shaft suggested that the engine was still providing power to the tail rotor system before the impact and that the power was sufficient to have twisted the drive shaft to failure as the tail rotor was abruptly stopped from rotating upon hitting the ground (see Photographs 6a and 6b).

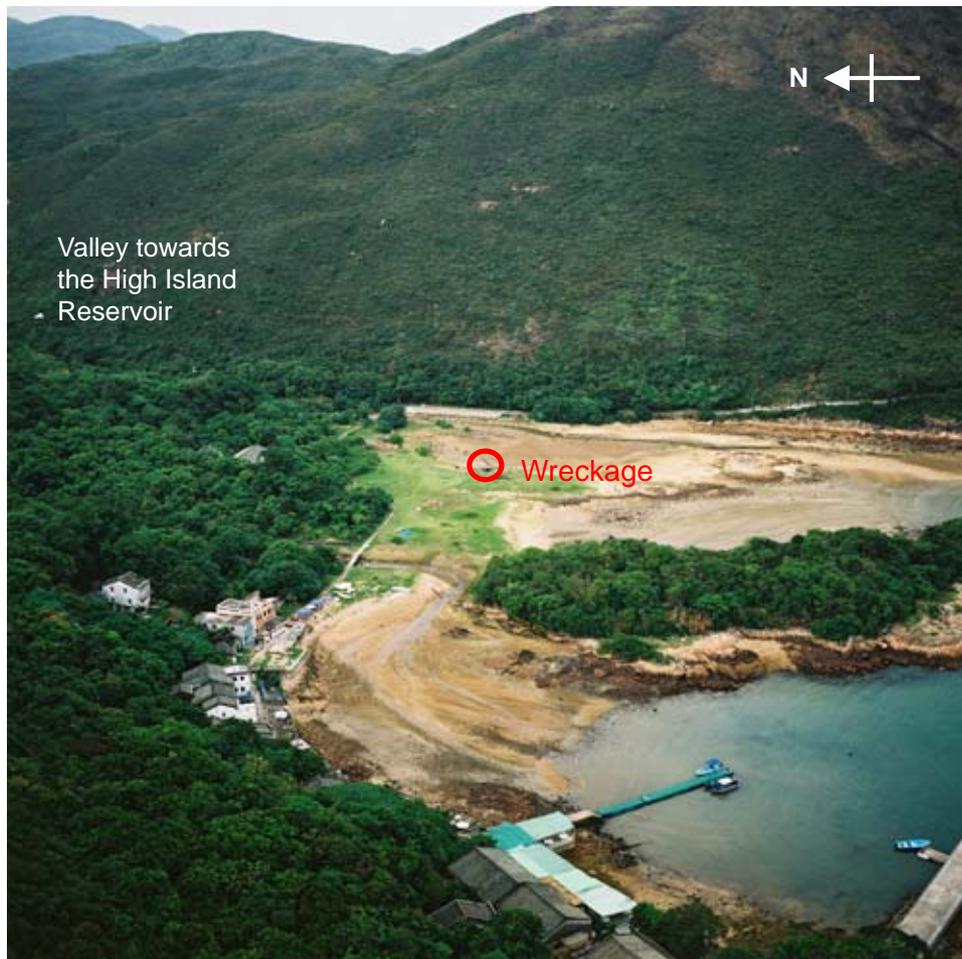
Photograph 7 Topography at Pak A

2.1.8.2 In the pilot's assessment (see Paragraph 1.7.4), he stated that the wind was coming from between 220° and 240° at 5 to 10 knots earlier of the day. He further stated that he initiated a slow 180° spot turn to the right, manoeuvring the helicopter to a southerly direction into wind. It was therefore evident that the helicopter had lifted off in a tailwind condition.

2.1.8.3 As regards the wind strength, the pilot stated that the wind was 5 to 10 knots in the morning. According to the reports from HKO (see Paragraph 1.7.1.3), the wind over Hong Kong had in general picked up speed in the afternoon. Combining this change with the influence of ‘valley effect’, a wind stronger than that anticipated by the pilot might have prevailed over Pak A at the time of the accident flight. However, in the absence of a real-time measurement of on-scene wind data, the exact surface wind conditions over Pak A at the time of the accident could not be accurately determined.

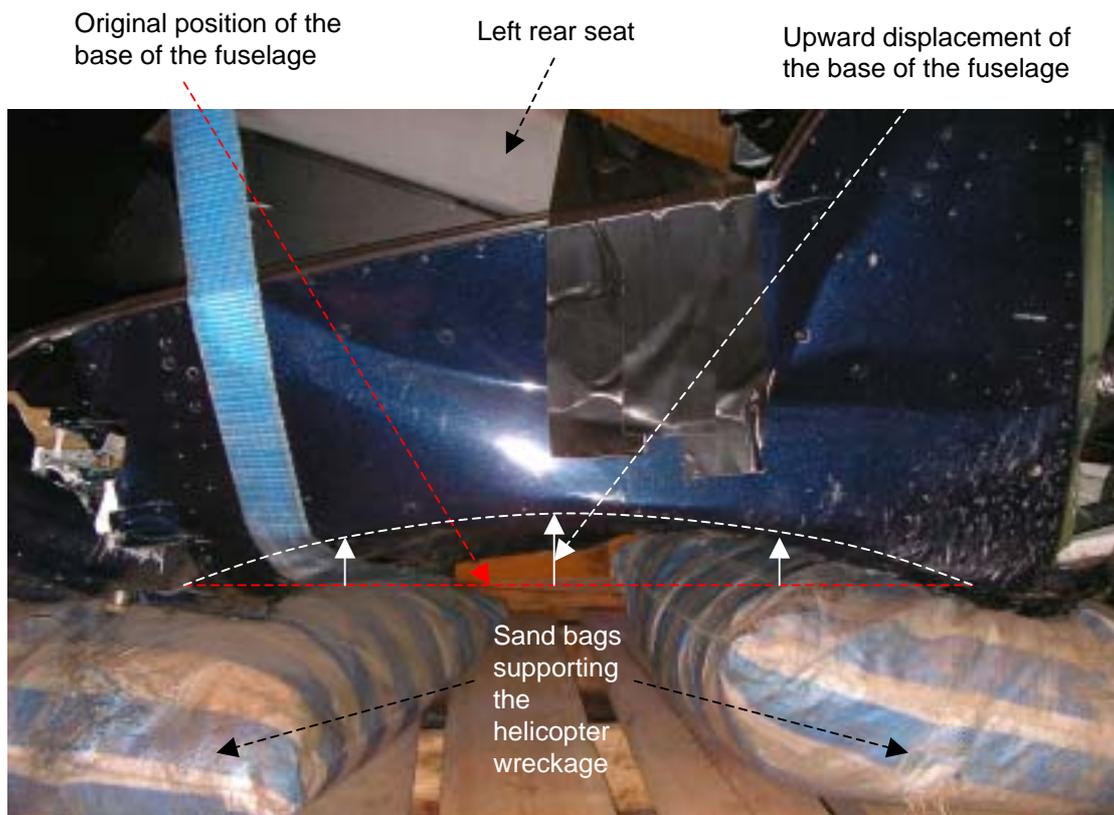
Photograph 8 Deformation of the Left Underside of the Fuselage due to the Accident (Left Side View)

Although the general shape and dimensions of the cockpit and occupant space were preserved, the perspex canopy was extensively damaged following the impact. Impact damage to the left underside of the fuselage (see Photograph 8) resulted in approximately 1 cm upward displacement of the left rear seat. This damage reflects the significant vertical deceleration forces applied to the occupants, and which caused the spine injuries. There was no evidence of any other significant injury to the pilot or passengers attributable to the structural damage or to intruding external objects.

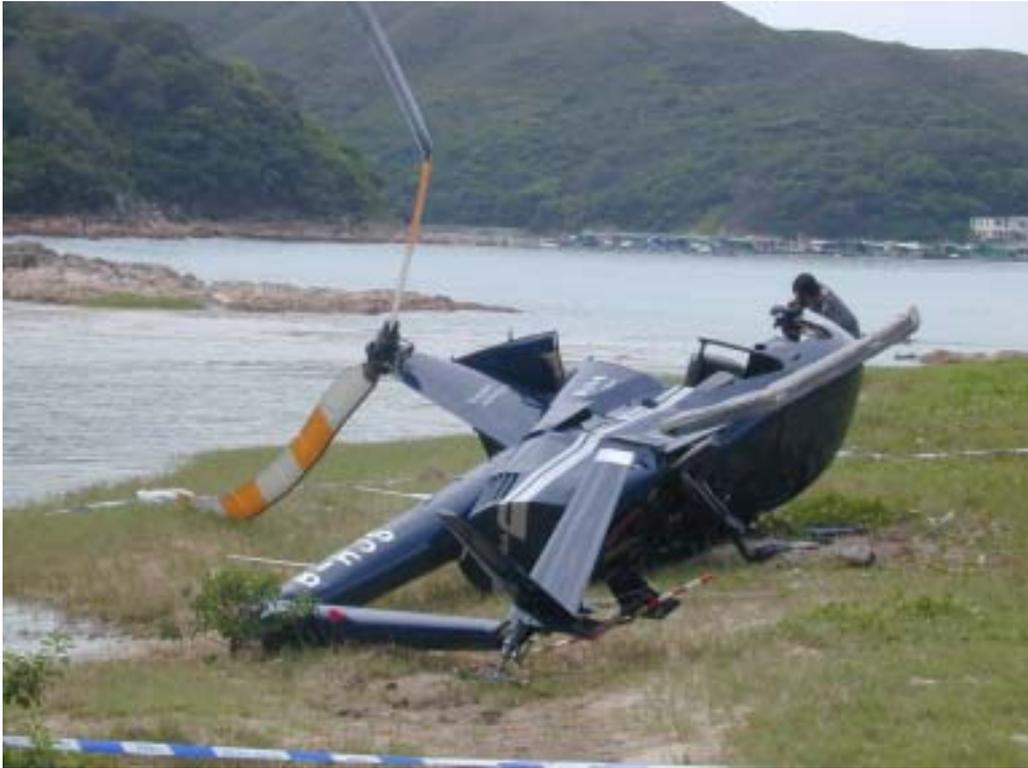
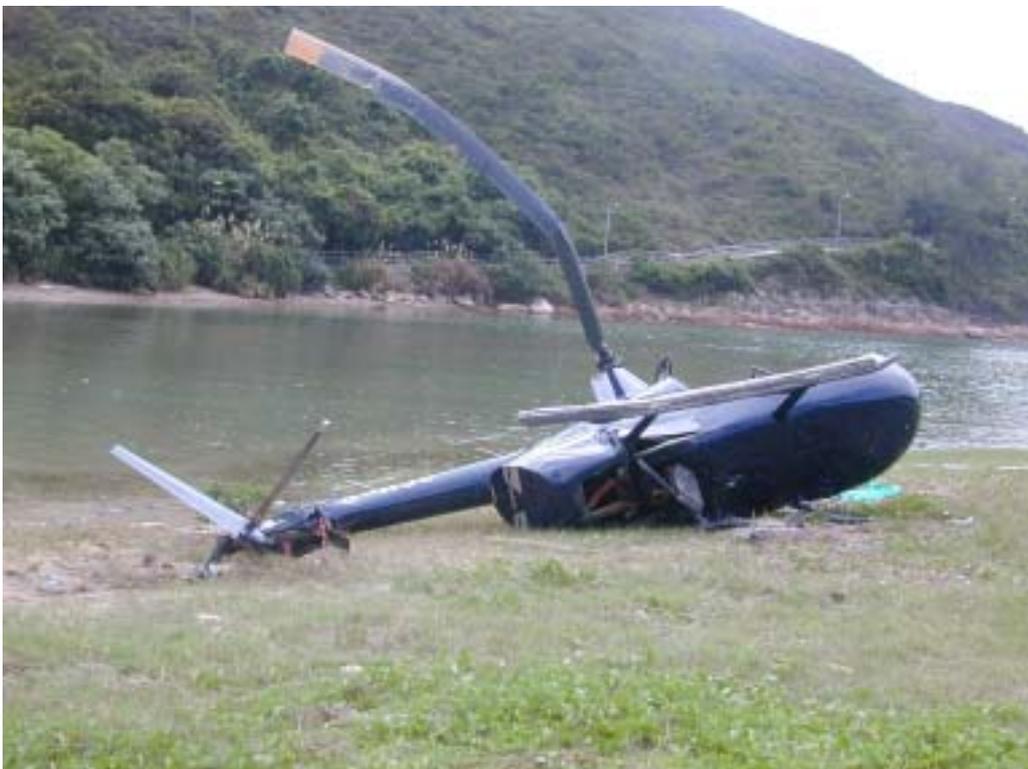
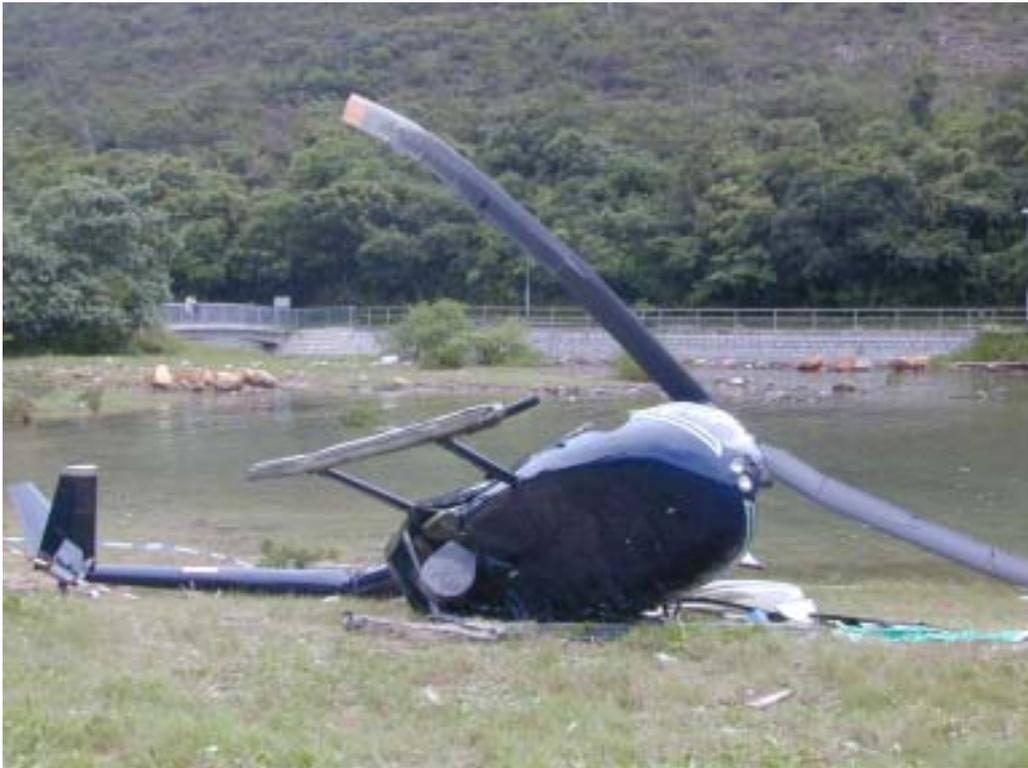
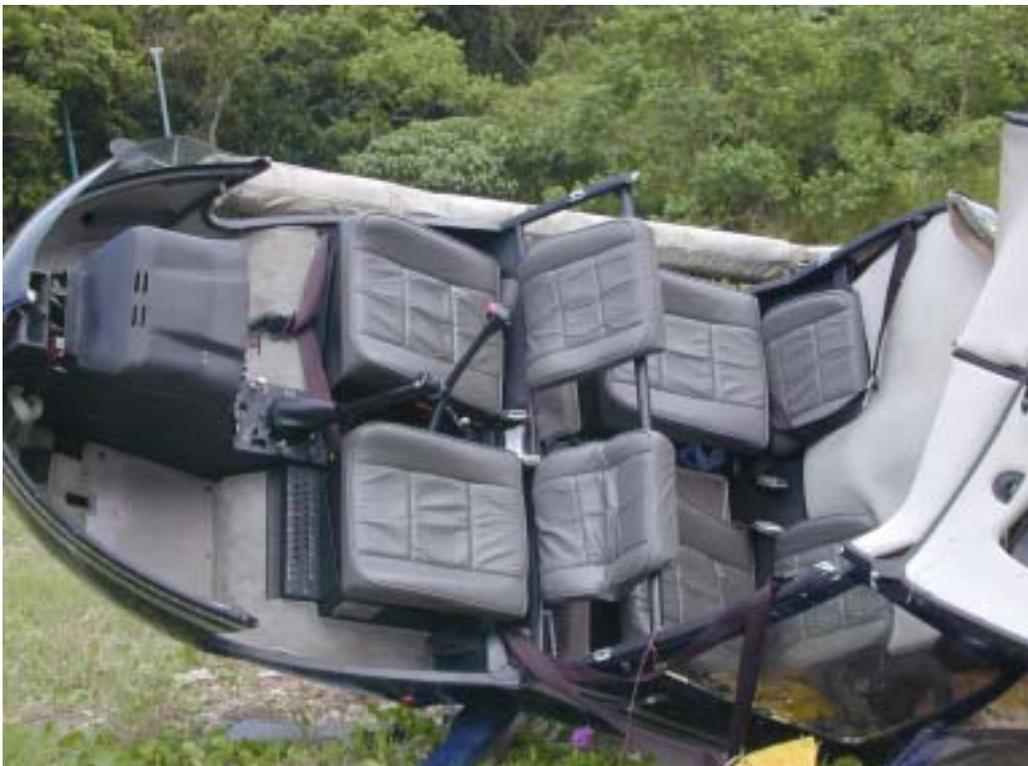
Appendix C
Damage to the Helicopter

Helicopter Wreckage (viewed from the rear of the helicopter)

Helicopter Wreckage (viewed from the right rear of the helicopter)

Helicopter Wreckage (viewed from the right front of the helicopter)

Helicopter Cabin
(perspex canopy removed by emergency service personnel during rescue operation)
