**SERIOUS INCIDENT REPORT 1/2017**

**Report on the Serious Incident to Gulfstream Aerospace G550  
Registration B-8256 Operated by  
Hanergy Jet Company Limited  
During the Approach into  
Hong Kong International Airport, Hong Kong  
on 13 January 2015**

**Hong Kong  
June 2017**

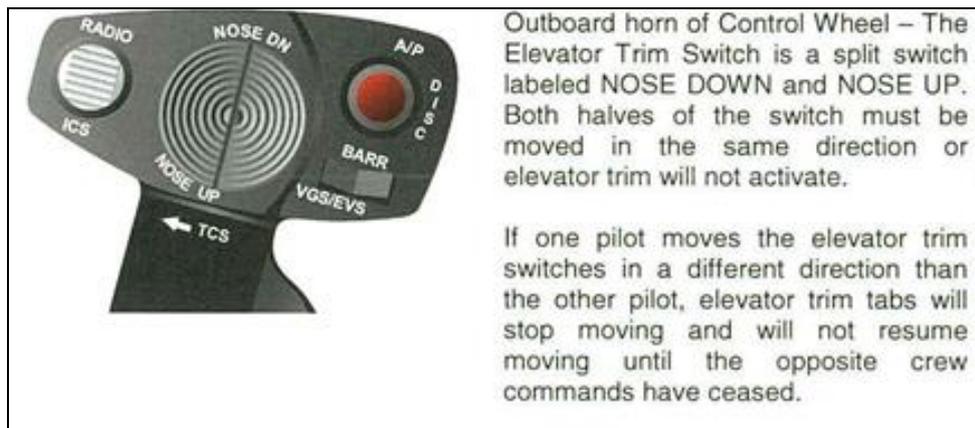
For electrical trim control, it is initiated by the elevator trim switch (see **Figure 1** below) on each control wheel. The elevator trim servo and bracket in the tail compartment move the elevator trim tabs in the desired direction when either elevator trim switch commands a change in trim tab position. It is important to note that the elevator trim switch is a “dual/split-switches” which must

**Figure 1 - The Elevator Trim Switch on the control wheel**

cause of AP disengagement and the aircraft pitch trim movement, as analysed in paragraphs 2.1.5, 2.2 and 2.3.1 above, the most plausible reason would be that the AP “normal” disengagement and the full nose-down pitch trim were caused by pilot’s input to either the elevator trim switch or the manual trim wheel.

It is recommended that HHG should review and strengthen flight crew training on situational awareness, monitoring of aircraft status with particular emphasis on the AP and pitch trim systems, their effects on flight control, and avoidance of inadvertent input to any aircraft systems. (Para 2.3.1 and 2.3.2 refer)

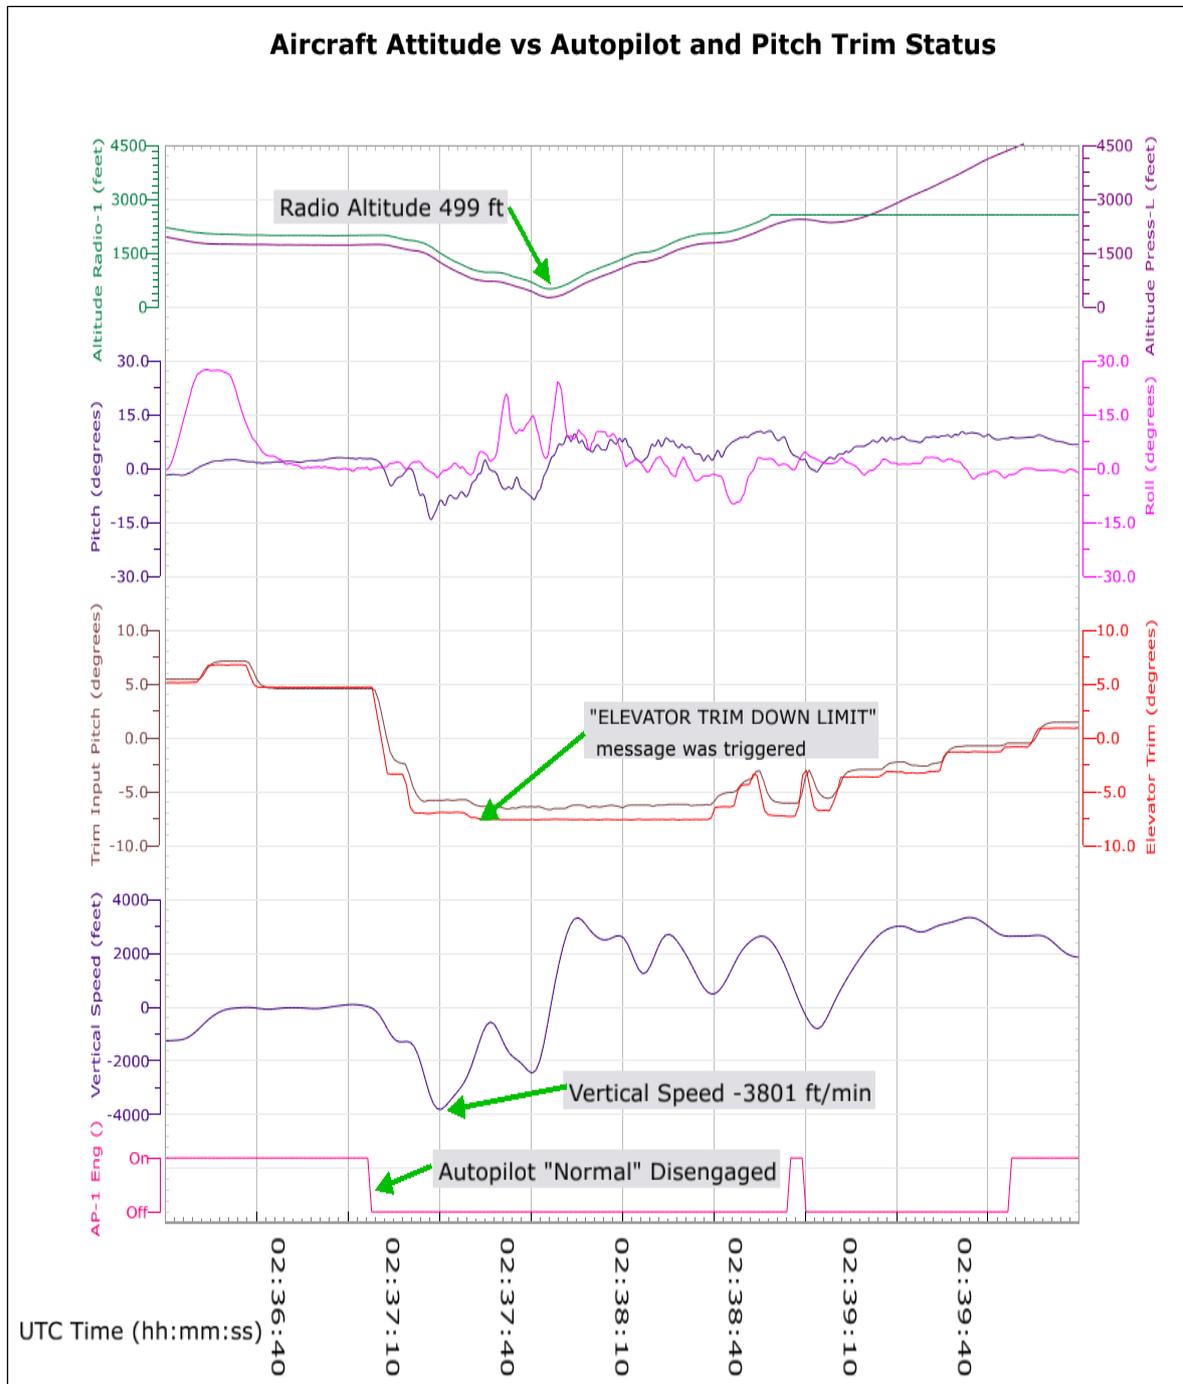
# Appendix 1

**Appendix 1 – Aircraft Attitude vs Autopilot and Pitch Trim Status**

- 2.2.2. According to the DFDR data, the aircraft began to pitch down and lose height quickly when the parameters “Trim Input Pitch” and “Elevator Trim” were moving synchronously from 4.6° and 4.7° to -6.7° and -7.6° respectively. It indicates that the aircraft’s pitch trim output was working accordingly with respect to its input, indicating that the serviceability of the pitch trim system was in order at that time.
