**AIRCRAFT ACCIDENT REPORT 1/2005**

**ACCIDENT INVESTIGATION DIVISION**

**Civil Aviation Department  
Hong Kong**

**Report on the accident to  
Airbus A330-342 B-HYA  
Within the Manila Flight Information Region  
on 18 July 2003**

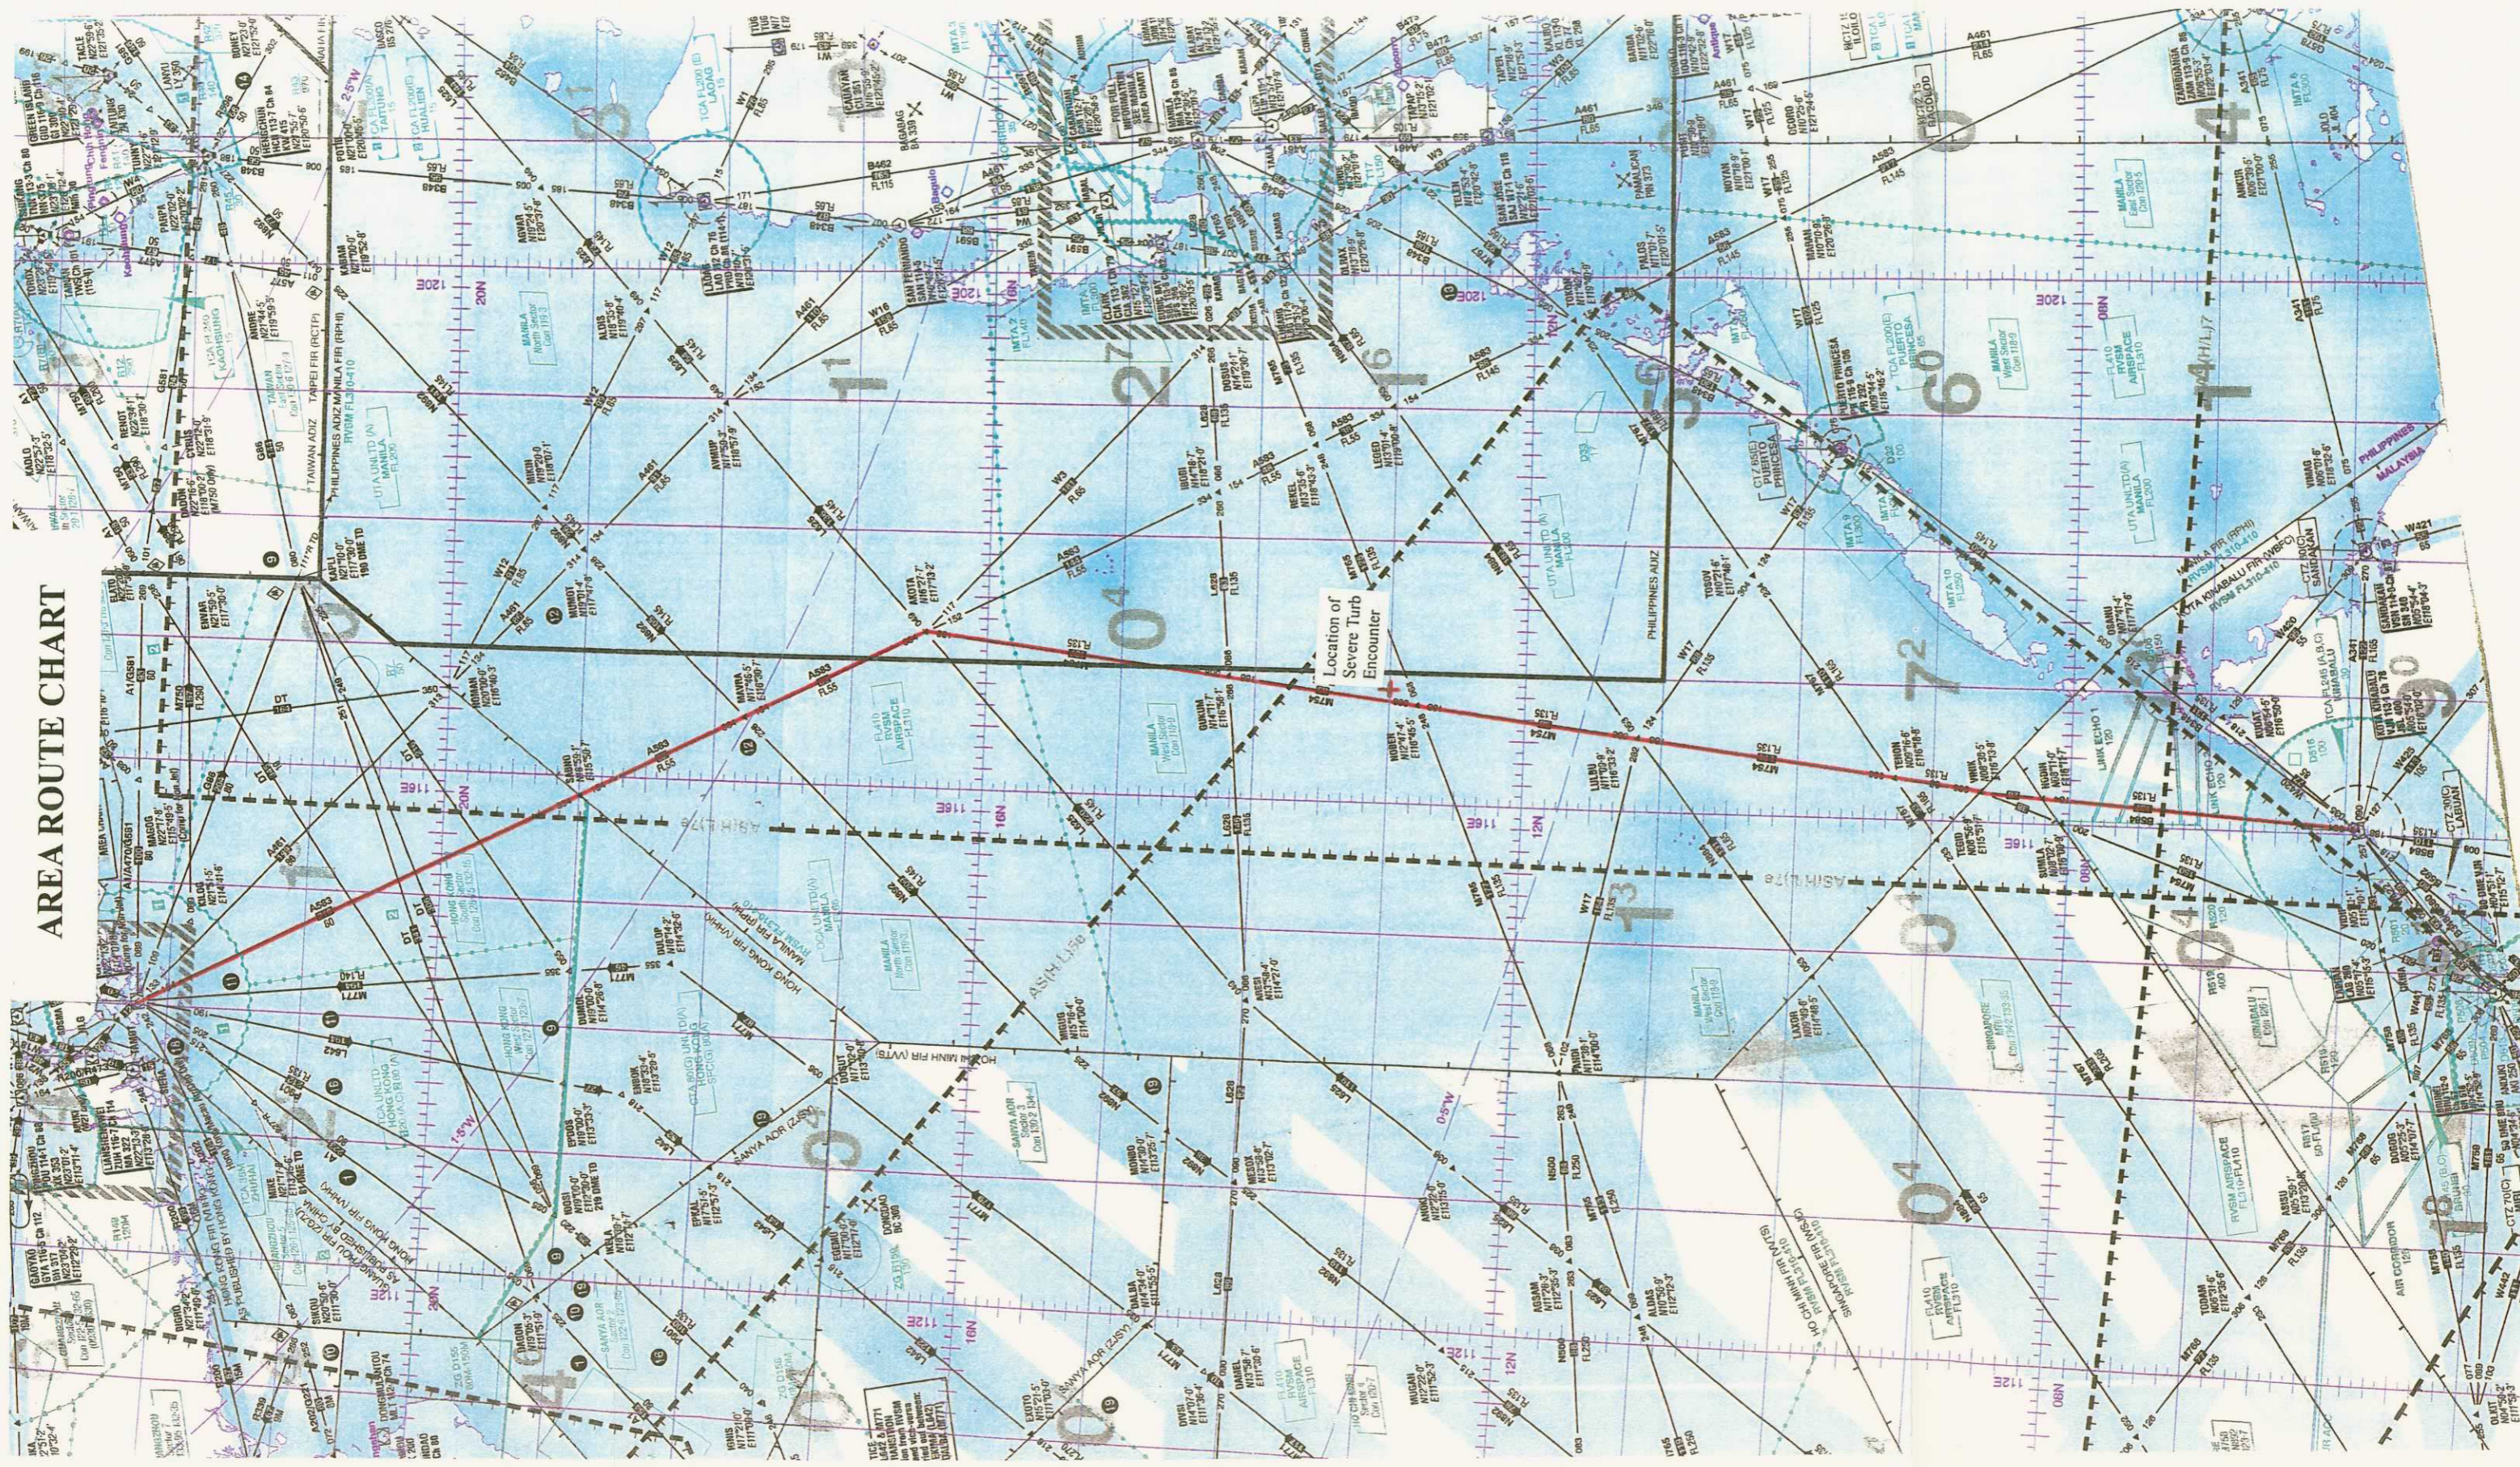
### PLOT OF AIRCRAFT TRACK

Prior to NOBEN, with yellow and green weather returns observed on the radar, they requested permission from Manila ATC to deviate 10 NM to the right of track for weather avoidance. At 0510, shortly after commencing track deviation, the aircraft encountered severe turbulence. (Appendix 2 depicts the aircraft track at around the time of the turbulence encounter.)

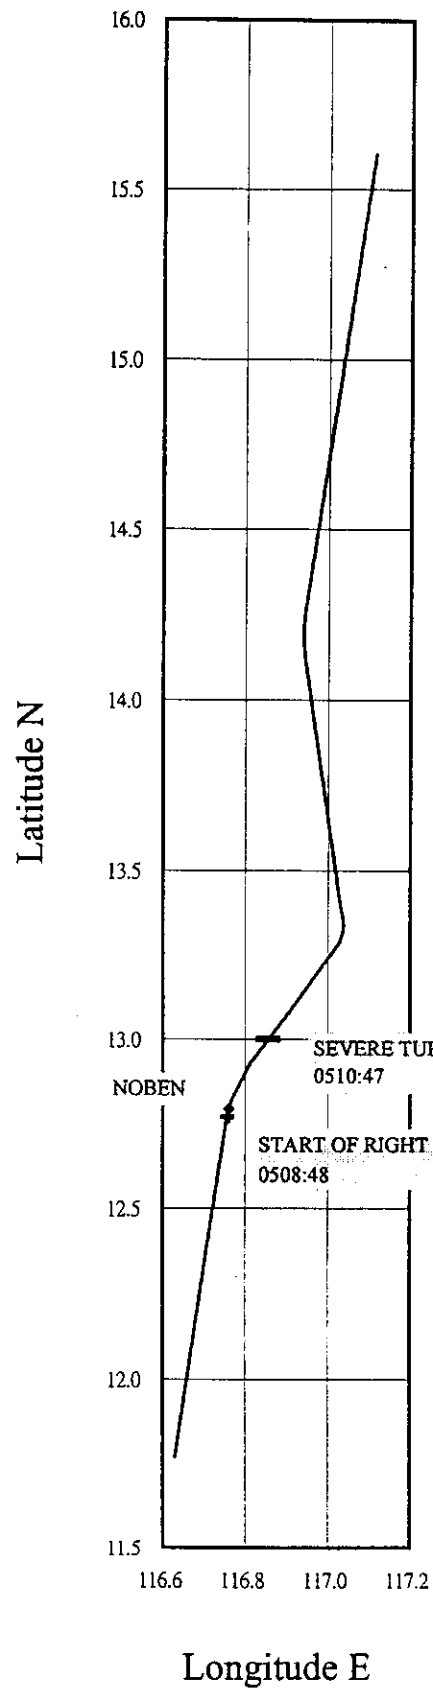
# PLOT OF DFDR DATA

1.3.2. The sudden jolts experienced inside the cabin were indicated by excursions of vertical acceleration in the positive (+) and negative (-) sense recorded by the DFDR. The maximum vertical acceleration encountered was + 1.89 'G' during the first gust, while during the second gust the acceleration reached a maximum of + 1.27 'G' and a minimum of - 0.52 'G'. These excursions occurred over a period of 17 seconds. An engineering inspection was carried out after landing and revealed no structural damage to the aircraft. (Appendix 3 shows the DFDR Data Plot during the period of turbulence encounter.)
