Accident Bulletin 1/2012

(An Update Bulletin to Accident Bulletin 2/2011)

**Update on Investigation into
Aircraft Accident to the Government Flying Service Eurocopter AS332 L2, B-HRN
during Fire Fighting Operation on 27 December 2010**

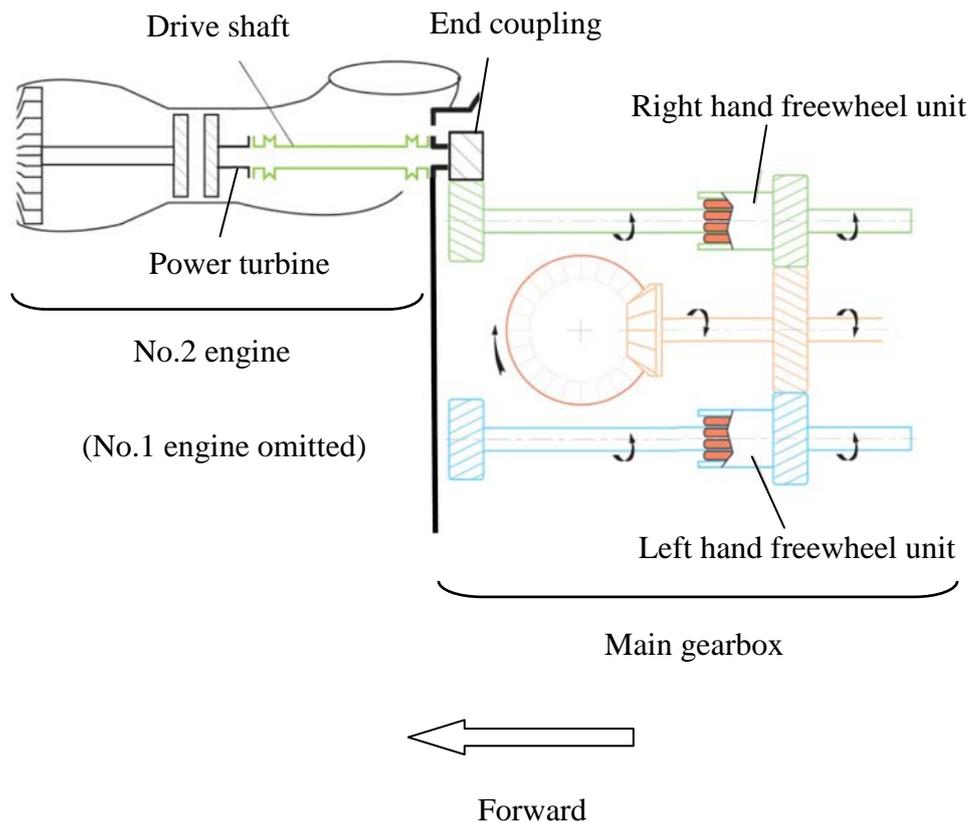
Figure 1 AS332 L2 Super Puma Engine to Main Gearbox Connection Configuration

6. The investigation so far did not identify evidence indicating that there was any anomaly internal to engine. Since the power turbine of both engines is a free turbine and it is mechanically connected to the corresponding freewheel unit inside the MGB, the team pursued investigation into a genuine overspeed of No.2 engine power turbine due to possibly a momentary ‘disconnect’ from the MGB.

7. The MGB, including the two freewheel units inside, were closely examined. There were no signs of damage. The condition of the right freewheel unit was similar to other freewheel units observed in overhaul, except that the level of fretting wear on the ramps of the freewheel shaft was a little higher than usual. On two of the ramps, there were signs and marks of roller sliding longitudinally. On other ramps, vertical scratch marks and metal pickup were observed indicating that the rollers could have slipped.
