Accident Bulletin 1/2011

(An update Bulletin to Accident Bulletins 1/2010 and 3/2010)

**Update on Investigation of
Aircraft Accident on CPA 780 on 13 April 2010
(Airbus A330-342 Registration Mark B-HLL)**

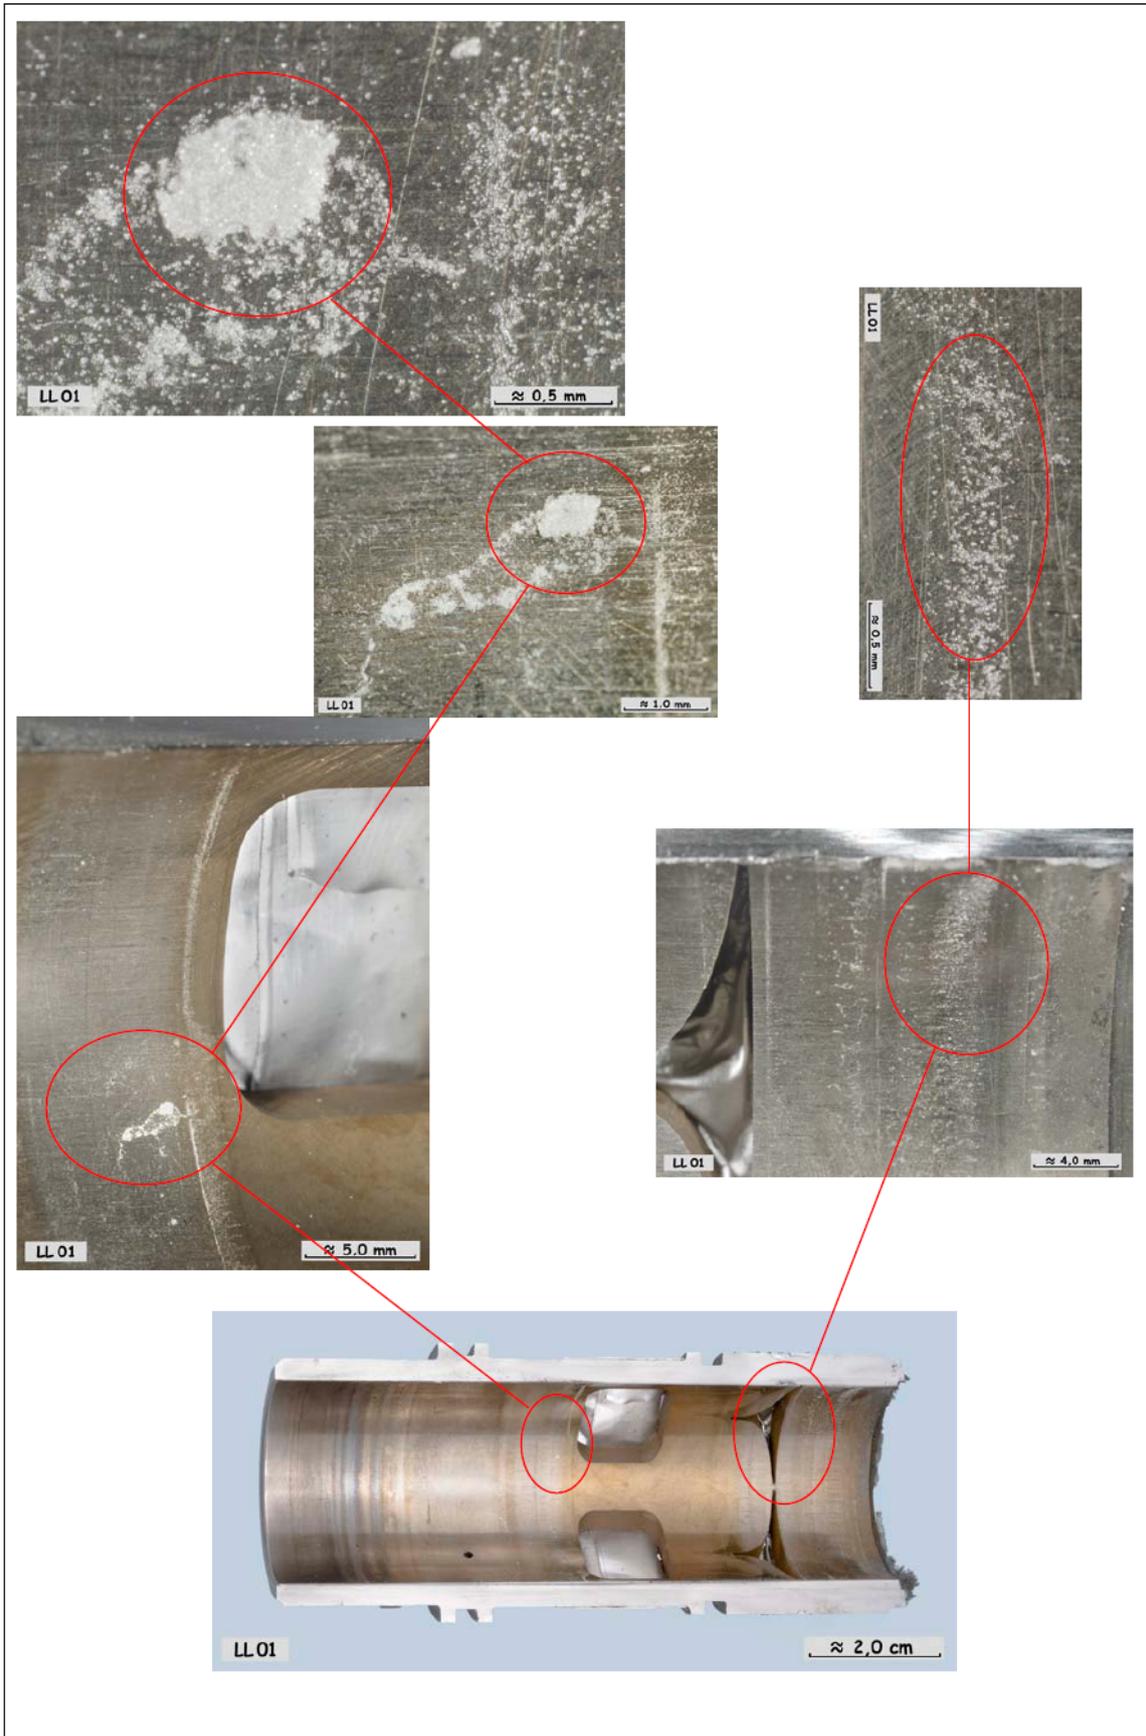
7. All the FDR data, QAR data, the PFR and the ACMS reports were reviewed and analysed. There was no evidence of unusual command signal from the Electronic Engine Control (EEC), the manual thrust, and the auto thrust systems. The engine fuel system components were subject to detailed examination. This revealed that the MMV in the FMU of both engines were seized at positions consistent with the corresponding final engine power. The VSVC from No. 2 engine was also found seized. These seizures were caused by contaminant in the form of fine spherical particles (spheres), evidence of which was found throughout the engine fuel system and in fuel samples from the aircraft tanks. The abnormal engines performance during the flight was believed to have been caused by stiction and eventual seizure of the MMV.

8. The spheres that seized the MMV of the FMU of both engines were in the order of 5 to 20 microns in size (see Figure 1). In other areas of the fuel system, spheres of 30 microns in size were also identified. Analysis showed that the spheres contained carbon, oxygen, sodium, chlorine, and sulphur (see Figure 2) and were mainly sodium polyacrylate, which was consistent with the super absorbent polymer (SAP) material used in the filter monitors on a fuelling dispenser. Further analysis revealed the presence of crystalline sodium chloride on the surface of some spheres (see Figure 3). [Note: Filter monitor removes small amount of particulate matter and dispersed free water from aviation fuel. On contact with water, the SAP absorbs the water and turns into gel that swells to fill the monitor, and in extreme situations, the gelling process may shut off the flow across the monitor completely.]

Figure 1: The cut-away view of No. 1 engine MMV sleeve showing the presence of spheres. Similar spheres were also present in No.2 engine MMV sleeve.

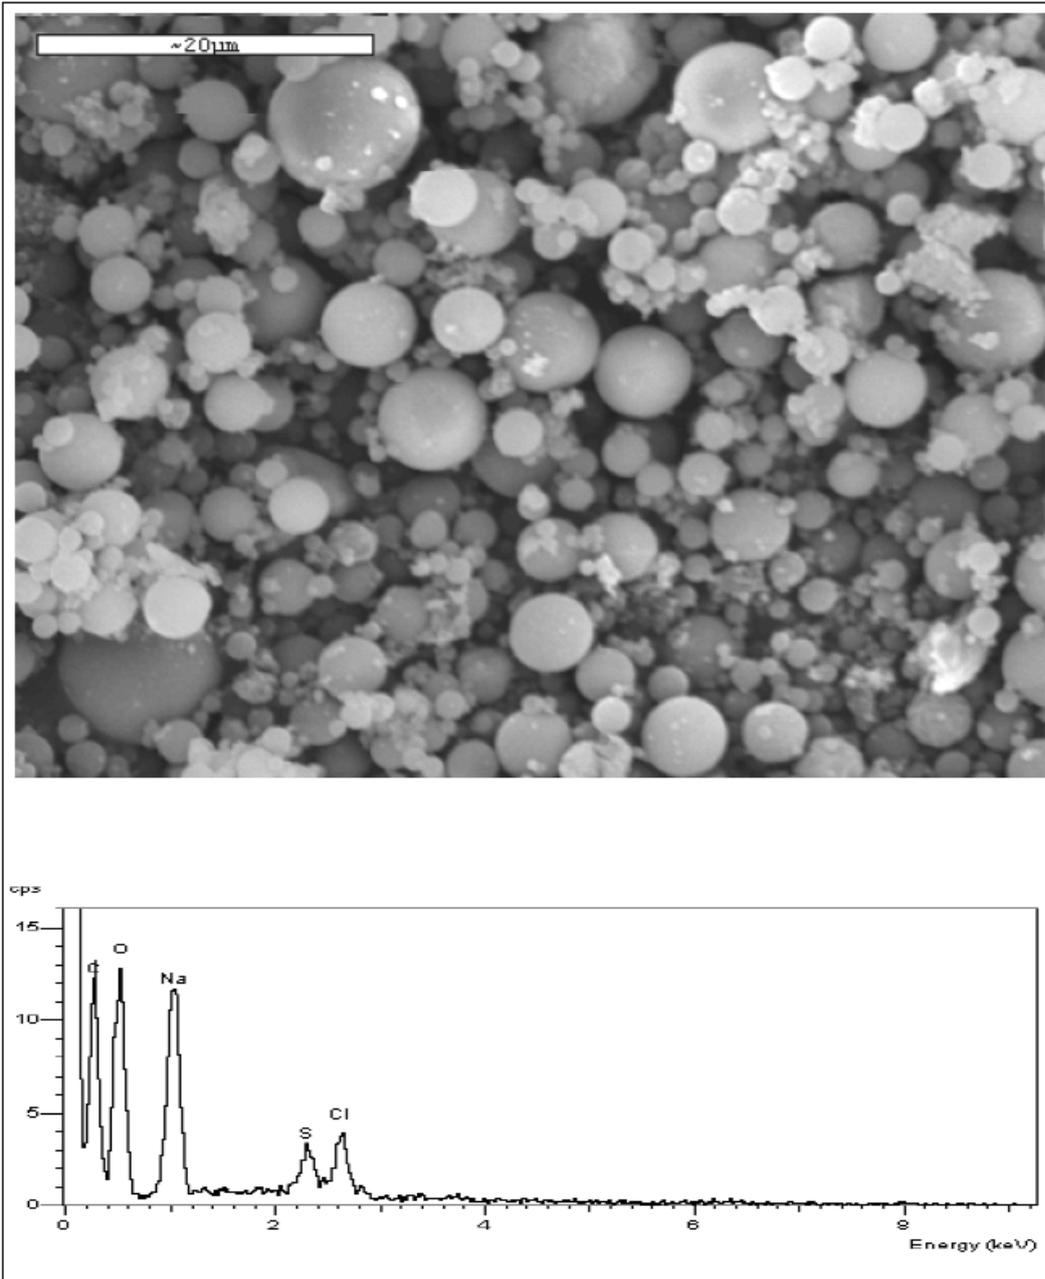
Figure 2: Microscopic view of spheres and their composition under Scanning Electronic Microscope (SEM) analysis.

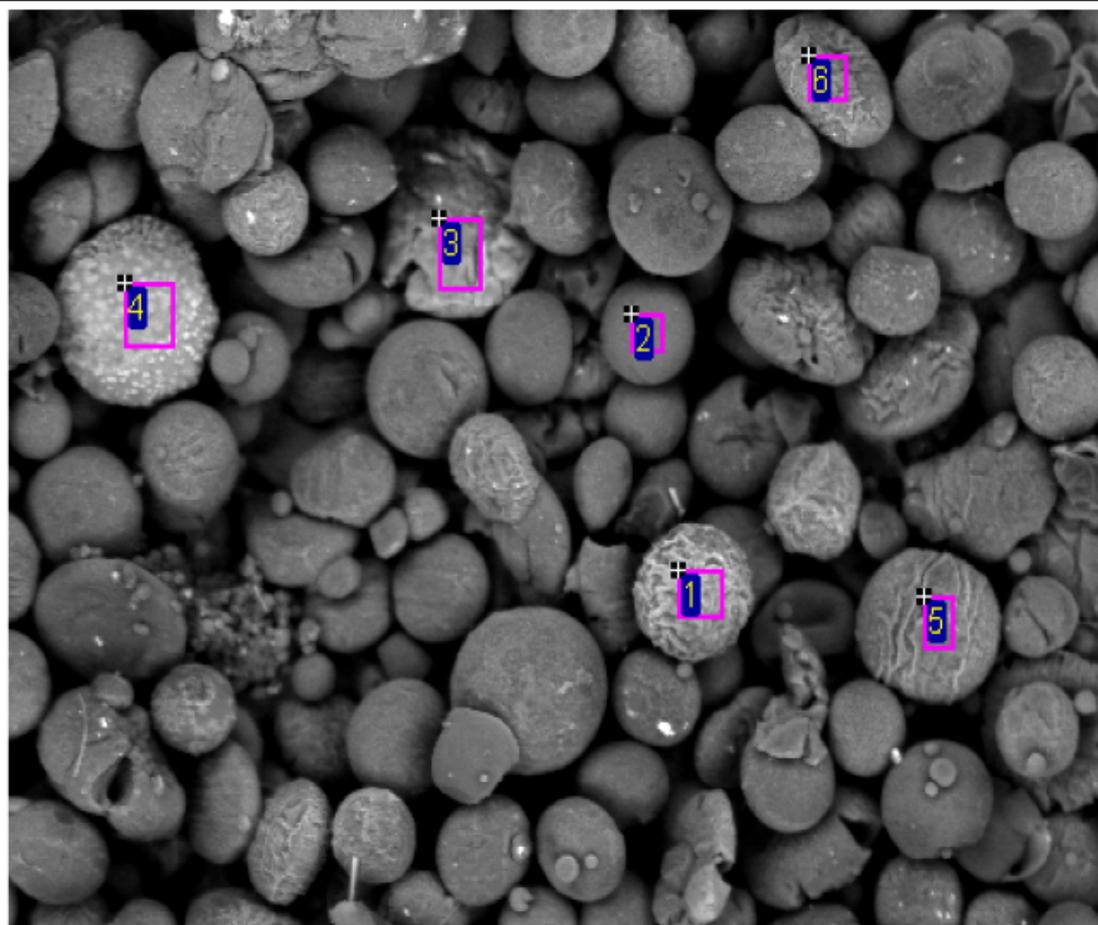
Spectrum	C	O	Na	S	Cl	
1	51.71	30.98	13.40	0.58	3.33	More Cl (and presumably NaCl) on brighter spheres
2	71.52	20.42	7.39	0.25	0.42	
3	53.93	29.74	11.60	0.60	4.13	More Cl (and presumably NaCl) on brighter spheres
4	35.50	42.06	16.46	2.83	3.15	More Cl (and presumably NaCl) on brighter spheres
5	54.82	32.16	11.47	0.46	1.08	
6	54.87	31.48	10.69	0.66	2.30

Figure 3: The presence of crystalline sodium chloride on the surface of some spheres.

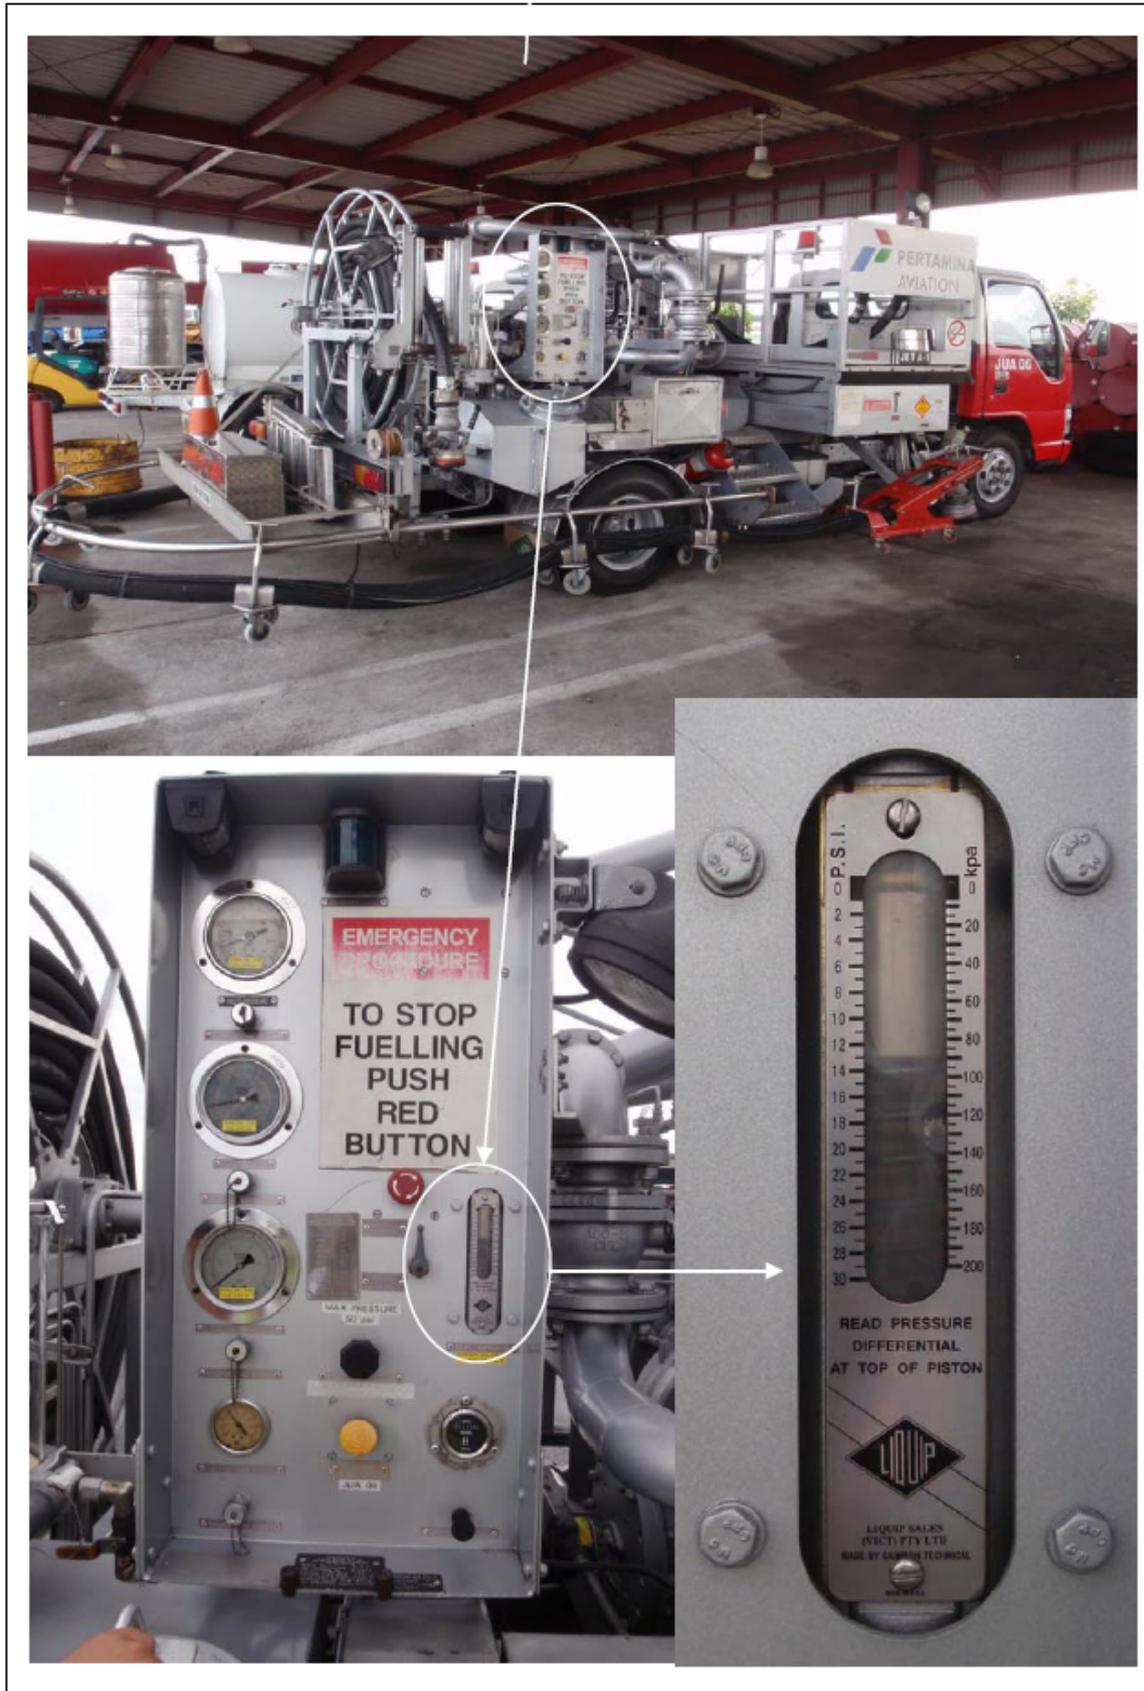
- The dispensers were mostly operated at flow rates well below the capacity defined by the dispenser manufacturer. Such low flow rate operation could reduce the effectiveness of the differential pressure monitoring (See Figure 4), which a high differential pressure would indicate clogging of the filter monitors in the dispenser, and therefore possible contamination of the fuel.

- The recording and monitoring of the weekly differential pressure of the dispensers was not performed properly. The differential pressure reading, which was taken under low flow rates during refuelling operation, may not have correctly indicated the condition of the filter monitors.

Figure 4: The differential pressure gauge of a dispenser.

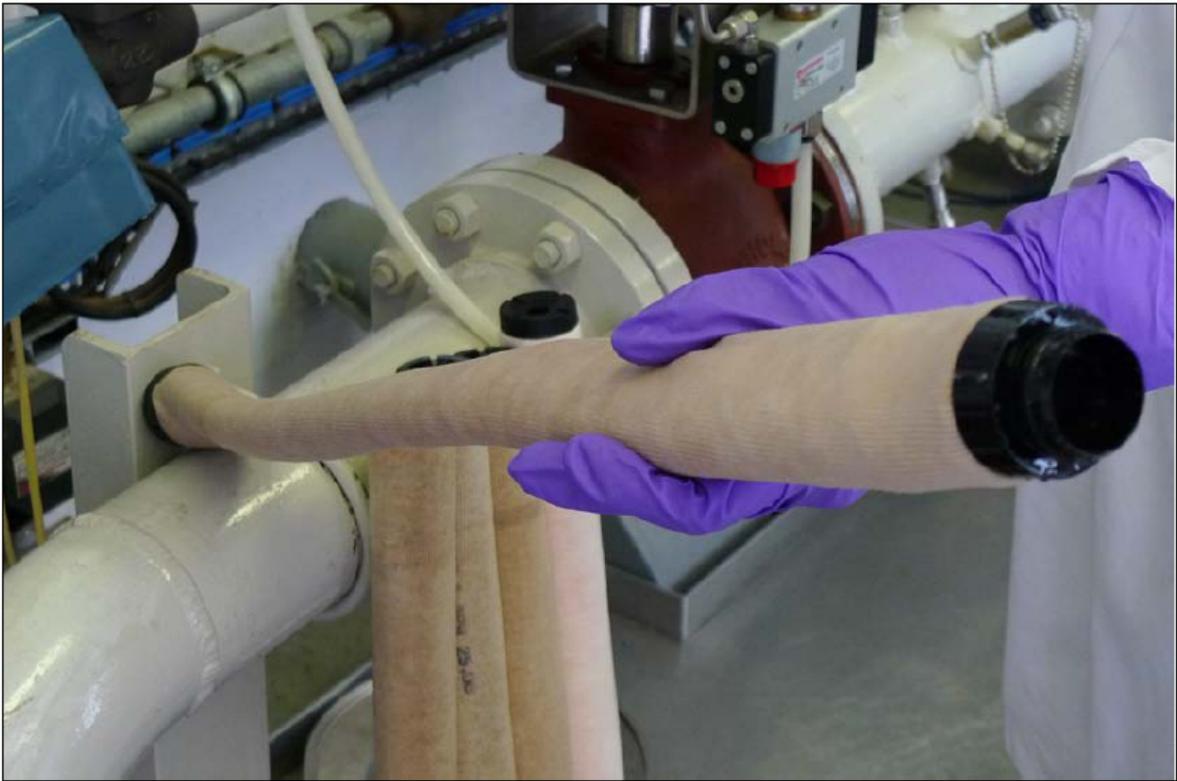
17. It was noticed that one of the forty filter monitors (Model FG-230-4) was found collapsed when it was being removed from dispenser JUA06 for the investigation. Subsequent tests showed that the collapsed FG-230-4 did not allow flow across the monitor when installed in a test rig. Further test on similar FG-230-4 demonstrated that they could be collapsed in a bulk water "slug" test and a collapsed monitor could lose their structural rigidity and shorten in length by up to 20 mm (See Figure 5a and 5b). A study of the installation of FG-230-4 inside the filter vessel of the dispenser indicated that a collapsed FG-230-4 could be dislodged inside the vessel when there is sufficient back pressure, which could result in fuel bypassing the filtration system. Nevertheless, occurrence of filter bypass in previous refuelling could not be established.

18. The FG-230-4 support core is metallic and should withstand a differential pressure of 12 bars to meet the specification defined in document EI 1583 "Laboratory tests and minimum performance levels for aviation fuel filter monitors" 4th Edition. The manufacturer of this filter monitor, Facet International (Facet), indicated that their FG-230-4 passed annual quality testing which include the collapse pressure test. However, Facet conducted additional tests after this occurrence on FG-230-4 from the stock of various lots and the results showed a collapse pressure of 11 to 11.5 bar range which would fall below the 12 bar requirement. In a typical operating conditions, the refuelling system will seldom reach 11 bar pressure and a 12 bar requirement is in place to include a considerable margin above typical operation. At the time of writing this Bulletin, Facet was redesigning the FG-230-4 to provide additional strength.

Figure 5a: A collapsed monitor loses the structural rigidity.

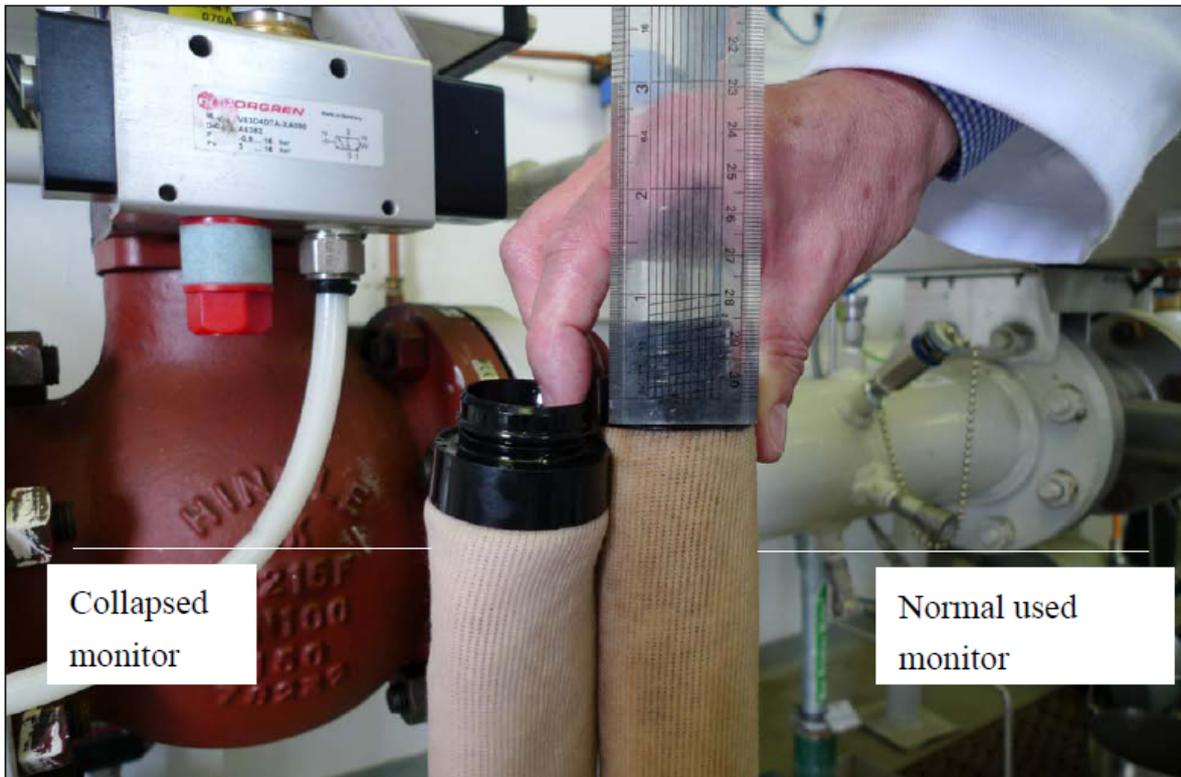
Figure 5b: A collapsed monitor is shorter than a normal monitor.
