AIRCRAFT ACCIDENT REPORT 1/2014

**Report on the accident to Aerospatiale SA 315B LAMA
Registration B-HJV operated by Heliservices (Hong Kong) Limited
on the hillside of Kau Lung Hang Lo Wai, Fanling, Hong Kong
on 3 January 2011**

**Hong Kong
January 2014**

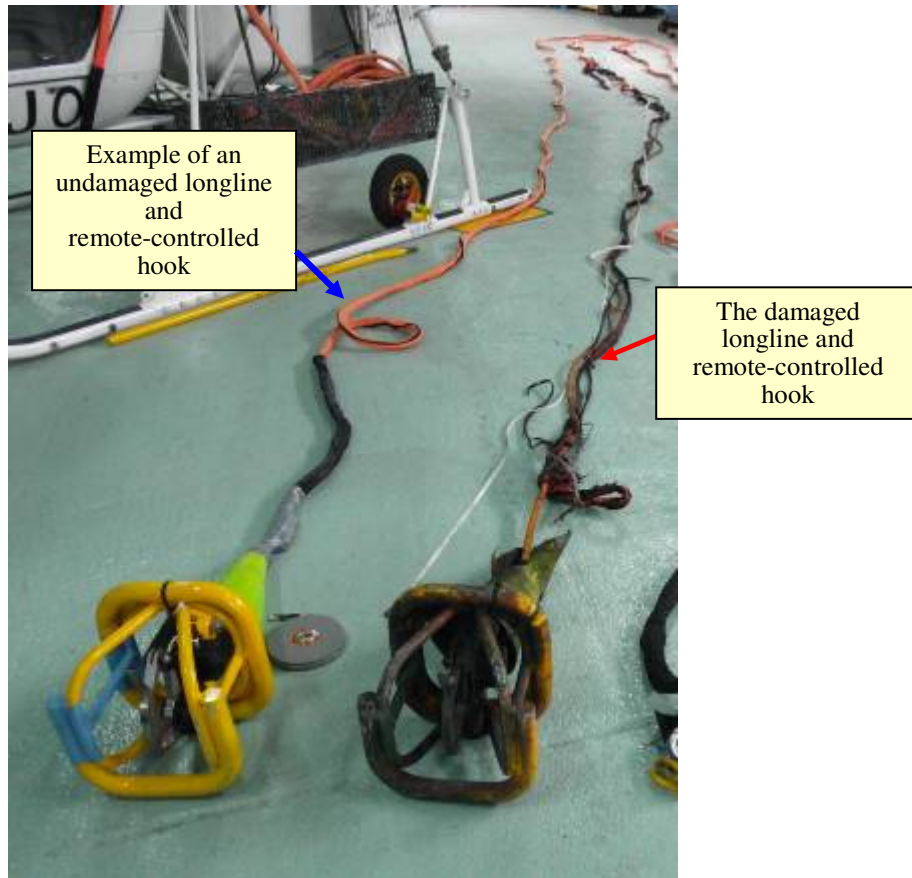
Photo 5 : The longline and remote-controlled hook

Both the longline and remote-controlled hook of the underslung assembly were found to have been damaged after the accident (See Photo 5).

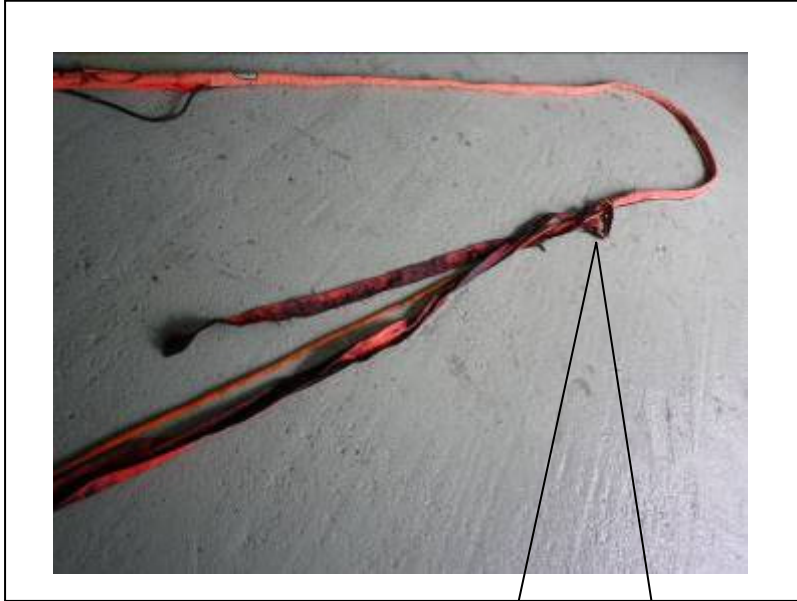
Photo 6 : The damaged longline

1.3.2.1.1 The lower 11 metres of the 30.5 metres (100-foot) longline's protective nylon jacket was found to have been crisped and fragmented with a large portion of the shrouded electrical cable missing. The yellow rubber sleeve above the remote-controlled hook was also found to have been badly burnt. The length of this damaged section of the longline was consistent with the height of the overhead lines at Pole 9 of the FNL-TKR No. 1 Circuit.

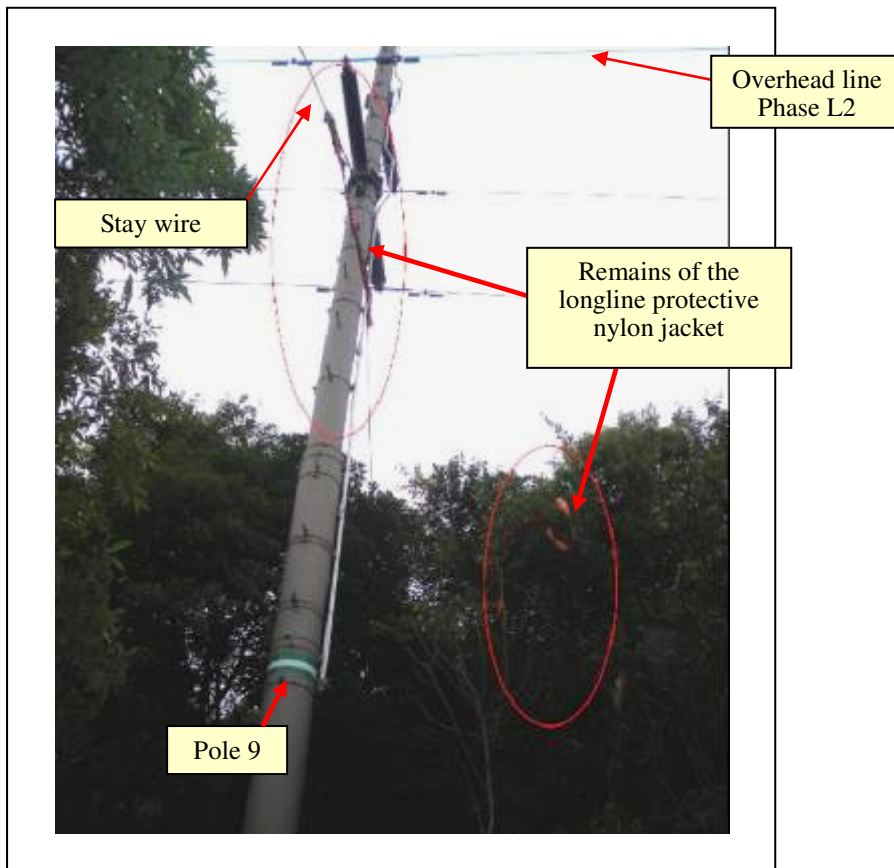
1.3.2.1.2 Remains of the protective nylon jacket were found to have been scattered over the accident site with some hanging on the nearby tree branches and the Stay Wire which was used to provide mechanical support and anchorage to Pole 9.

Photo 8 : Remains of the longline’s protective nylon jacket found on the Stay Wire and nearby tree branches

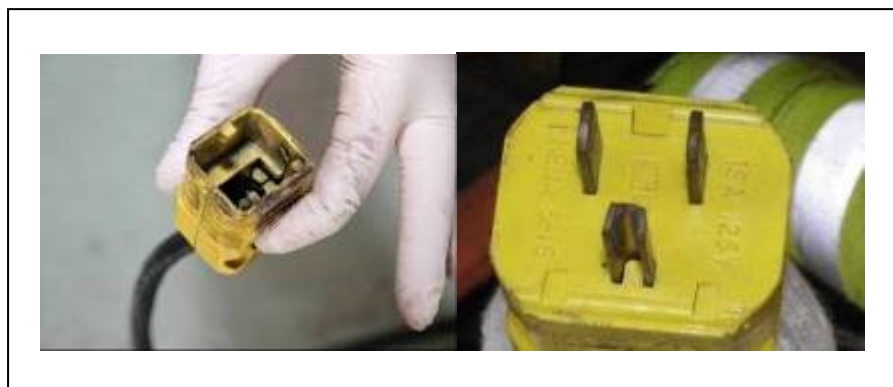
1.3.2.1.3 The 3-pin electrical plug which connected the longline’s low voltage cable to the helicopter electrical circuit was found to have been damaged.

Photo 9 : The damaged electrical plug (left) and example of an undamaged electrical plug (right)

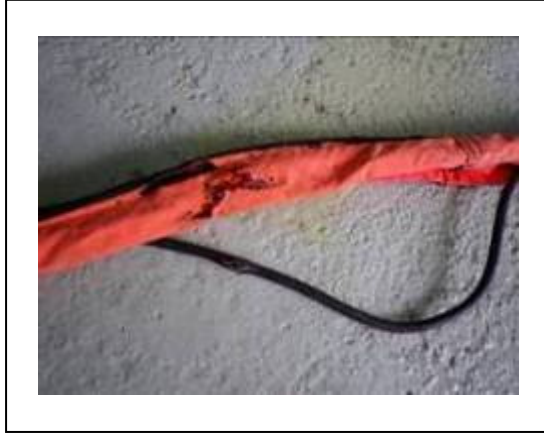
- 1.3.2.1.4 The upper 20 metres portion of the longline was found to have remained mostly intact and undamaged, except for some burn marks found along the protective nylon jacket and minor damage was found at a few locations of the low voltage electrical cable.

Photo 10 : A close view of the upper portion of the longline where burn marks and slight damage were found

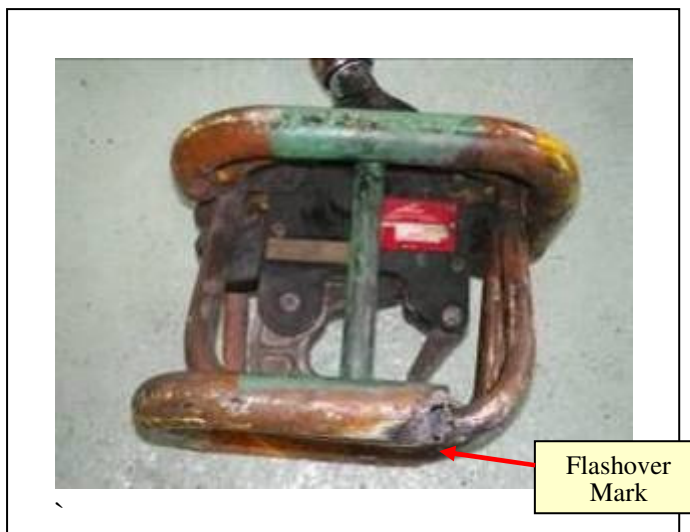
- 1.3.2.2.1 The remote-controlled hook which was connected to the bottom end of the longline was charred, showing clear burn marks and signs of flashover. The release mechanism was damaged with an unserviceable solenoid.

Photo 11 : The charred remote-controlled hook

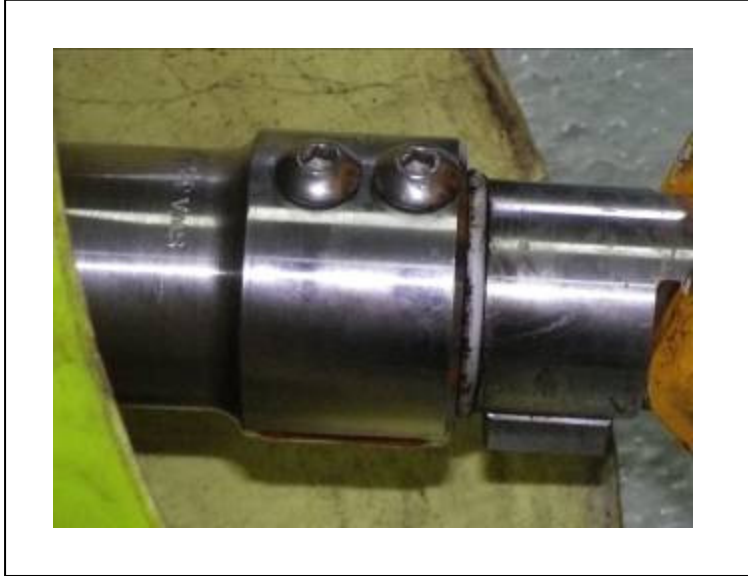
1.3.2.2.2 The bearing which connected the longline to the remote-controlled hook, allowing turning movements of the two parts, seized up.

Photo 12 : The seized bearing

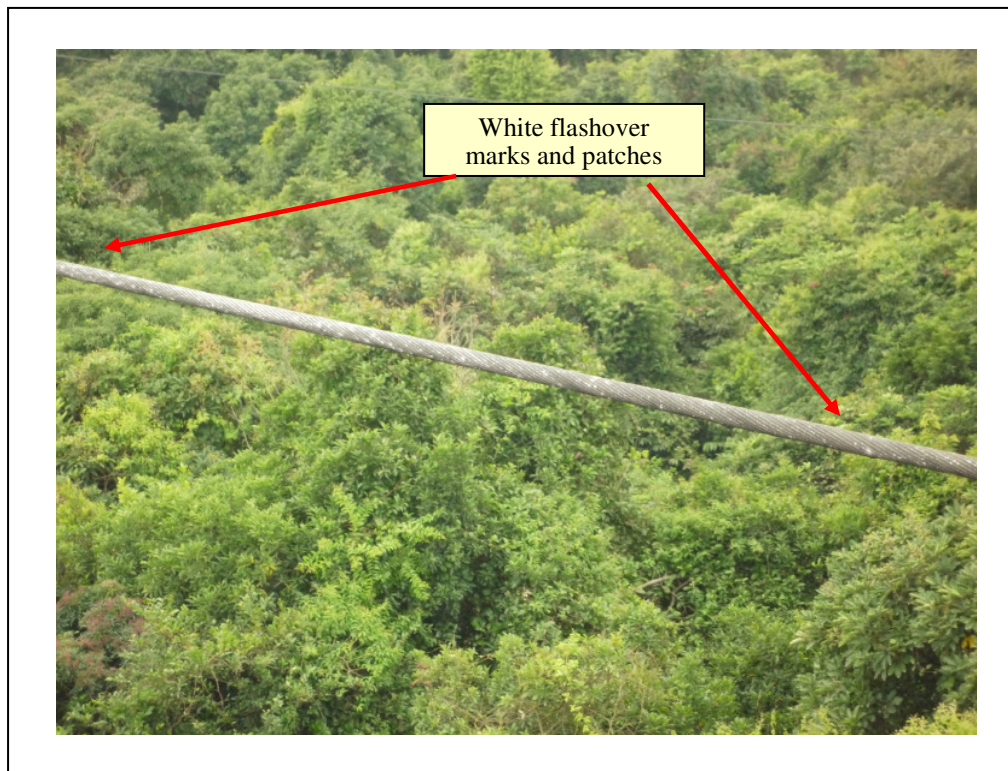
1.4.1.1 Some white flashover marks and patches were found on the overhead Phase L2 conductor at locations approximately 2 to 4 metres from Pole 9 towards Pole 10. This indicated that flashover had occurred at or close to this area. The event log of CLP (See Section 1.16.2 and Appendix A) which showed substantial disturbances in the voltage and current waveforms of Phase L2 also confirmed that a short circuit had occurred in Phase L2 of the FNL-TKR No. 1 Circuit.

Photo 13 : White flashover marks and patches found on the overhead Phase L2 conductor

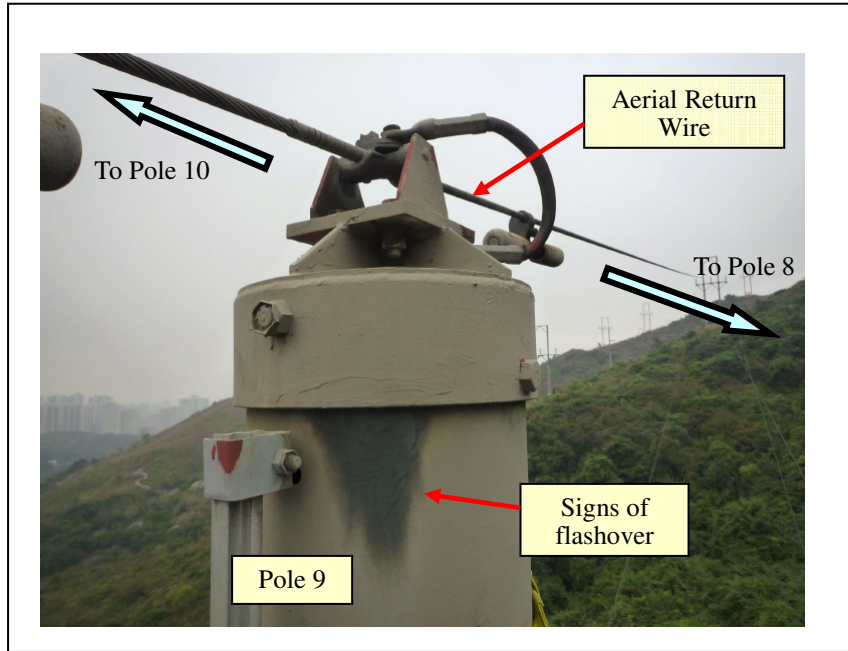
1.4.1.2 Burn marks were also found at various earth connection points on the pole, including at the top of Pole 9 where it connected the aerial return wire and at the bottom of the pole where it connected to ground.

Photo 14 : Burn mark at the top of Pole 9

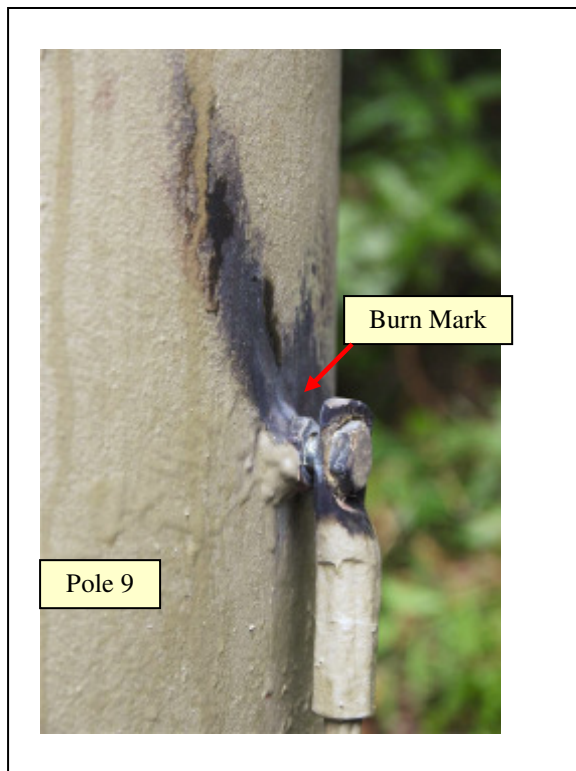
Photo 15 : Burn mark at the earth connection point to ground at the bottom of Pole 9

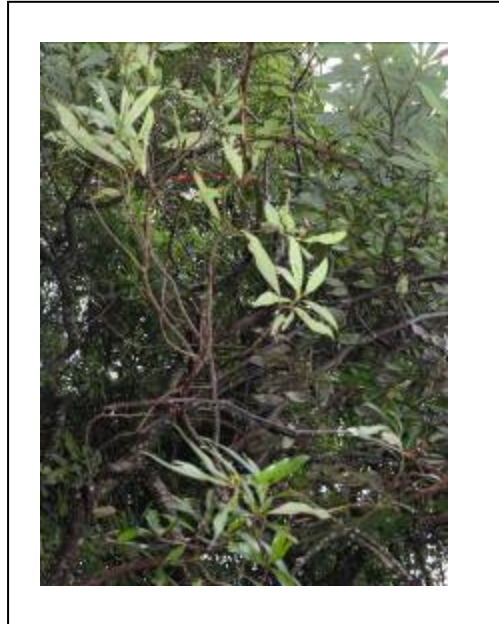
1.4.2.1 Some of the tree branches surrounding the accident site were also found to have been burnt.

Photo 16 : Burnt tree branches surrounding the accident site

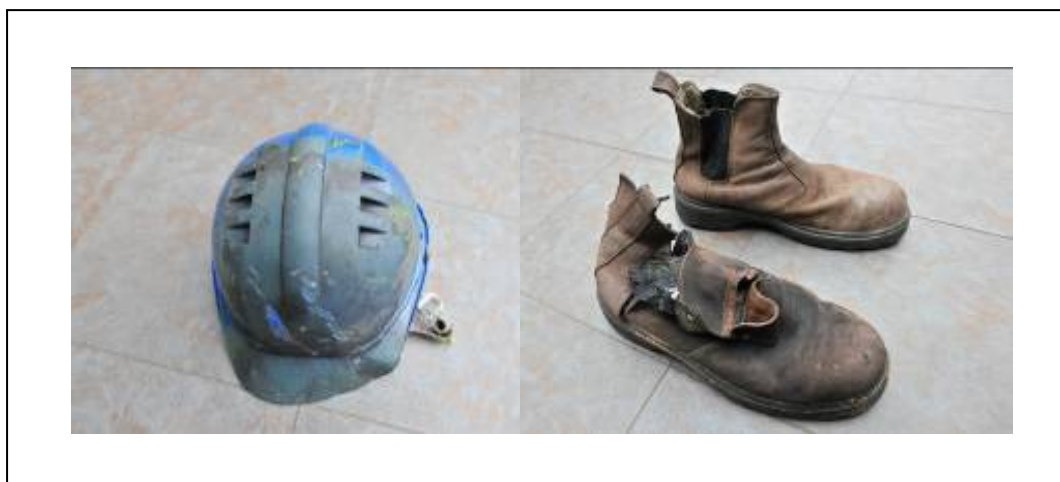
1.4.2.2 The clothing and Personal Protective Equipment (“PPE”) of the injured ground workers was burnt and damaged.

Photo 17 : Burnt PPE of the workers

1.15.4 On arrival, Worker 1 who suffered serious burn injuries was seen lying on his back on the steep slope, assisted by Worker 3 who had also suffered minor injuries. The thick winter clothing and PPE of both workers which included inter alia, a safety helmet, safety shoes and work gloves, were burnt and damaged.

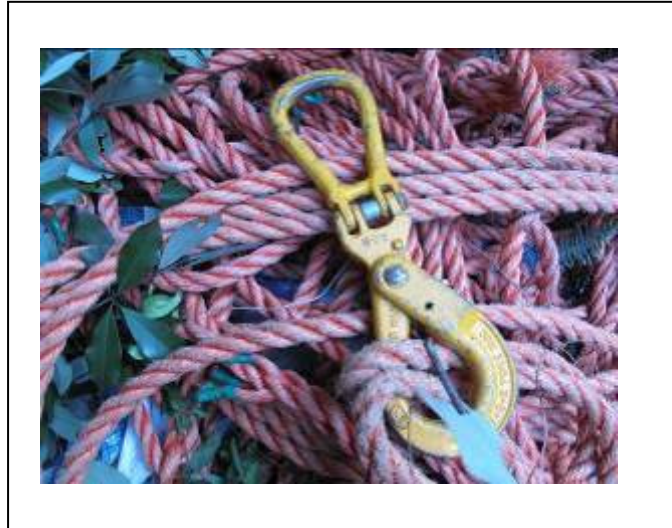
1.4.2.3 Unlike the underslung assembly, the cargo net and the “8-shaped” hook, which connected the cargo net to the underslung assembly, were left at the accident site alongside the cargo load. They were found mostly intact with no burn marks or mechanical damage.

Photo 18 : The “8-shaped” hook

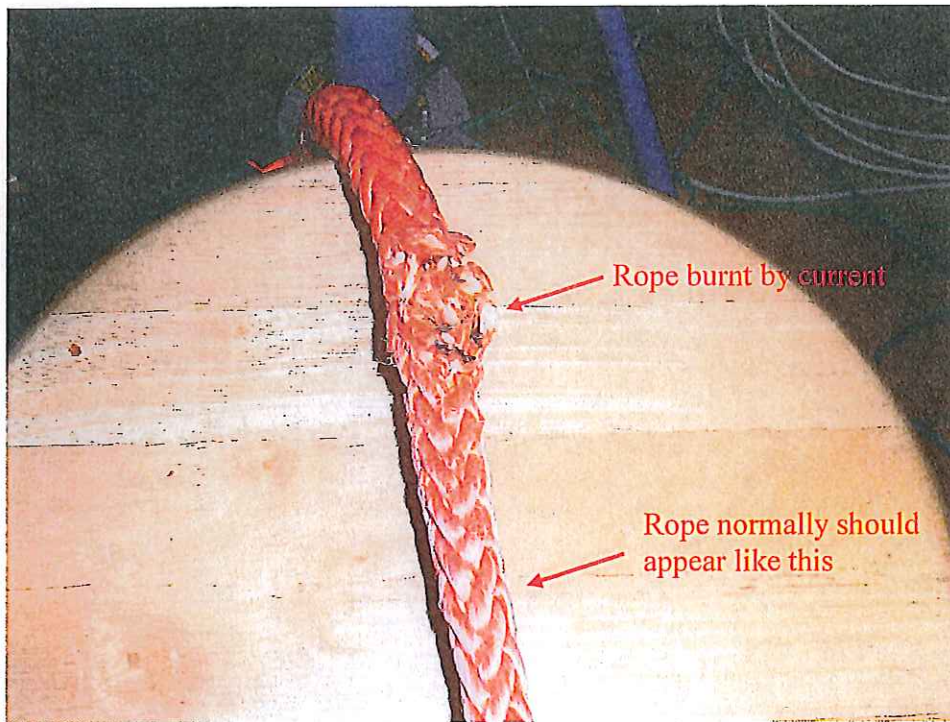
fire (as mentioned in the table above) was put off as shown in Fig. F3. It is also worth noting that the fire broke out at a location at which the electrical resistance was high (probably due to inhomogeneous electrical properties of the rope because of bending, for example).

Fig. F3 The polyethylene rope was burnt when the sheath was broken down electrically with an application of 40 kV
