AIRCRAFT ACCIDENT REPORT 1/2013

**Report on the accident to Eurocopter AS332 L2 Super Puma
Registration B-HRN operated
by the Government Flying Service of Hong Kong
at Shing Mun Reservoir on 27 December 2010**

**Hong Kong
April 2013**

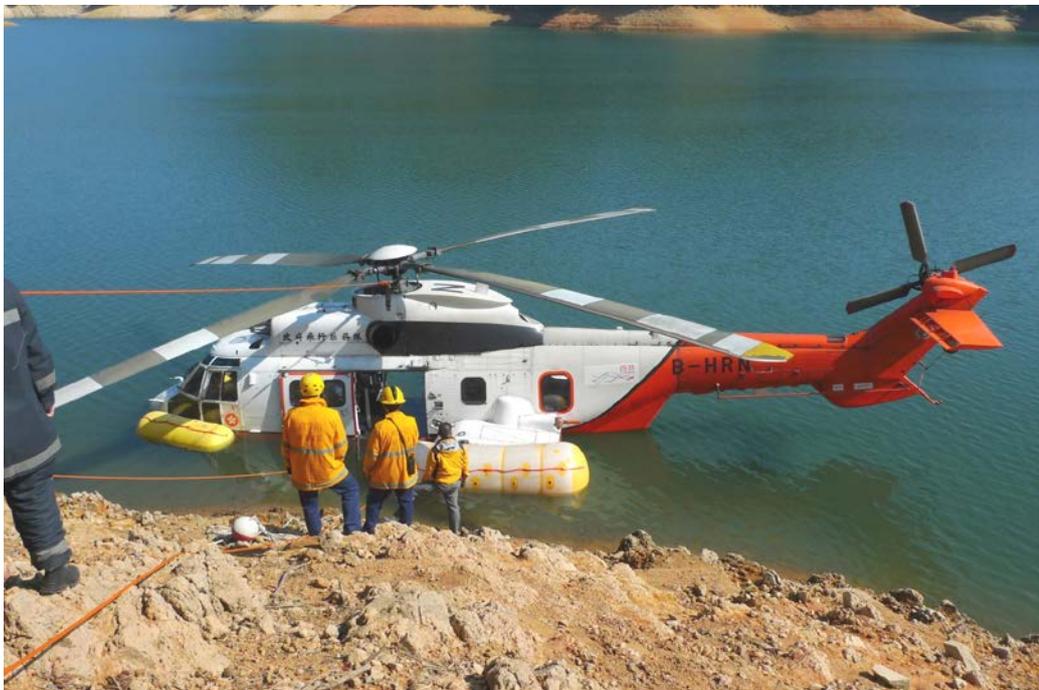
Figure 11 B-HRN on Floats and Secured

The helicopter ditched in a controlled manner with the four emergency floats deployed and fully inflated, and it was then kept afloat. There was no structural damage to the helicopter caused by the accident. Some of the airframe, electrical and electronic components were damaged due to being submerged into water. The helicopter was rescued from the reservoir two days later and transported back to the GFS Headquarters for further investigation.

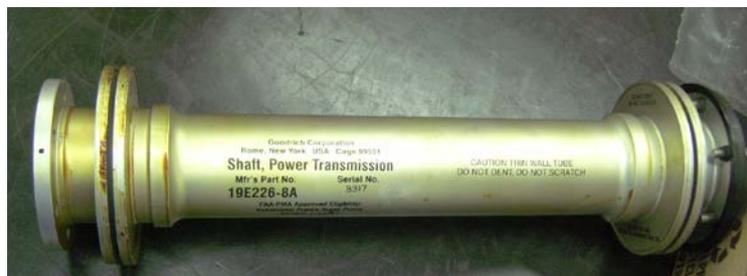
Figure 13 No.2 Engine-to-MGB Coupling Shaft of B-HRN

The coupling shaft and its connections were inspected. The shaft was intact and there were no anomalies observed at the connections. The sensors for measurement of the No.2 engine power turbine rotational speed were checked and their functionality was found normal. This ruled out the possibility that a nuisance warning of the No.2 engine NF had happened and incorrectly triggered the automatic shutdown of No.2 engine.

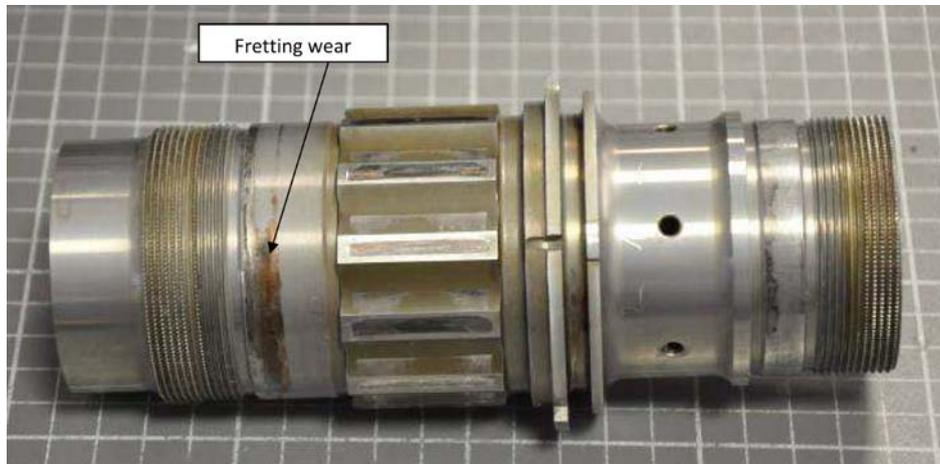
Figure 14 Fretting Wear at the Support Area of the Freewheel Shaft

Although the existence of this kind of fretting wear was consistent with what usually observed on other freewheels in the D-level workshop, the level of fretting

on this freewheel shaft was a little higher than what was usually observed during MGB overhaul.

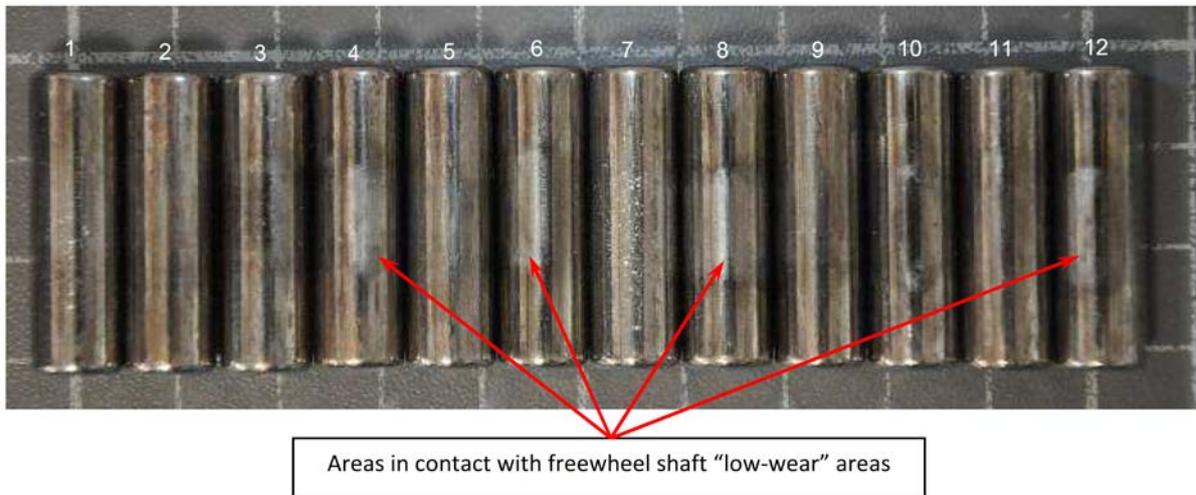
Figure 15 Signs of Contact with the Ramps on the Rollers

The rollers were found in conformity with the specifications. During the detailed visual inspection, signs of contact with the ramps at the “low-wear” areas were visible. Fretting wear were also shown at the end surfaces in contact with the freewheel cage.

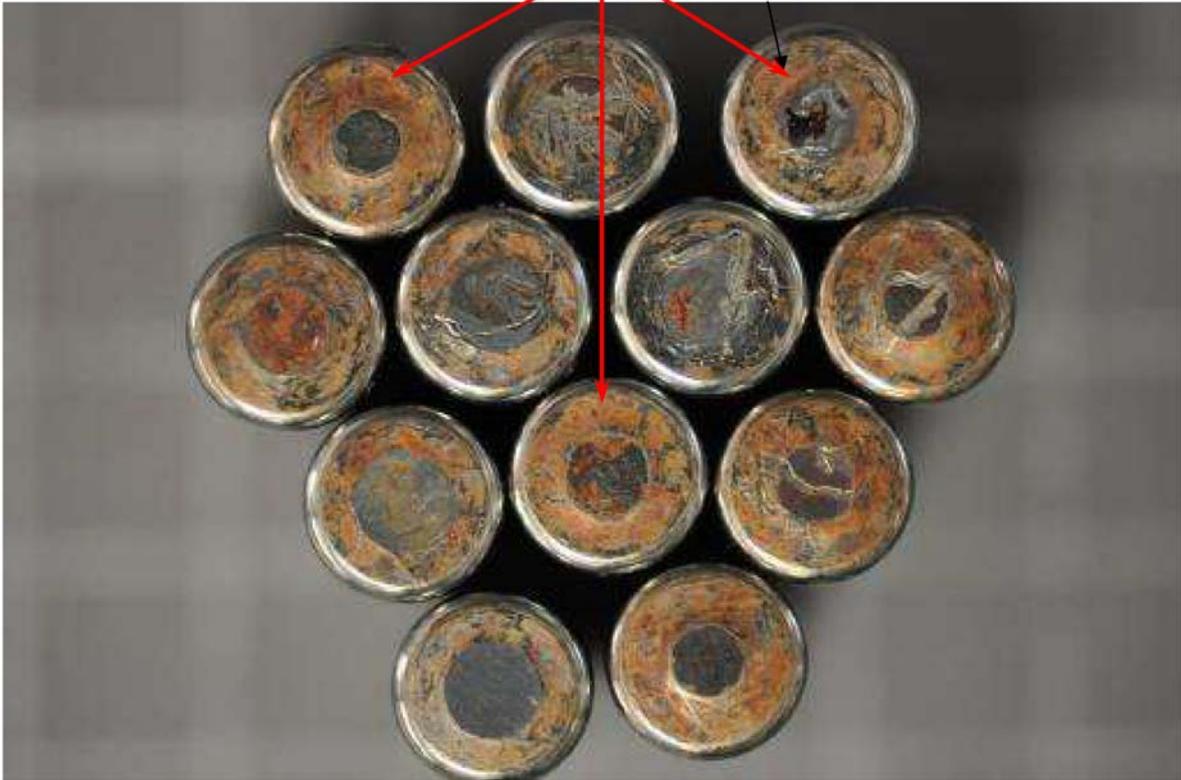
Figure 16 Wear on the Ends of the Rollers

Fretting wear showing contact with the freewheel cage

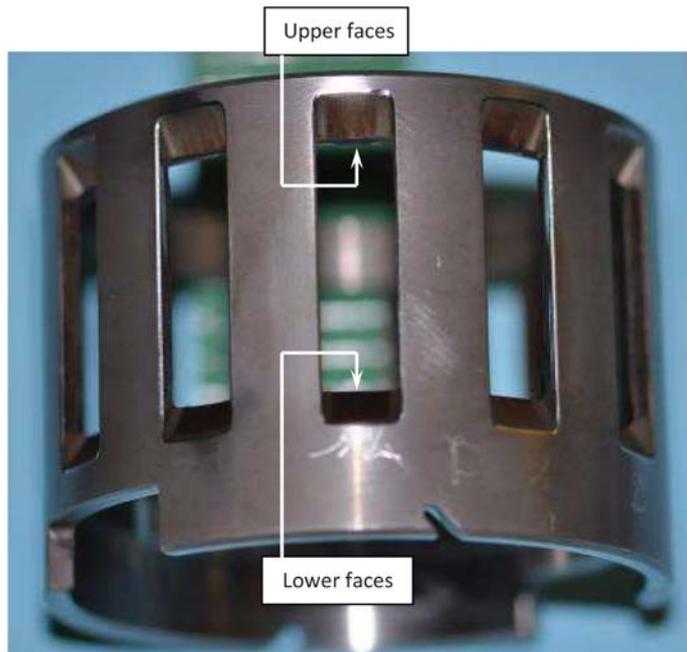
Figure 17 Upper and Lower Faces of Cage

On the other hand, fretting wear was observed at the upper and lower faces of the cage. However, the fretting wear was considered normal. In addition, the guidance springs for the cage were also found in good conditions.

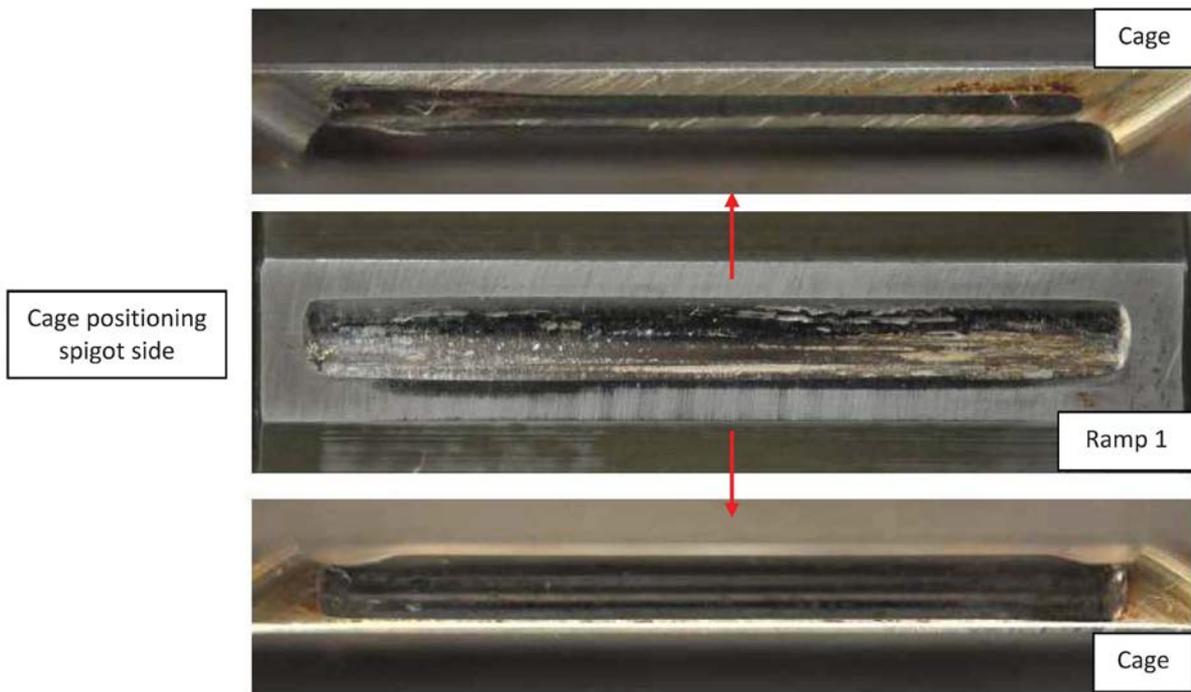
Figure 19 Comparison of Wear on Cage Recess Facing Ramp #1

Furthermore, from the wear on the lateral surfaces of the cage recess facing ramp #1, and similarly on ramp #7, it could be observed that the roller had stayed parallel to the ramp and the recess during the operation. The photographs of #1 ramp and cage recesses are shown as follows.

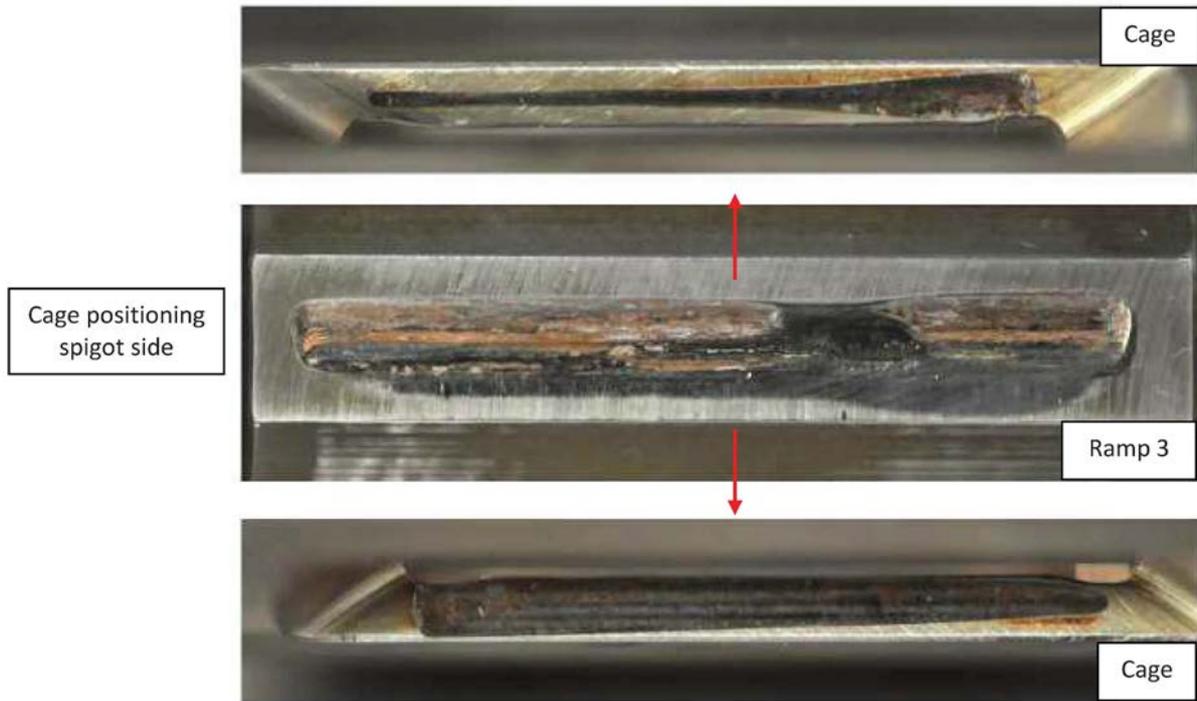
Figure 20 Comparison of Wear on Cage Recess Facing Ramp #3

A similar comparison was carried out on ramp #3 and the cage recess. It could be observed that the roller did not work parallel to the ramp and the cage recess, probably due to the micro-displacement of the roller. Similar wear shapes were also observed on ramps other than ramp #1 and #7.

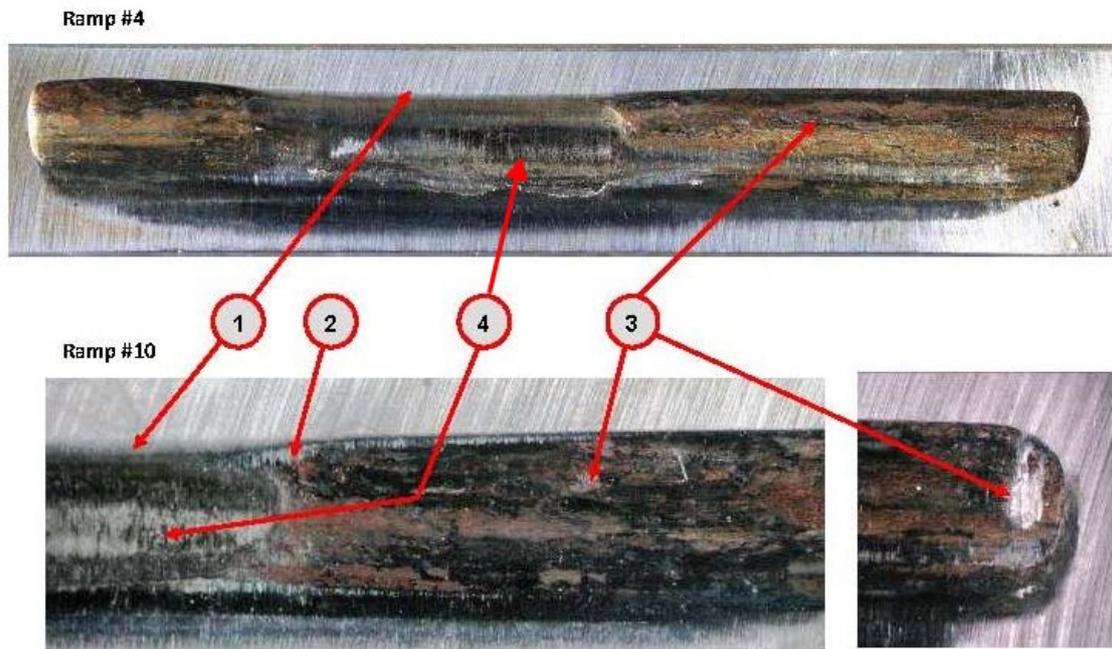
Figure 25 Wear Analysis on Ramp #4 and #10

In the wear of ramp #4 and #10, the wear depth at the central area was much lower than those at both ends of the worn areas at which fretting wear was also observed.

On these “low-wear” areas, circumferential scratches were observed indicating that the rollers had slipped on these areas.

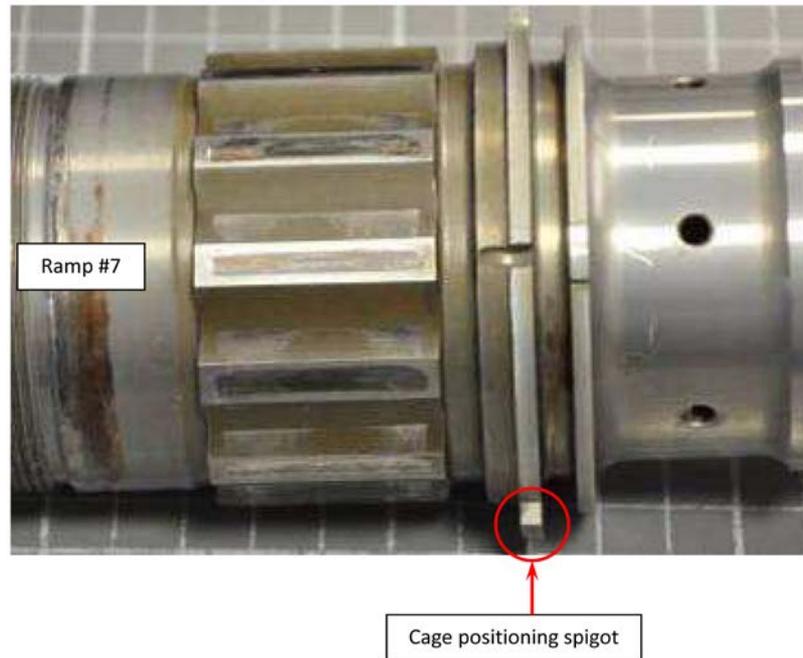
Figure 26 Ramp #7 and Spigot

Ramp #1 and #7 were located at 90° to the spigots which position the cage on the freewheel shaft. Therefore, these two ramps were diametrically opposite to each other.

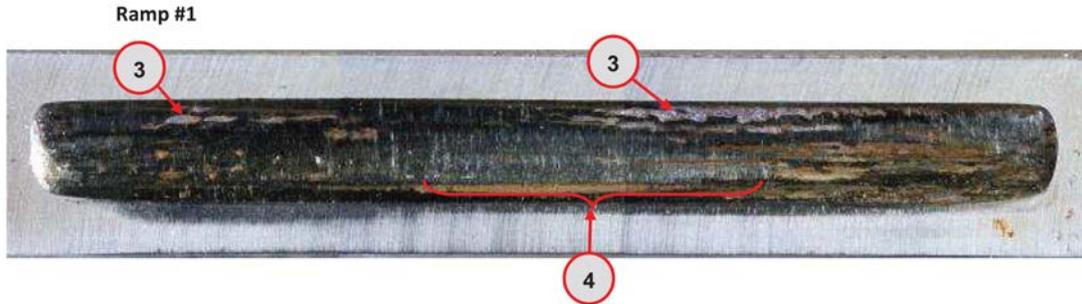
Figure 27 Wear Analysis on Ramp #1

On the whole width of these two ramps, there were wear signs or marks of metal pick-up and scratches indicating roller skidding. Unlike other ramps of this freewheel shaft, the wear on these two ramps was parallel to the nominal axis of the ramps and the wear depth was quite constant all along the ramp width. This confirmed that the roller stayed parallel to the ramp and the cage recess. However, this kind of wear shapes was not observed on other freewheels. This could be due to a particular cage behaviour which was still not fully understood.
