**SERIOUS INCIDENT REPORT 1/2011**

Report on the Serious Incident of an Attempted Take-off on Taxiway

Flight FIN070 Airbus A340-300 OH-LQD

at the Hong Kong International Airport

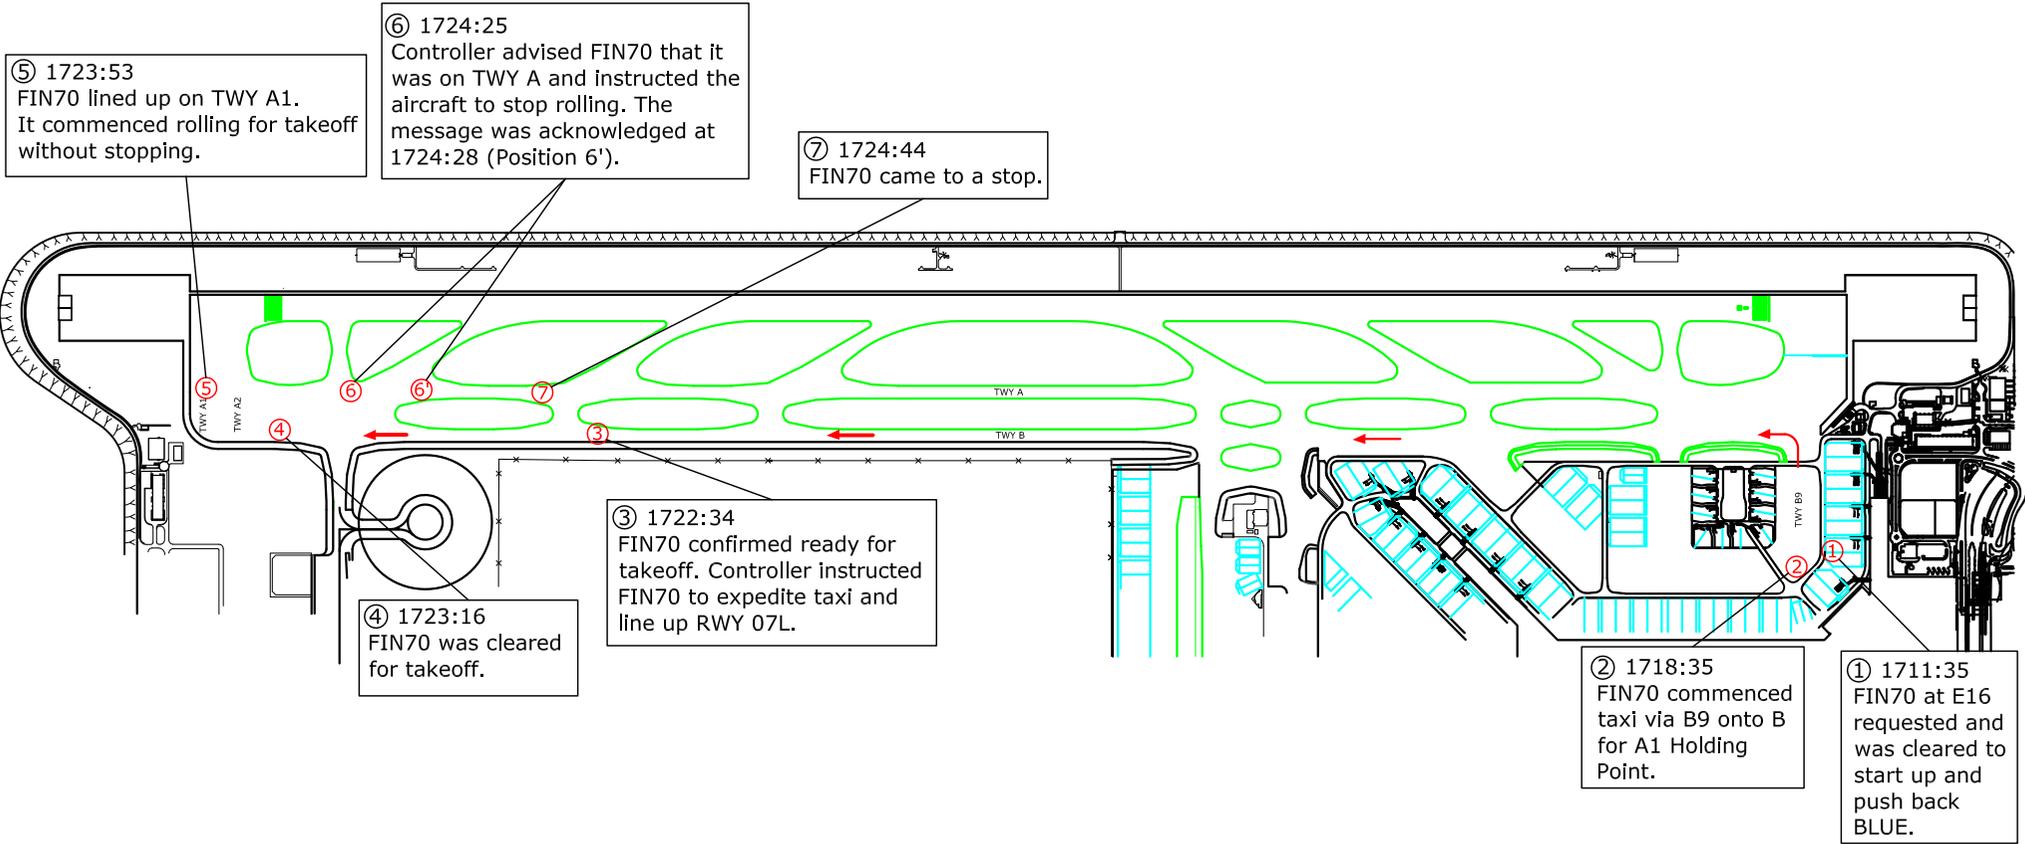
# Aircraft Track of FIN070 Based on A-SMGCS Recording

When FIN070 was approaching the RWY 07L Holding Point towards the western end of TWY B, the Air Movements Controller (AMC) cleared the aircraft for take-off. The aircraft took the normal right turn at the end of TWY B onto TWY A1 towards RWY 07L. However, before the aircraft reached the runway, it took a premature right turn onto TWY A, a taxiway parallel to and situated in between RWY 07L and TWY B. Upon entering TWY A and being aligned with the 07L orientation, it commenced a rolling take-off. This abnormal manoeuvre was detected by the Ground Movements Controller (GMC) on the Advanced Surface Movement Guidance and Control System (A-SMGCS), who promptly alerted the AMC. The AMC immediately instructed FIN070 to stop rolling. The aircraft came to a halt abeam TWY A5, approximately 1400 metres (m) from the western end of TWY A. (The aircraft track of FIN070 based on A-SMGCS recording is shown in Appendix A)

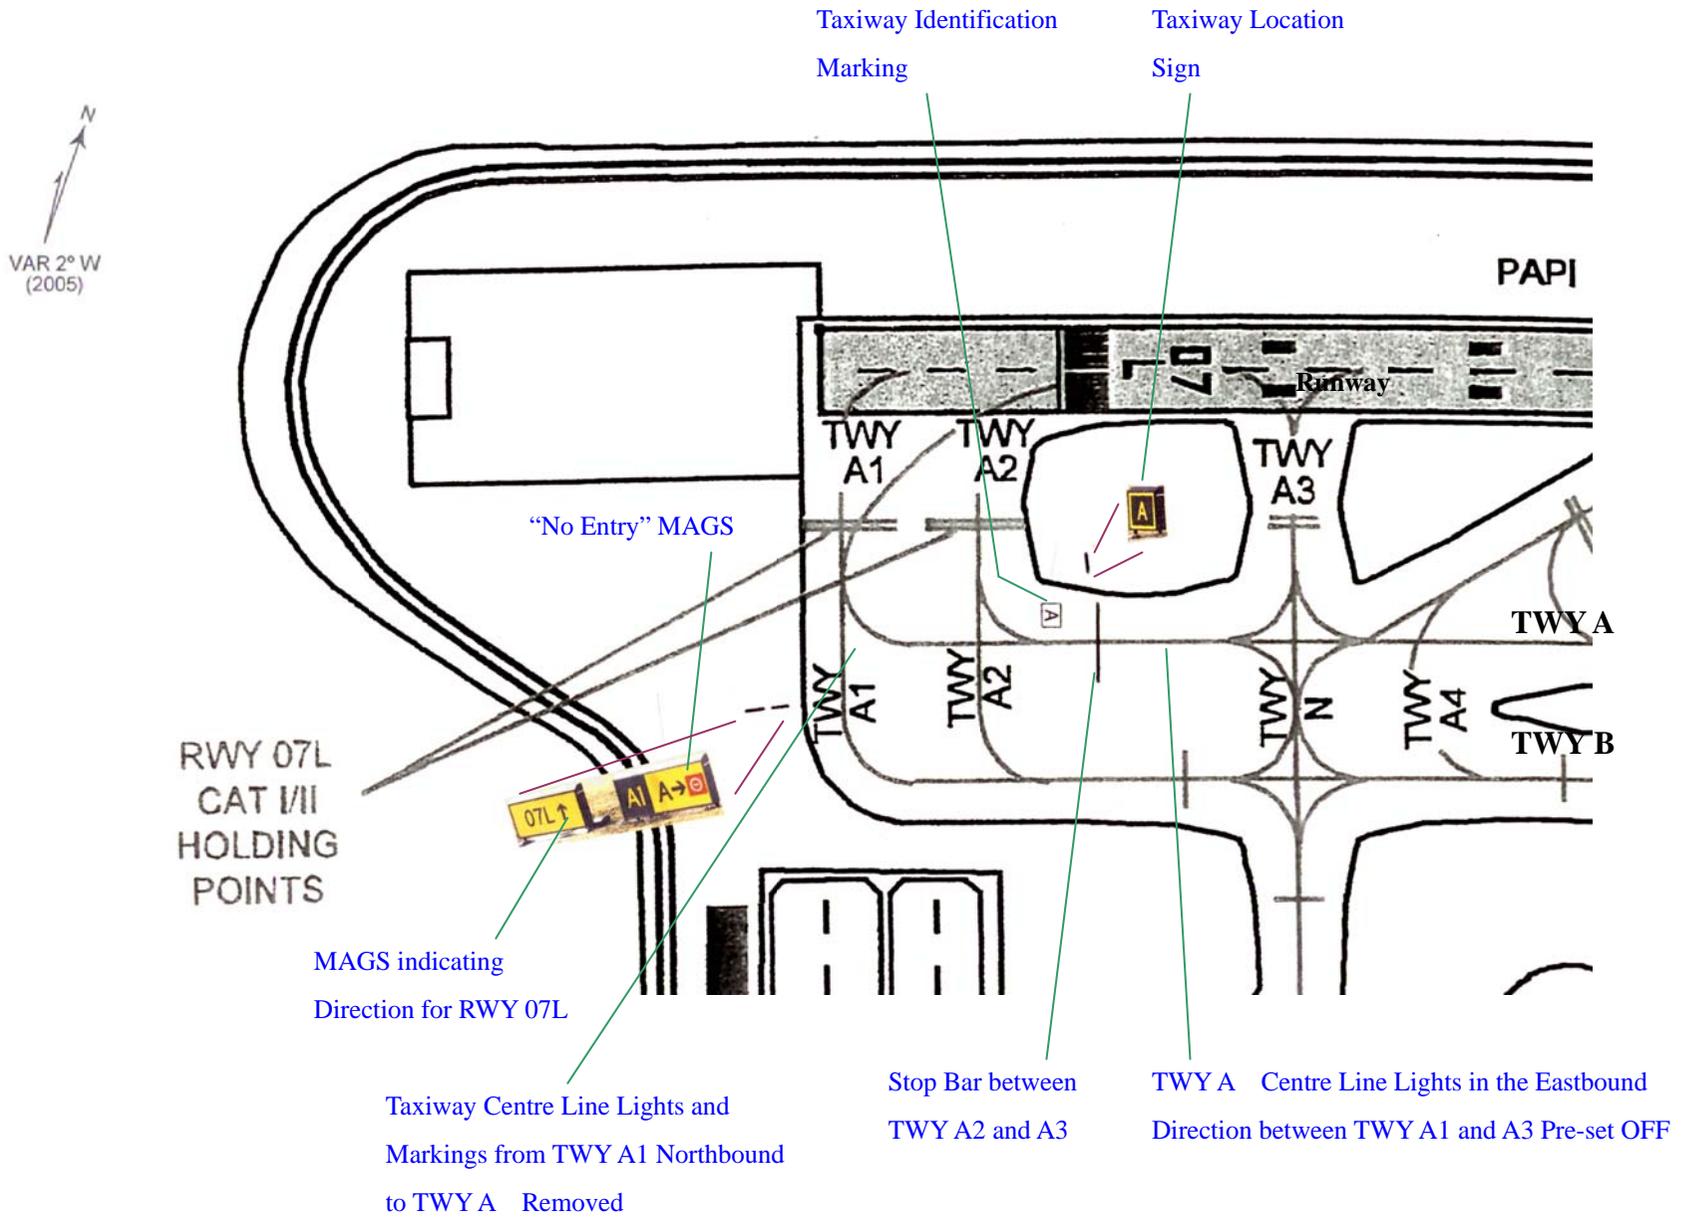
# Improvement to Guidance for Aircraft in the Vicinity of TWY A1, TWY A2 and RWY 07L

- 2.1.4 It was further noted that with a taxiway identification mark on the pavement and a taxiway location sign on the left hand side grass area of the eastbound TWY A between TWY A2 and TWY A3 (See Appendix G), TWY A was well identified. The investigation team had critically reviewed the visual aids on the airfield around TWY A and TWY A1 and were satisfied that they provided adequate visual guidance to pilots and to safeguard against inadvertent entry into TWY A, unless important warning signals were not heeded. Specifically, the right turn from TWY A1 onto TWY A involved manoeuvring onto an initially unlit concrete pavement area, leading to an obvious taxiway with green centreline lights, blue edge lights and a red stop bar across TWY A, instead of a green threshold bar had it been on the runway.

- 2.12.6 Upon completion of modification works on the AGL, including the installation of stop bar lights on TWY A, and improvement to airfield ground marking and signage in accordance with the recommendations in the investigation report of the 2008 incident, OI62/08 was cancelled on 15 October 2010, just slightly more than a month before this incident. As a prudent measure to prevent recurrence of similar incidents, the Investigation Team recommended soon after the FIN070 incident that the above interim ATC procedure be re-instated. OI 46/10 was accordingly issued on 29 November 2010, requiring the AMC to withhold the take-off clearance for RWY 07L until ascertaining that the departure aircraft has completely crossed TWY A by referring to the A-SMGCS or the SMR.

OI 46/10 also recommended the use of TWY A to access Holding Point A1 or A2, thus eliminating the possibility of lining up on TWY A.

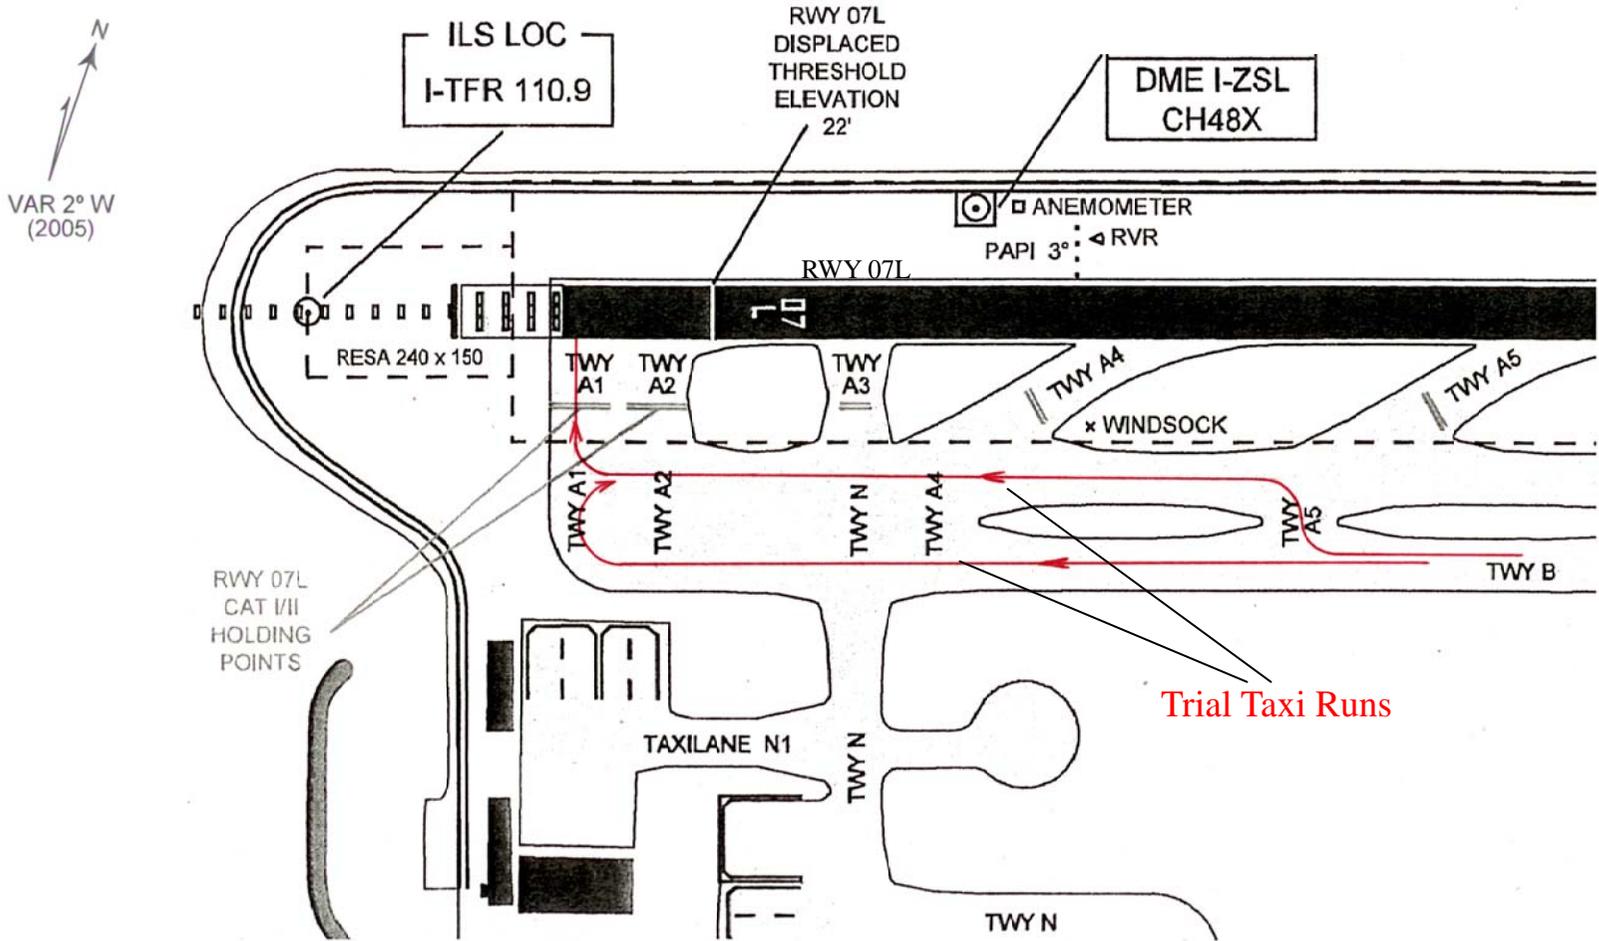
# Trial Taxi Run

1.21.1 To better appreciate the runway and lighting conditions as seen from the cockpit on the day of the incident, a series of trial taxi runs were carried out at the HKIA on the evening of 21 December 2010. The weather conditions on the day of the taxi runs were similar to those on the day of the incident. An Airbus A330, which has the same dimension and wheel height as an Airbus A340, was used to assess the visual conditions from the cockpit of FIN070. Also, the cockpit instrument displays on the Airbus A330, including the PFD and ND, are similar to those of an A340.

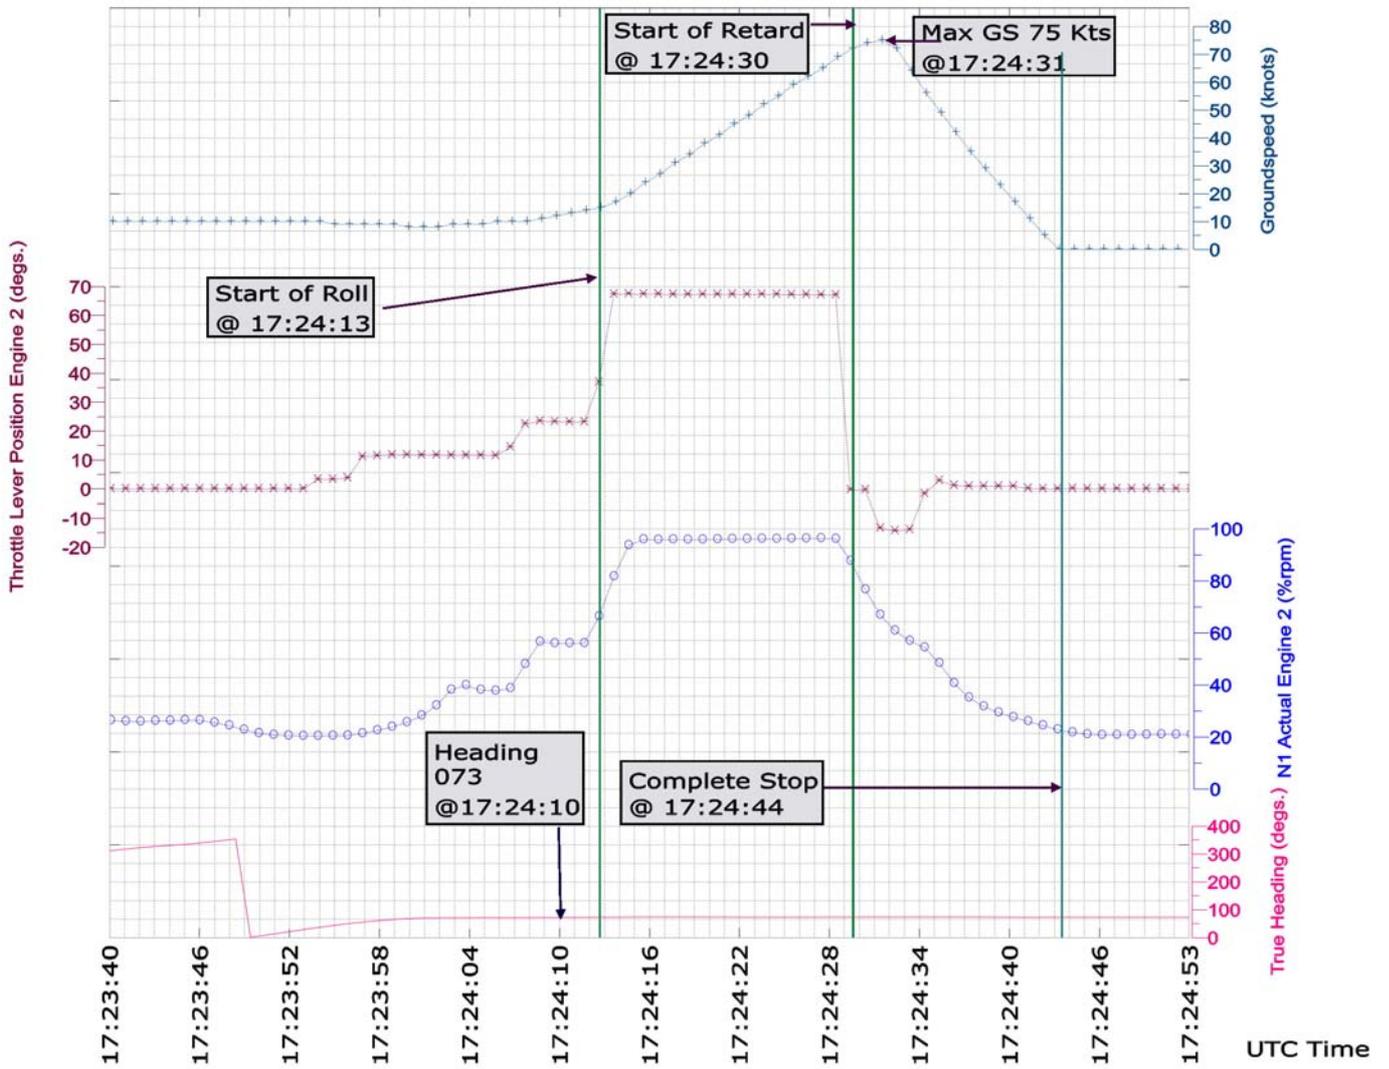
**Engine Control and Aircraft Performance Status During Take-off Phase**

2.3.1 According to the DFDR data retrieved, together with the ATC radio transcript, the flight crew obtained the take-off clearance at 1723:14 and started the take-off roll at 1724:13. ATC instructed the flight crew to stop rolling at 1724:24 after the aircraft was found rolling on the taxiway. The crew stopped the take-off roll by moving the engine throttle levers to idle position at 1724:30.
