AIRCRAFT ACCIDENT REPORT 1/2018

**Report on the accident to Cessna 152
Registration B-HPA operated by the
Hong Kong Aviation Club Limited
at Shek Kong Airfield, Hong Kong
on 21 May 2016**

**Hong Kong
September 2018**

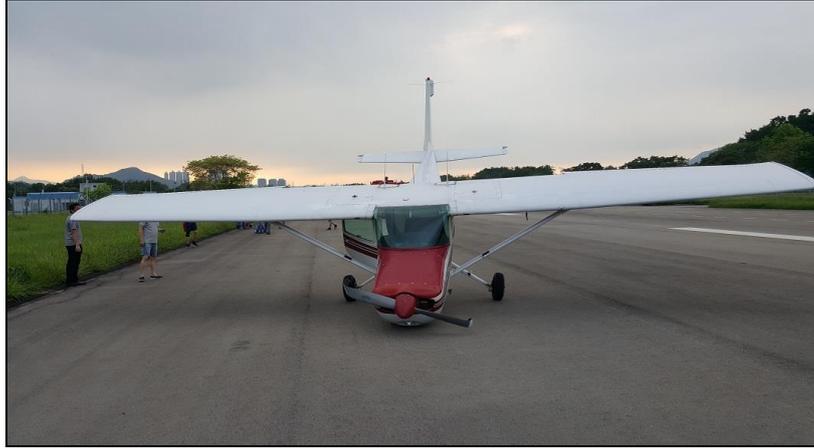
- 1.1.4 During the landing flare, engine throttle was set to idle by the Student. It was planned to be a touch-and-go, but the aircraft bounced upon touch-down and lifted into the air again. The Student did not immediately execute a go-around as required by HKAC's prescribed balked landing procedures. Upon the second touch-down, the aircraft had a hard nose landing, which resulted in the propeller strike and the collapse of the nose landing gear. The aircraft then veered to the right and stopped at the runway in a nose down position (See Figure 1).

Figure 1 Aircraft stopped in a nose down position on Runway 11

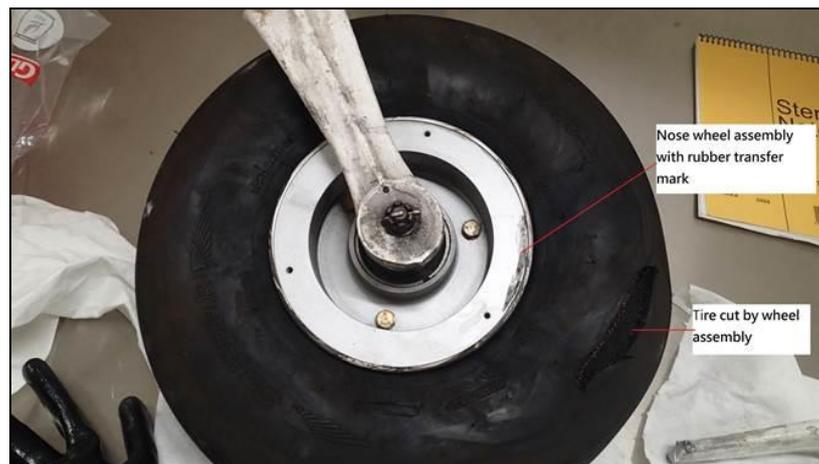
1.3.1 The nose tire exhibited a cut, and the nose wheel assembly exhibited a rubber transfer mark (See Figure 2). The nose wheel assembly and wheel fork were found detached from the nose landing gear (See Figures 3 and 4).

Figure 2 Damage on nose wheel assembly

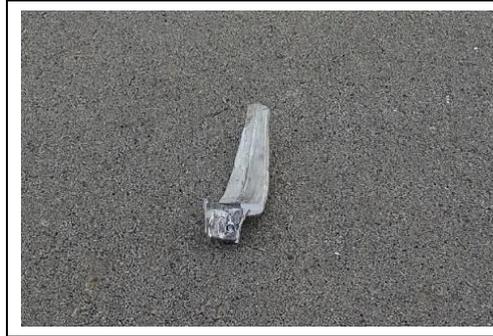
Figure 3 Broken nose wheel fork

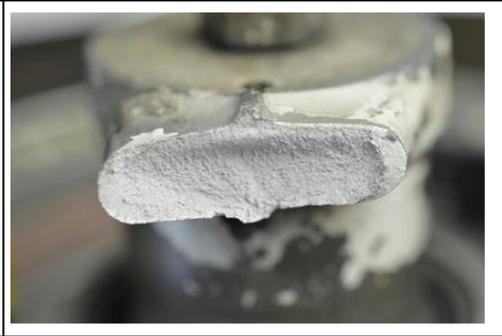
Figure 4 Broken nose gear fork at axle

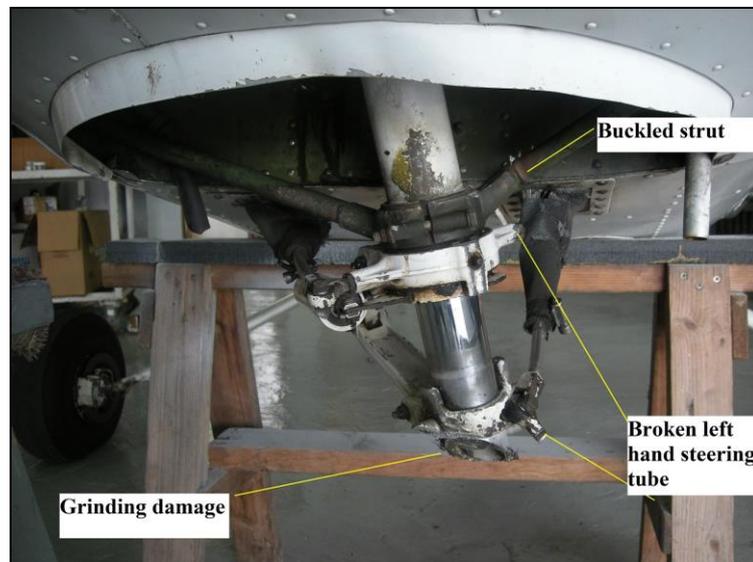
- 1.3.2 The nose gear strut was broken and tilted rearward and to portside. The supporting strut was buckled and the left hand steering tube was broken. There was grinding damage on the broken nose gear strut (See Figure 5).

Figure 5 Damage of nose landing gear

3.1.11 The collapse of the nose landing gear and damage to the engine mount truss was due to overload during the hard nose landing.

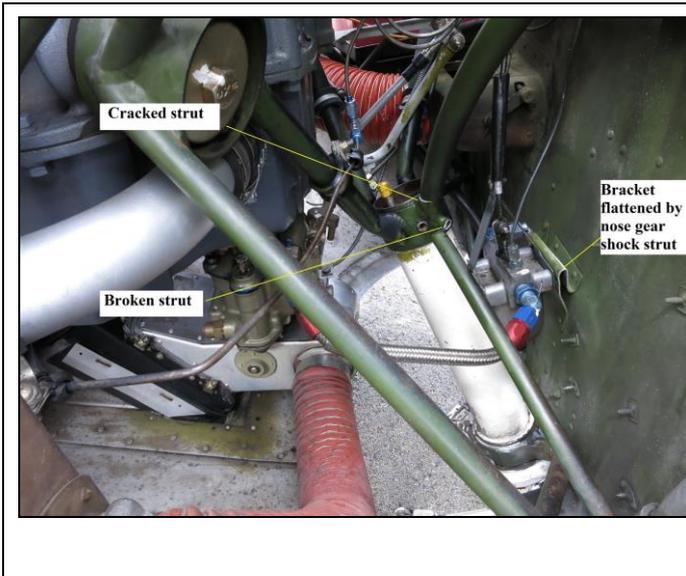
- 1.3.3 The engine remained intact and secured to the aircraft structure. The engine mount truss was deformed. The left hand side of the truss had one cracked strut, one broken strut and two buckled struts (See Figures 6a and 6b). The fuel strainer bracket was flattened by the nose gear strut. Exhaust pipe also had grinding damage (See Figure 7).
- 1.3.4 Both propeller blades exhibited impact damage and the blade tips were bent rearward (See Figures 8 and 9). Rub marks were found on the engine cowling (See Figure 10).

Figure 6a Damaged engine mount truss

2.4.3.1 Both Cessna’s report and the microscopic inspection of the fracture surfaces of the nose wheel fork were consistent. There was no pre-existing failure, and the fracture of the nose wheel fork was due to overload. Examination of the detached nose wheel assembly revealed a cut exhibited on the nose tire and a rubber transfer mark on the nose wheel assembly. The cut and transfer mark indicated that the aircraft had experienced a hard nose landing, in which the tire was compressed and/or folded over and made contact with the nose wheel assembly. The deformed engine mount truss also incurred substantial damage with broken and buckled struts due to high impact load.

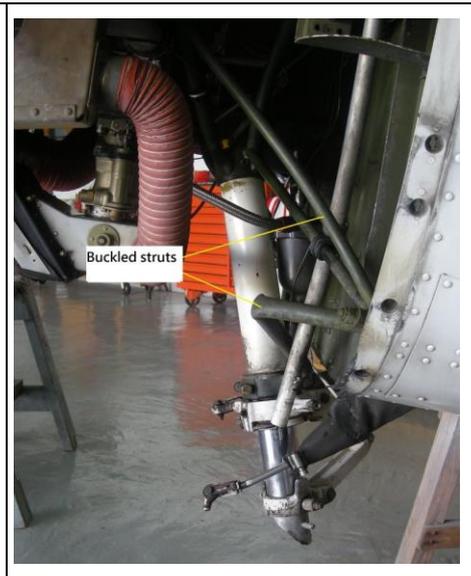
Figure 6b Buckled struts of truss

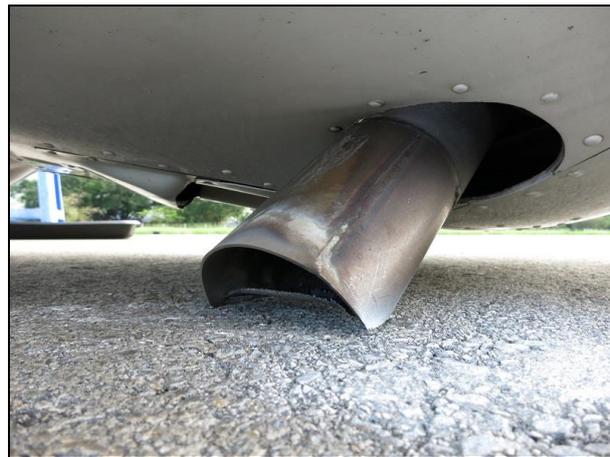
Figure 7 Grinding damage of exhaust pipe

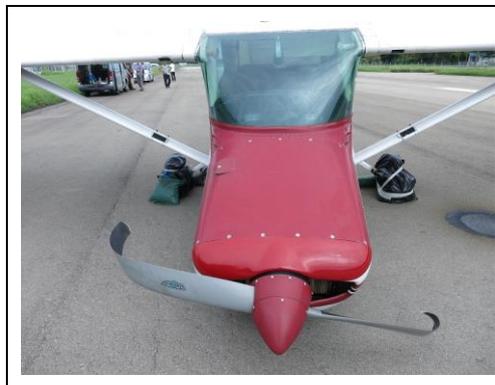
Figure 8 Propeller blades bent rearward

each other. These slash marks were consistent with the propeller striking the runway surface. From examination of the propeller blades, the backward bending indicated forward aircraft speed, whereas bending of more than one blade indicated that the engine was still running at the time of impact. With only three slash marks found, it indicated that the engine stopped shortly after the propeller strike.

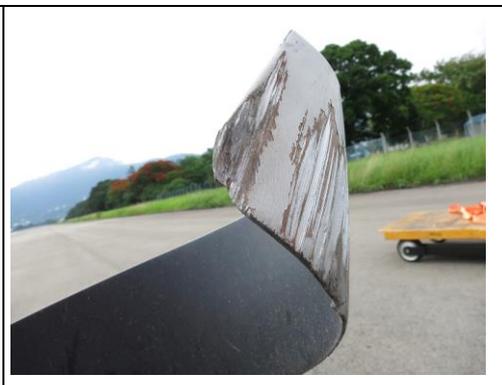
Figure 9 Damage of propeller blade

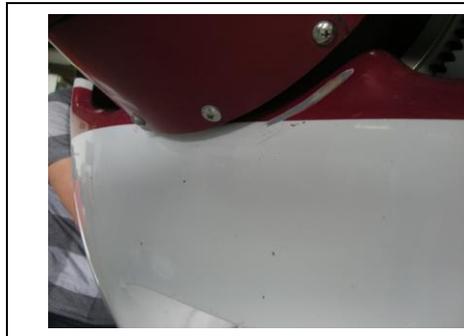
Figure 10 Rub mark on engine cowling

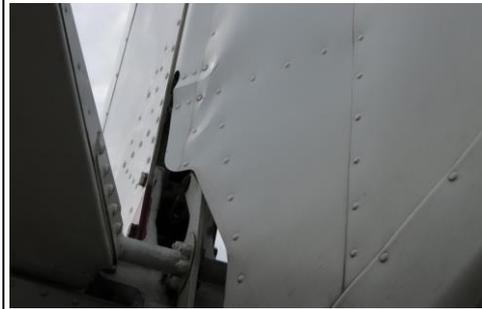
- 1.3.5 There was minor wrinkled damage on the skin surface around the attachment point of the rudder and rudder control cable (See Figure 11).

Figure 11 Wrinkled damage on the skin surface around the attachment point of rudder and rudder control cable

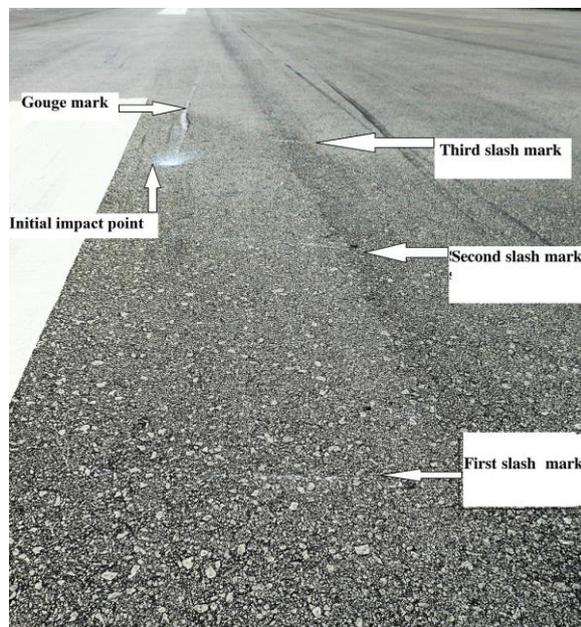
1.12.1 The main body of the aircraft was intact, except that the nose wheel assembly and nose wheel fork were detached and found on the runway. An impact point was located near the second centerline marking of Runway 11. Right after the impact point, a 0.9 m long gouge mark was found while the remaining ground mark was a scratch mark continuing to the final position of the aircraft. Three slash marks were found (See Figure 12).

Figure 12 Impact point and slash marks

2.4.3.2 The ground marks were consistent with the damage to the aircraft. The first slash mark was located near the second runway centerline marking. A total of three slash marks were found along the centerline, separated slightly apart from

2.4.3.3 Near the slash marks, an impact point was found on the runway centerline. The impact point was covered by a piece of metal, indicating a very high impact force when the nose gear strut pressed on the runway surface.

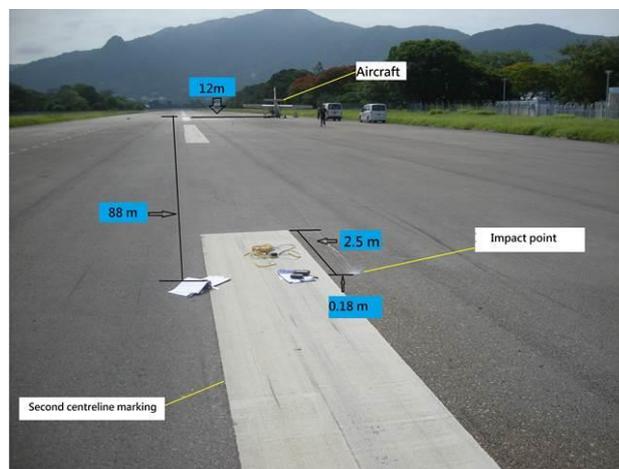
Figure 13 Aircraft final position

1.12.2 The aircraft moved forward for approximately 88 m and finally stopped at 12 m to the right of the runway centerline. No tire mark was found. (See Figure 13 - aircraft final position and Figure 14 - wreckage plot.)

2.4.4.2 No tire mark was found, which was consistent with the Student's statement that he did not apply any rudder or brake. The aircraft moved forward for approximately 88 m and finally stopped at 12 m to the right of the runway centerline.

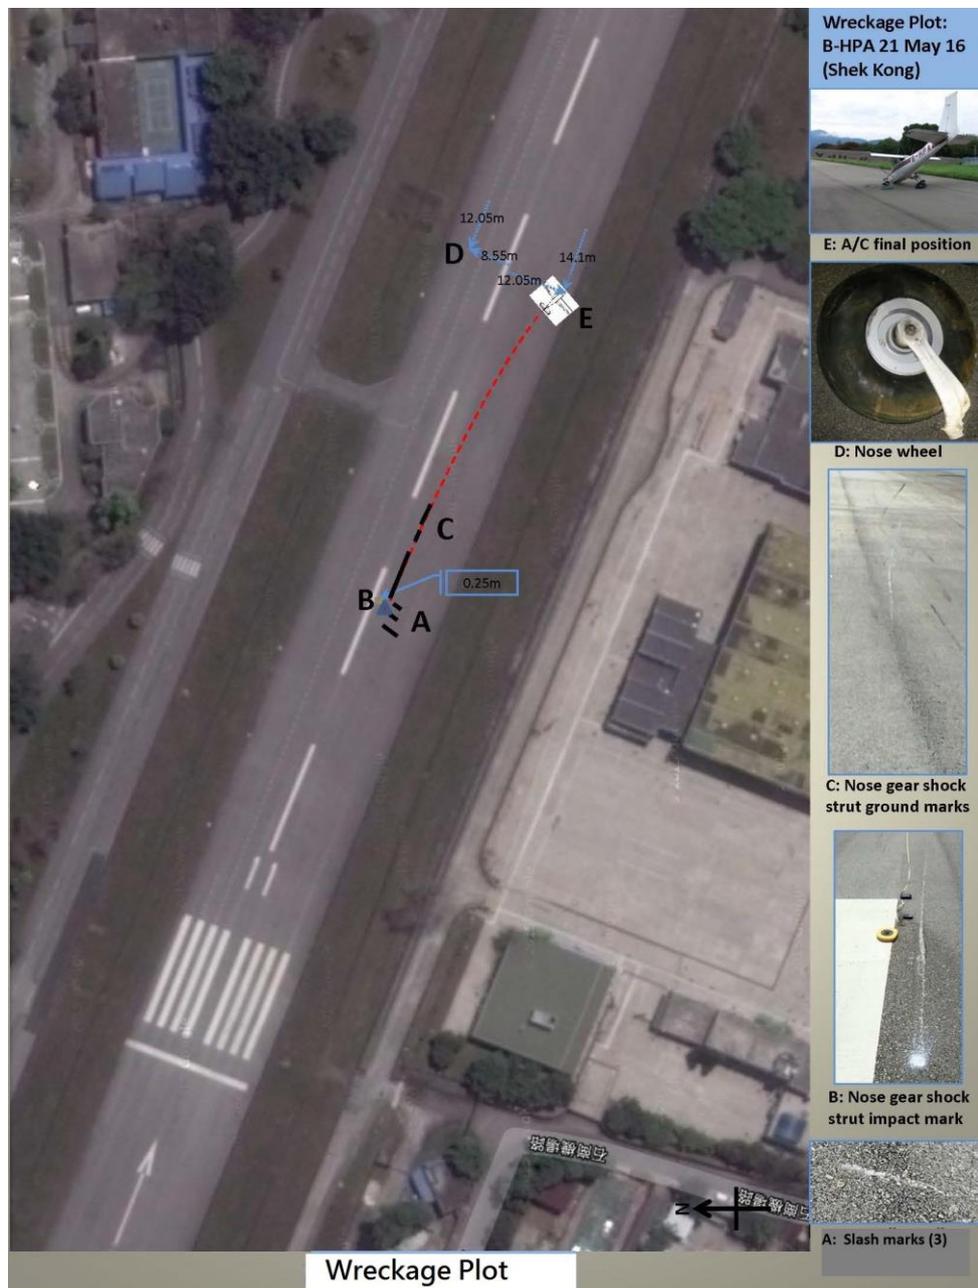
Figure 14 Wreckage Plot

2.4.4.1 The track of the aircraft could be traced by a ground mark continuing from the impact point to the final stop position. The first 0.9 m segment of the ground mark was a gouge mark while the remaining was a scratch mark. The gouge mark revealed that the broken nose gear was pressing on the runway surface. The gouge mark was subsequently lightened to scratch mark, showing that a reduction in force exerted by the nose gear on the surface, partially shared by the main landing gears.

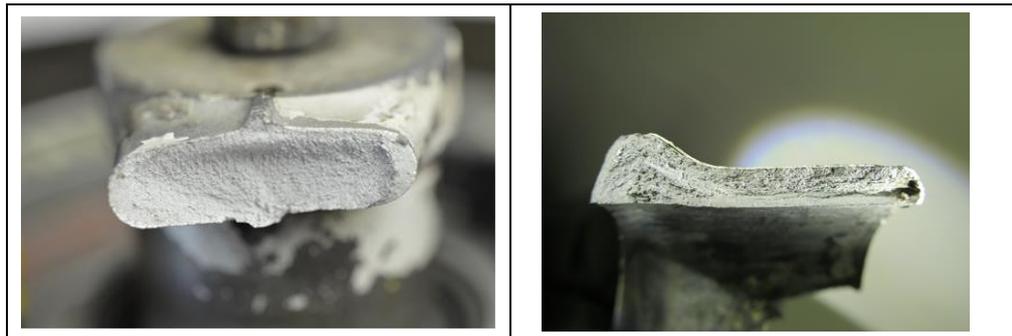
1.16.1 Microscopic inspection of the fractured surfaces indicated that there was no pre-existing failure on the nose wheel fork and the failure was due to overload (See Figures 15 and 16).

Figure 15 Broken nose gear fork at axle

Figure 16 Broken nose gear fork at strut
