AIRCRAFT ACCIDENT REPORT 1/2015

**Report on the accident to Robinson R22 Beta II Helicopter
Registration B-HJN operated by the
Hong Kong Aviation Club Limited
at Shek Kong Airfield, Yuen Long
on 6 October 2013**

**Hong Kong
February 2015**

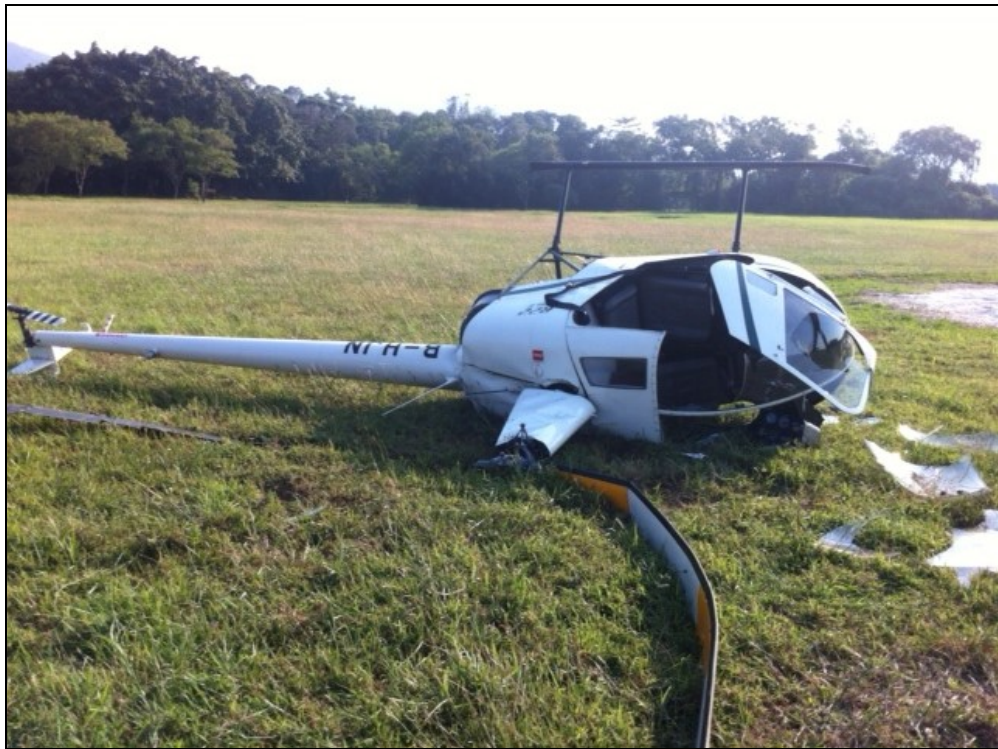
Photograph 1 – The Wreckage

1.1.5 The Instructor described that he did notice the helicopter was drifting to the right. In a second, the drift developed rapidly into a descent and a roll. The Instructor attempted to reach for the controls but was not able to touch the controls in time. The right skid contacted the ground. The helicopter rolled over 90° to the right, hit the ground and came to rest on its side (See Photograph 1). The engine stopped on impact.

Severe damage to the perspex canopy, horizontal stabiliser, main rotor blades, and deformation to the horizontal firewall were evident. The right skid tube extension was bent slightly inward. The damage was consistent with the impact upon the helicopter rolled over.

2.1.1.4 The post-accident inspection noted an inward bend to the right skid tube extension of the helicopter. It indicated that the helicopter had the right skid tube extension contacted the ground during its rightward drift before the helicopter rolled over.

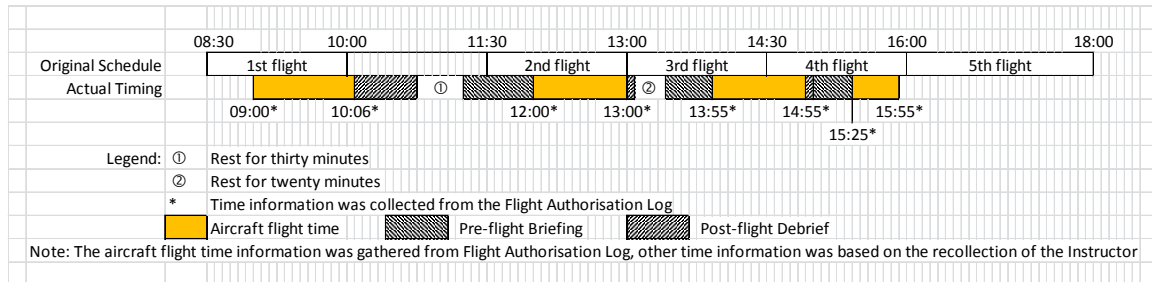
Figure 2 – Flying Training Arrangement and Execution of the Instructor

1.14.2.2 On the day of the accident, there were 12 helicopter training flights to be shared among three instructors. The Instructor and another flying instructor (“ ‘Instructor A’ ”) were each assigned five training flights starting at 08:30. The Instructor was assigned one flight between 08:30 and 10:00, and four flights between 11:30 and 18:00 (See Figure 2).

- 2.1.3.2 The demand for helicopter flying training was high. It was common for a flying instructor to conduct four to five training flights a day, as was the case on the day of the accident. The arrangement was made primarily based on the training demand.

- 2.1.3.3 The back-to-back arrangement of the booking slots, in the context of flying training arrangement, provided little allowance for flying instructors to take rest between flights. Inevitably, pressure on flying instructors to work continuously would be high in particular when there was a need to catch up with the schedule.

- 2.1.3.4 Taking into account the high training demand, the practice of assigning flying instructors without due consideration to their workload and rest periods was conducive to the development of tiredness.

- (a) A maximum of four instructional flights be conducted by an instructor per day.
- (b) Instructors might not conduct more than two consecutive instructional flights without rest.
- (c) Consideration on separating “high stress” flights in flight programming.

HKAC should review the control procedures to eliminate circumstances that can cause tiredness to flying instructors in instructional flying activities.
