HONG KONG
INTERNATIONAL AIRPORT

WRECKAGE INFORMATION

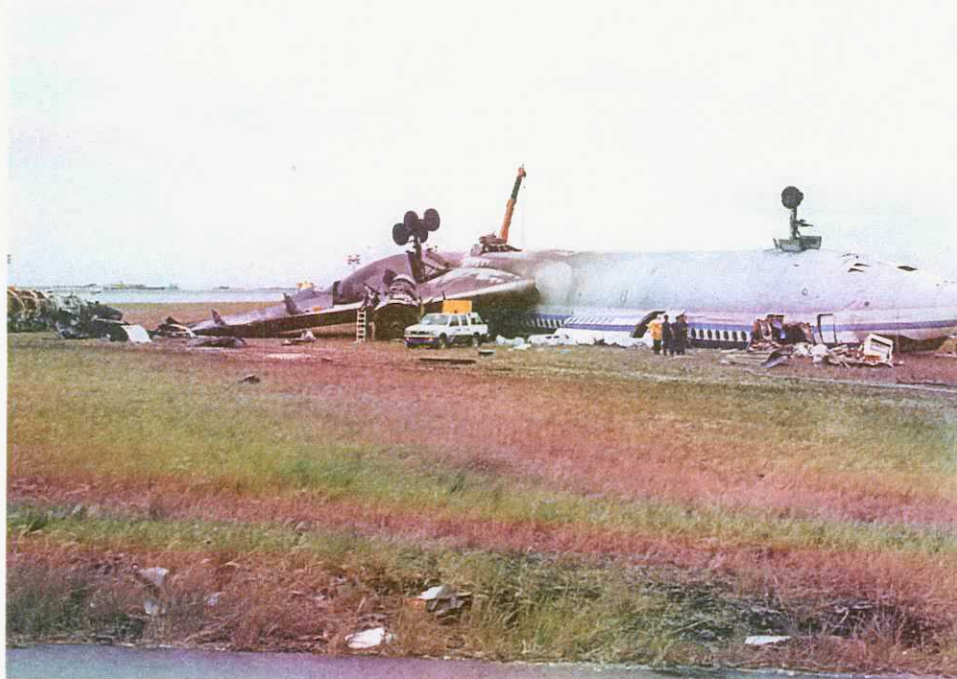
Main Wreckage (Figure 1)

The fuselage was found inverted at the main wreckage with severe impact damage and fire damage (Figure 1). The crown of the fuselage was crushed downward for the entire length (nose to tail). The pilot and co-pilot's windows were cracked and the side windows were pulled out and were lying outside the cockpit. There was no evidence of any bird strike or foreign object damage on the cockpit windows. The right side of the fuselage suffered slight impact damage just aft of the R1 entry door. The skin at this location was torn in the vertical direction (Figure 2).

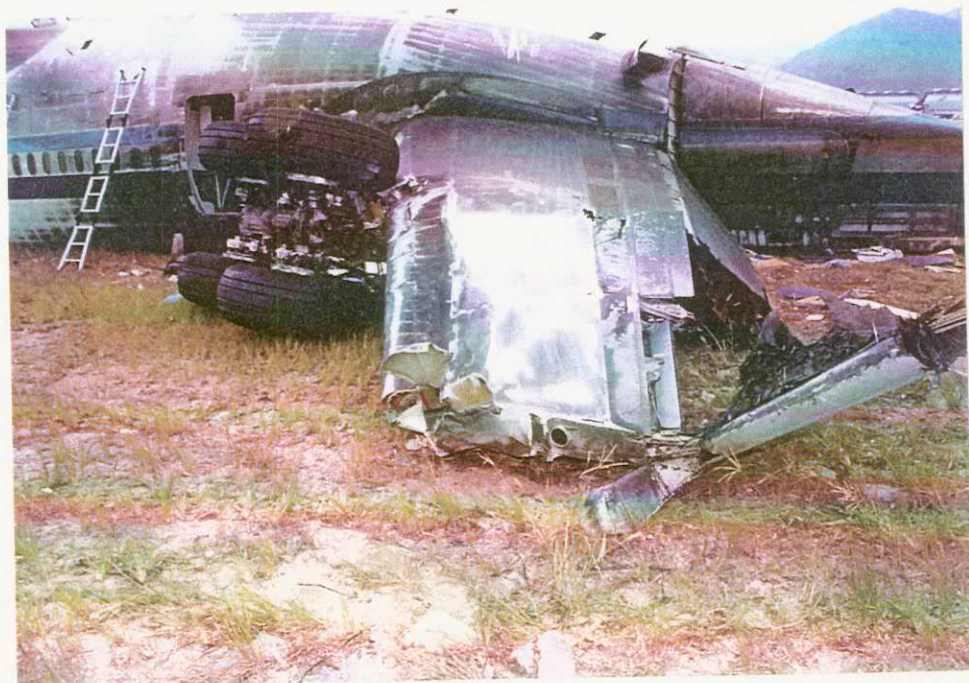
Right Main Landing Gear and Right Horizontal Stabilizer (Figure 4)

About a 10-foot section of the right wing upper and lower skins with front and rear spars remained attached to the fuselage (Figure 3). The trapezoid fitting which connects the fixed and folding retractable side brace of the right main landing gear remained attached to the fuselage. This fitting suffered no fire damage and was fractured in tension at the brace connection. The fractured surface exhibited overload features. This fracture surface area was cut from the fitting for detailed metallurgical examination. The right main landing gear had separated from the wing and fuselage point and was found near the aft right side of the fuselage under the right horizontal stabilizer (Figure 4).

The right horizontal stabilizer remained attached to the empennage with severe impact damage (Figure 4). The section outboard of Station 292 was bent down. The inboard section remained attached to the empennage. The right stabilizer suffered soot damage on the leading edge, upper and lower skins. The leading edge and lower skin exhibited

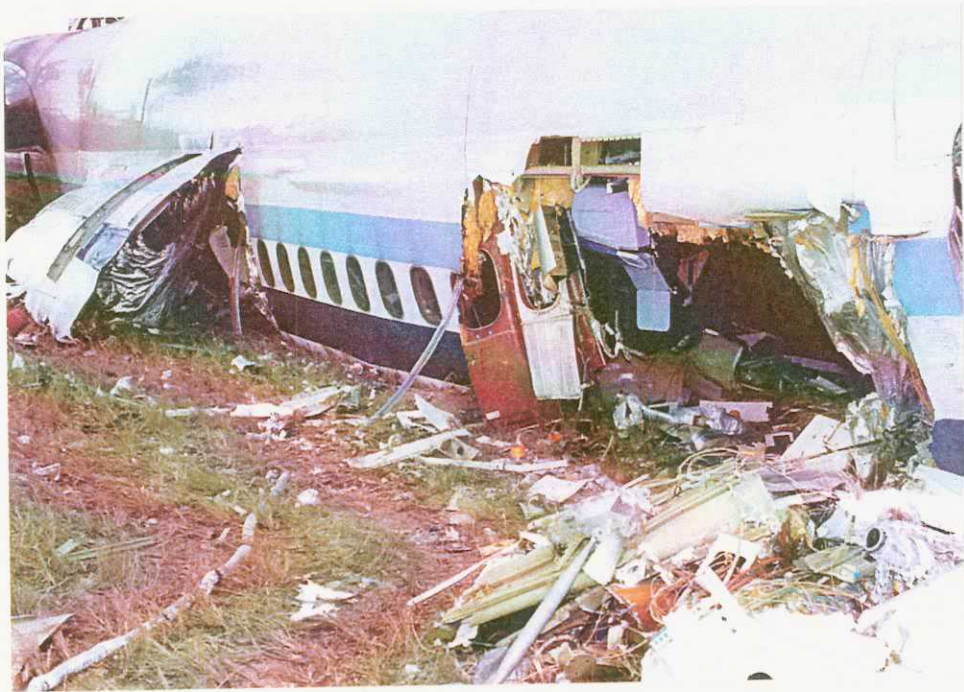
Left Forward Fuselage (Figure 5)

The left fuselage suffered crushing damage just aft and forward of the L1 entry door. A large section of the fuselage common to L2 door from Station 735 to Station 1059 was pushed out (Figure 5). The remaining portion of the fuselage remained intact with minor impact damage. The aft section of fuselage suffered external fire damage and soot damage on left and right sides.

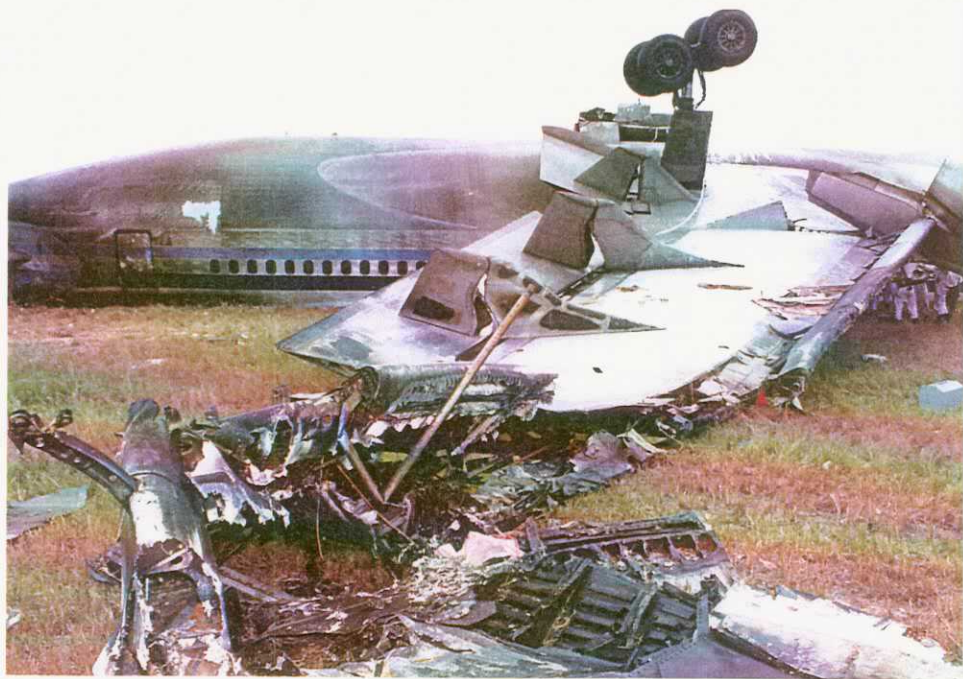
Left Wing (Figure 6)

The left wing remained attached to the fuselage and was found at the main wreckage (Figure 6). The inboard section of the wing exhibited evidence of sooting. There was evidence of scrape marks on the upper wing skin in a span-wise direction outboard of no.1 engine location. The leading edge at the inboard section was slightly damaged and suffered fire damage. The leading edge at the no.1 engine location was crushed aft and slightly upwards. The inboard slats remained attached to the wing and were found in extended position (approximately 30 degrees position). The leading edge outboard of the no.1 engine suffered severe impact and fire damage at various locations. The slats outboard of the no. 1 engine remained attached to the wing and were in the extended position. The outboard end of the slat suffered fire damage. The wing structure outboard from Station 855 suffered severe fire damage with the structure exhibiting melting. The front and the rear spars of the outboard section suffered severe fire damage and had sagged. The wing tip suffered severe fire damage. The outboard aileron and the wing-lets were consumed by fire. The spoilers remained intact with no apparent damage.

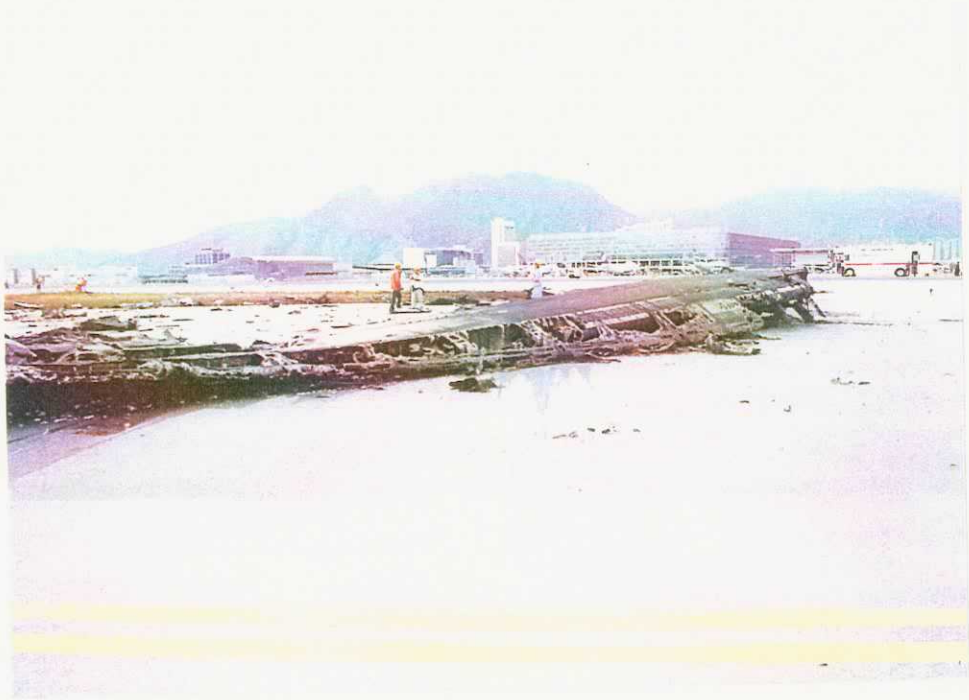
Right Wing Detached from Main Fuselage (Figure 7)

The wing outboard from the fracture was in one section and was found about 300 feet from the nose of the airplane in the main wreckage (Figure 7). The upper skin exhibited sooting from the fracture to Station 772 and was consumed by fire from Station 772 to the tip. There was a crack of about 30 inches long at the middle of the upper skin in a span-wise direction. The fractured surface on this crack was sooted. The upper skin was bulged upward 12 inches forward of the rear spar on the upper skin and the side rib. The upper skin bulge was 38x46 inches in area and bulged up for about two inches. The leading edge suffered severe impact damage and fire damage. The inboard slat was detached and recovered at the site. The middle and outboard slats suffered severe fire damage and remained attached to the leading edge. The leading edge from the fracture to Station 538 suffered fire damage. The inboard end of the leading edge suffered severe impact damage and was dented at various locations. The leading edge outboard of Station 538 was consumed by fire. There was no evidence of heavy scrape marks on the upper skin. Only light scrape marks were observed at the inboard end on the upper skin in a fore and aft direction. The wing tip suffered severe fire damage on the upper skin. The strobe lens reflector and the case with the bulb remained intact and suffered fire damage. There was no evidence of any scrape marks on the wing tip structure on the lower skin. The right wing lower skin was intact from the inboard fracture location to the tip and suffered severe fire damage. There was no evidence of any heavy scrape marks on the lower skin.

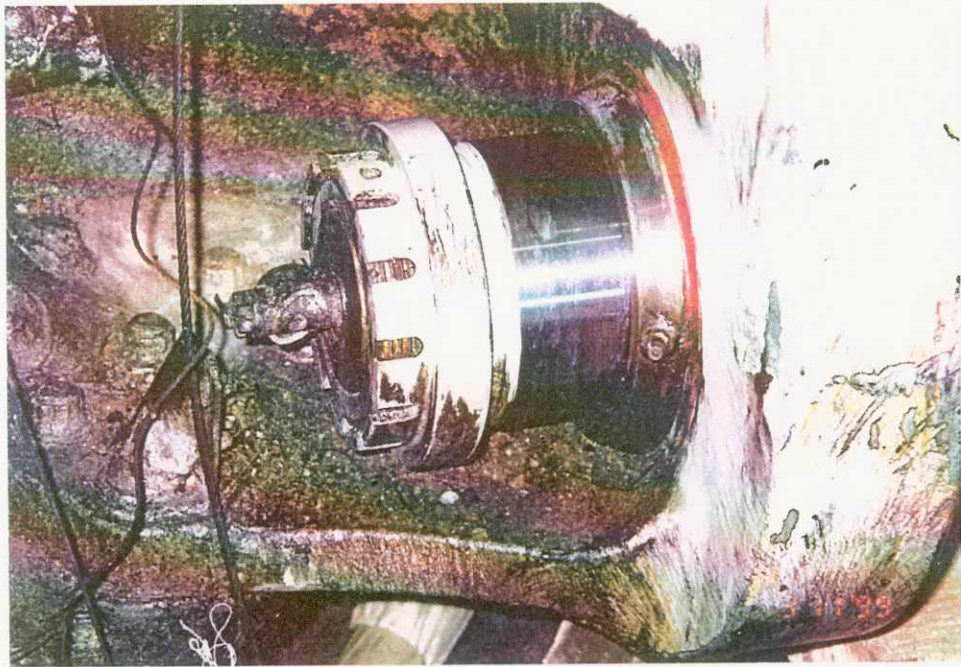
Forward Shear Pin (Trunnion Bolt) (Figure 9)

The right main landing gear was separated from its mount. The forward shear pin was sheared off from the forward mount and half of the shear pin remained in the forward lug of the forward mount. This section of the shear pin was pushed out and exhibited severe soot damage on the fracture surface. The remaining portion of the shear pin remained on the forward lug of the landing gear and exhibited some bending. The fractured surface on this portion exhibited surface rust and the fractured surfaces could not be examined. The aft lug of the forward mount fractured between the 4 o'clock and 10 o'clock positions. This section of the lug fractured into two pieces and was found on the runway between the touchdown point and the main wreckage. The mating fractured surface on the wing forward mount aft lug exhibited some discoloration but the mating fractured surface of the lug that was found on the runway did not exhibit any discoloration. All surfaces on the aft lug exhibited evidence of overload features. There was no evidence of fire or soot on the pieces of lug found on the runway. The forward fitting that remained attached to the landing gear fitting suffered soot damage. The forward mount fractured in the middle and exhibited impact damage in an upward direction (Figure 8).

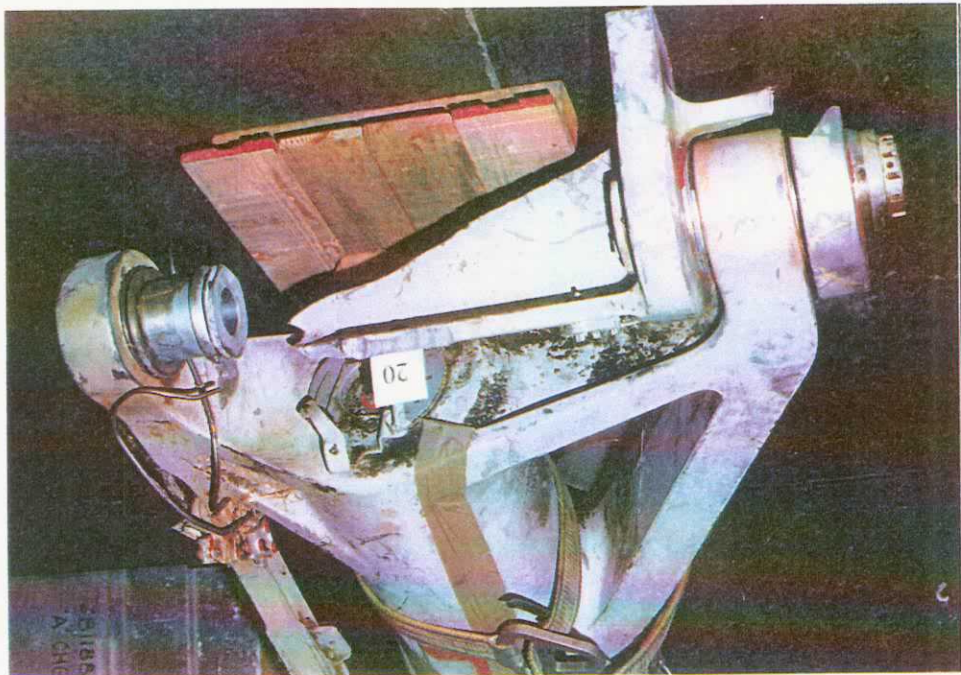
**Fractured RMLG Aft Attachment Fitting with Aft Shear Pin (Trunnion Bolt)
(Figure 10)**

The landing gear fitting between the forward and aft mount fractured and a portion of the fitting was missing. This section was attached to the landing gear with the aft pin still in place. This piece also exhibited impact damage between the forward and aft mount. The landing gear fitting between the forward and aft mounts suffered severe soot damage and the soot was evident on the fracture surfaces.

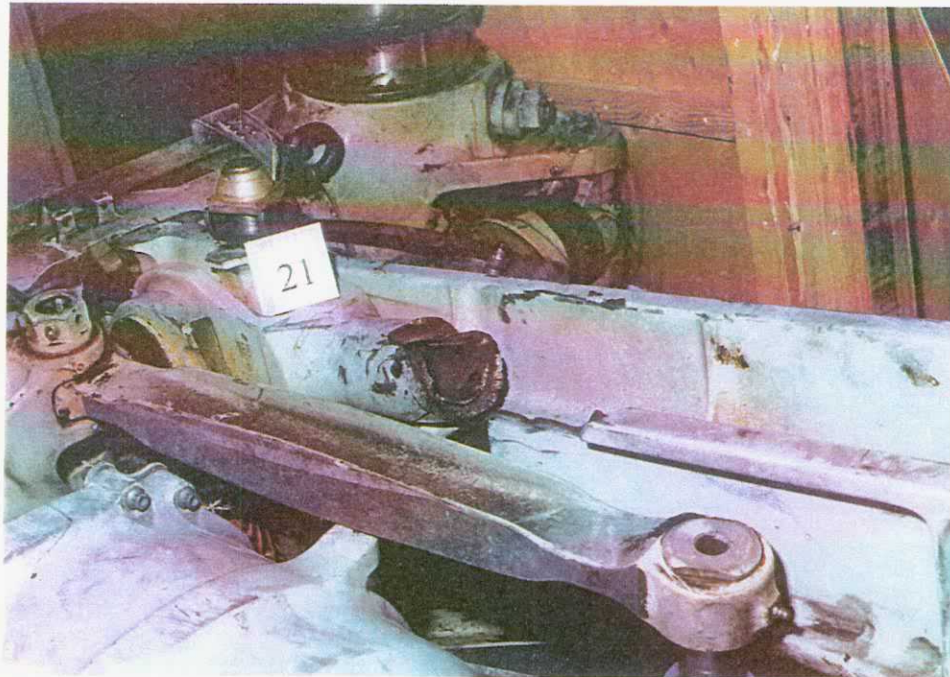
Fractured Fixed Side-Brace (Figure 11)

section of the fixed brace remained attached to the trapezoidal fitting along with the folding side brace (Figure 11). The trapezoidal fitting fractured from the trapezoidal panel that attached to the fuselage (Figure 12). The trapezoidal panel pillow block remained attached to the fixed and folding brace. The fractured surface exhibited evidence of overload features. There was no evidence of fire damage or soot damage to the right main landing gear.

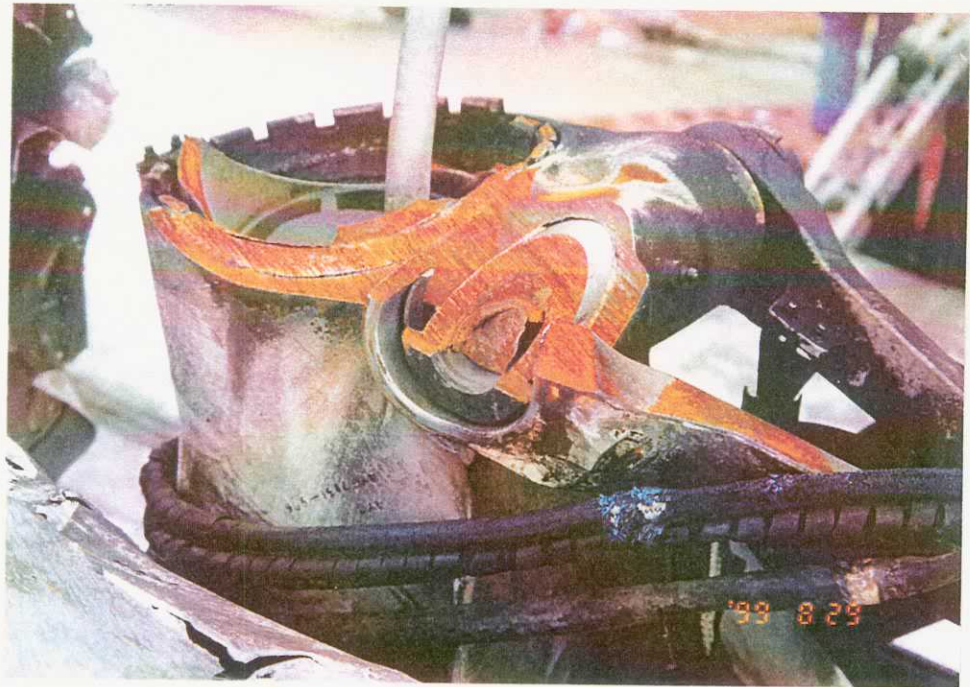
Fractured Center Landing Gear Oleo (Figure 13)

The centre landing gear fractured at the bottom of the cylinder (oleo) near the axle (Figure 13). The fractured surface exhibited overload features with a 45-degree shear lip and was severely rusted. The wheel truck with tyres was found on the runway near the main wreckage. There was evidence of heavy impact damage on the right hydraulic brake reservoir that attached on the wheel. The heavy impact mark was a 3/8-inch wide indentation and ranged up to 1/2 inch deep. There was no evidence of any fire damage or soot damage to the centre gear truck assembly. Only one tyre was inflated and did not exhibit any scuff mark on the inner or outer side. The other tyre was deflated and suffered severe sharp cuts on its side.

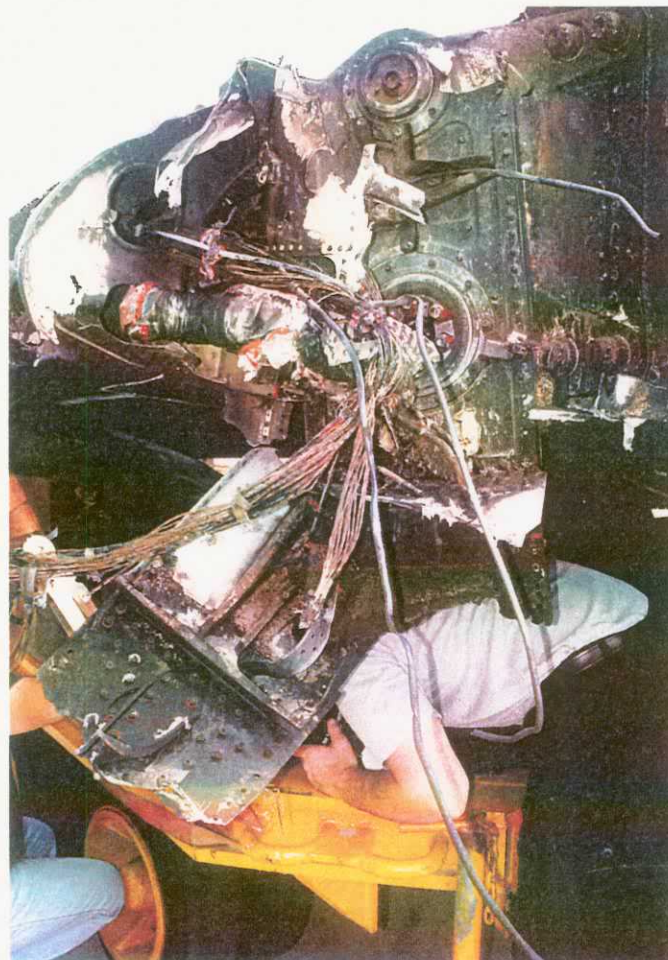
No. 3 Engine Pylon to Wing Forward Attachment Structure (Figure 14)

The no. 3 engine separated from the wing at its pylon attachment points and was found in the grassy area near the right wing (Figure 14). The front (tombstone fitting) pylon mount fractured about 24 inches from the upper wing skin. This fitting suffered severe fire damage and the web and the cap was bent aft at the fractured end. The tombstone fitting was attached to the wing front spar and pulled out of the pylon about five inches below the pylon upper spar. The upper spar that the front links were attached, was broken out of the pylon and attached to the wing mount. A large section of the tombstone fitting remained with the engine pylon. The web and the cap were bent forward with slight twisting. The rear engine mount and bulkhead separated from the pylon in one piece and remained attached to the wing. The rear engine mount separated from the left and right pylon skin and all the fasteners were pulled out of the skin. The upper spar cap at the outboard side of the pylon was bent in a "U" shape and the web/ skin separated from the cap indicating that the pylon was experiencing loads in the inboard direction. The upper spar cap at the inboard side remained attached to the web with no noticeable bending. The inboard pylon skin was bent inboard.

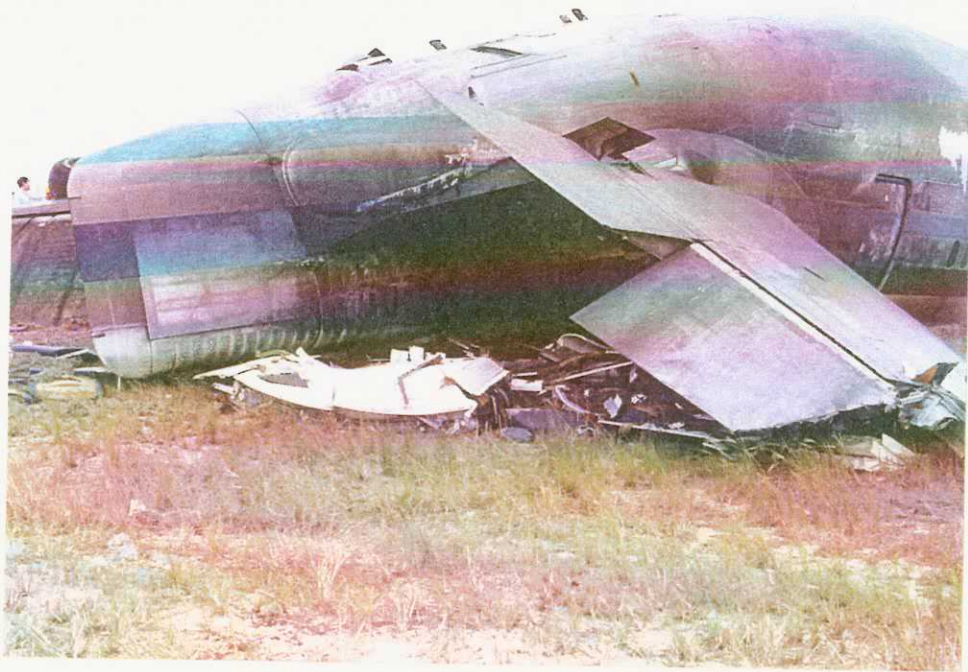
Left Horizontal Stabilizer (Figure 15)

The left horizontal stabilizer fractured at Station 290 (Figure 15). The inboard section remained attached to the empennage with upper skin. This section exhibited upward bending. The lower skin was fractured at the root in a jagged fracture pattern. The front spar and the associated structure at the fractured location were bent aft. The upper and lower skin suffered soot damage. The inboard elevator remained attached with no impact damage but exhibited severe soot damage. The outboard elevator fractured at Station 290. There was no scrape marks observed on the inboard section of the horizontal stabilizer.

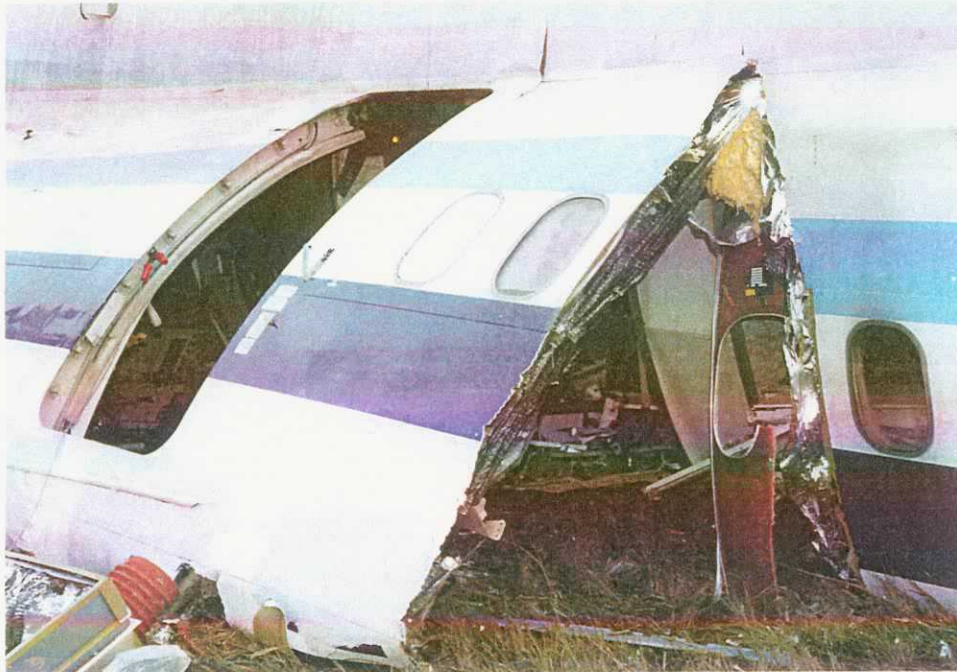
8. View of crack in right fuselage (forward) including Door 2R.

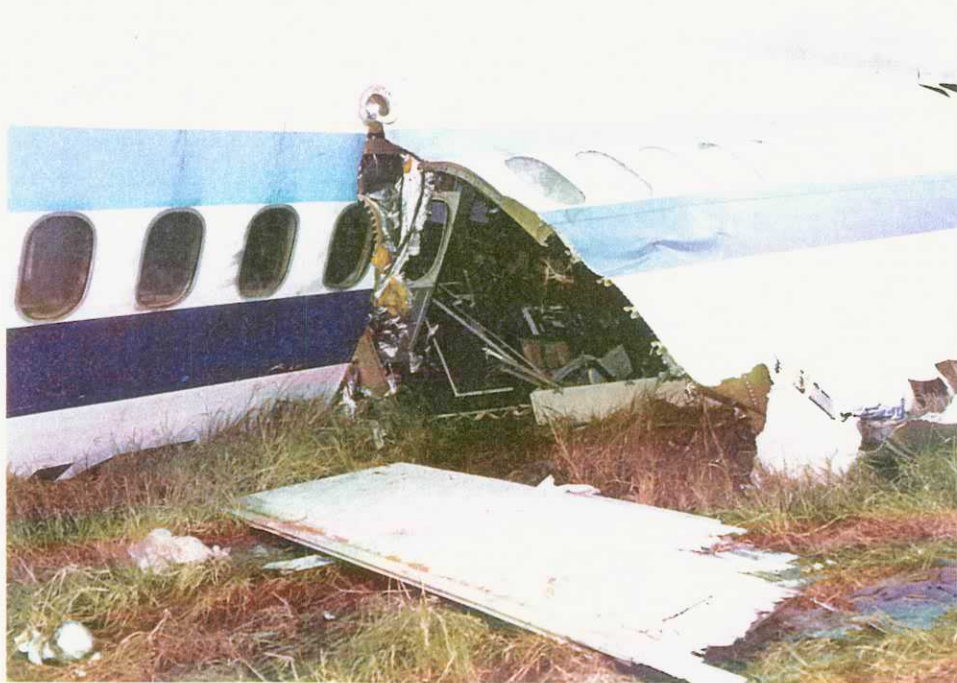
9. View of crack in right fuselage (aft).

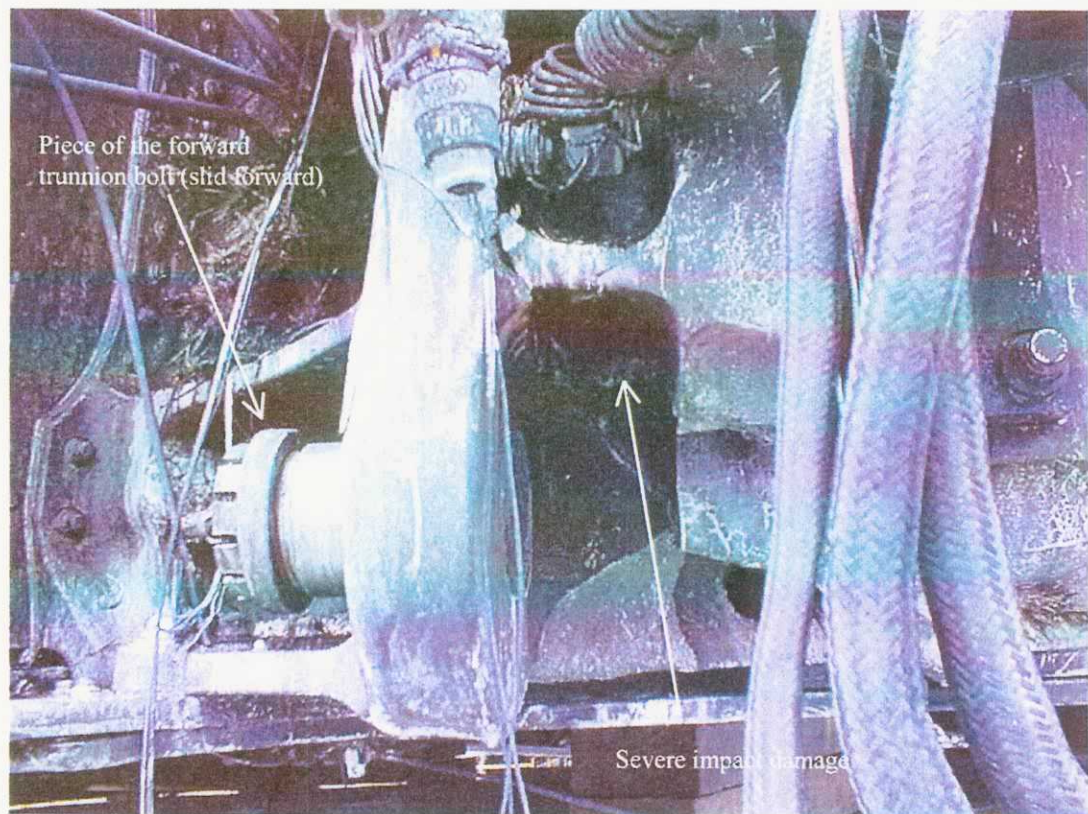
After shearing the forward trunnion bolt at the forward zero-margin groove, the forward trunnion of the right main landing gear was driven upwards and contacted the wing attach fitting, damaging the fitting. This is clearly evident in a photograph taken at the crash site (Figure 6) and in Figures 34 and 35 of the Materials and Process Engineering Report (Reference 2).

Figure 6. Damage to MLG-to-Wing Attach Fitting at the forward lugs

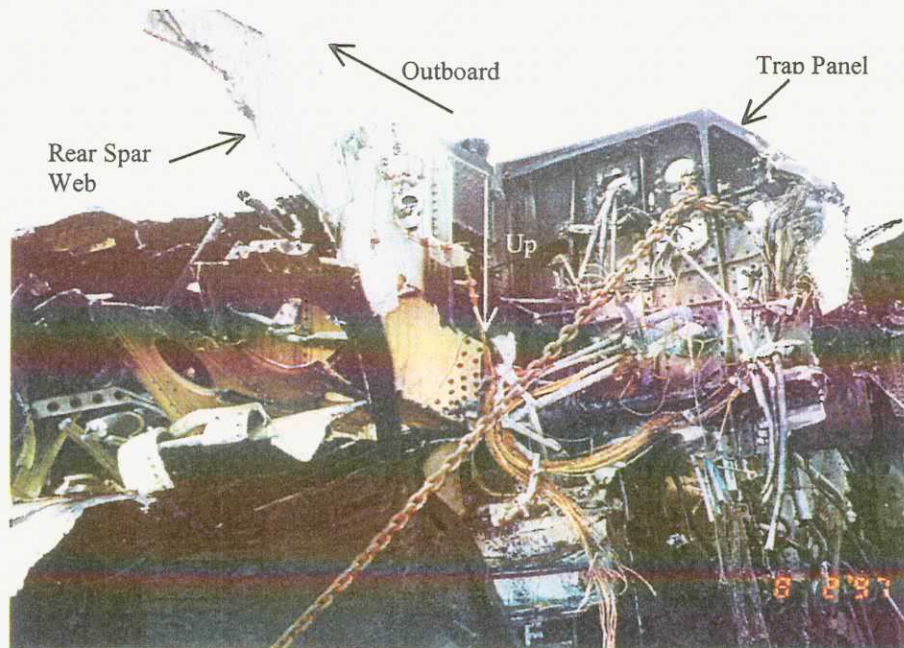
Figure 7. Right Wing Rear Spar Web Fracture from Ship 553 (FedEx - Newark)

A photograph of the FedEx aircraft showing the right wing rear spar web fracture is included as Figure 7. Note that the aircraft is inverted in this photograph.

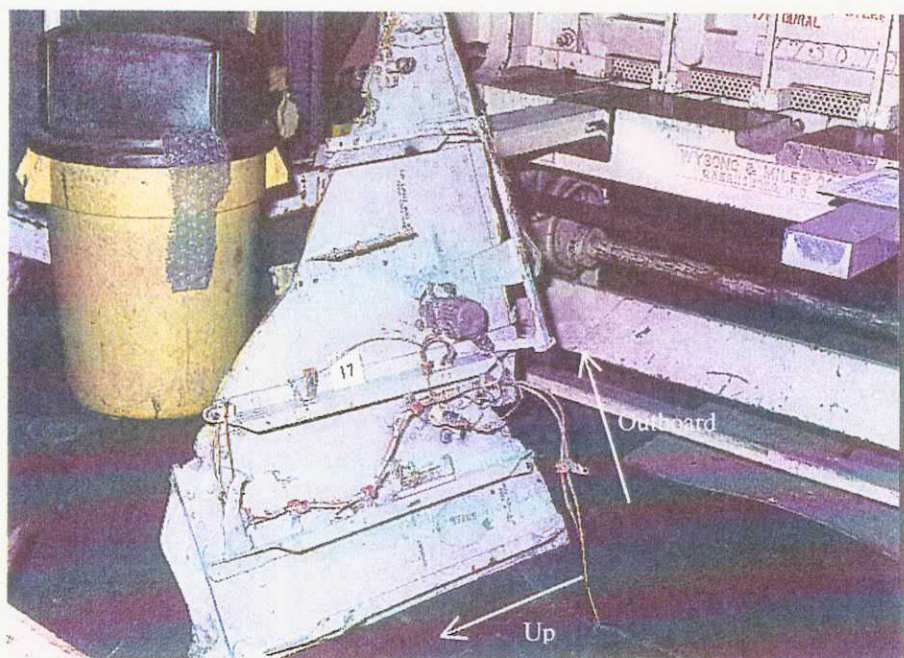
Figure 8. Right Wing Rear Spar Web Fracture from Ship 518 (China Airlines)

A lab photograph of the right wing rear spar web which was cut from the China Airlines aircraft is included as Figure 8. When examined closely it was observed that the rear spar web fractures from the two accidents occurred at almost identical locations.

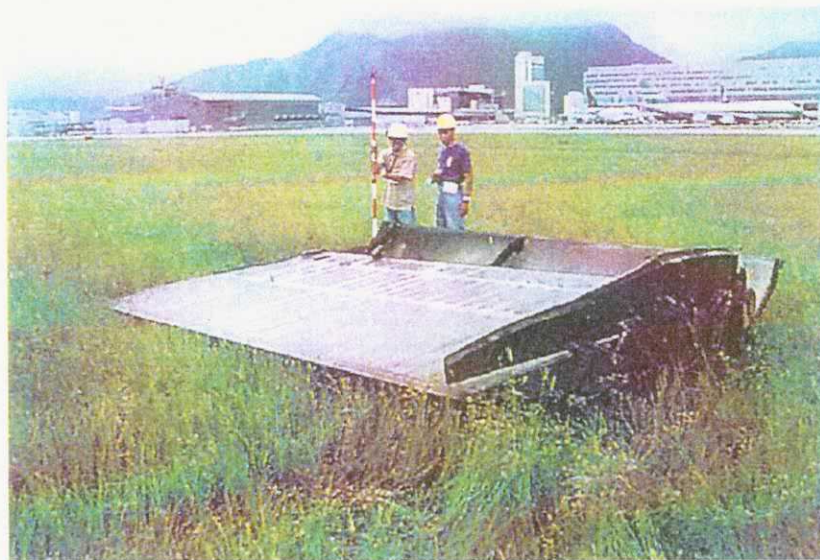
The China Airlines inboard flap was found off to the left of the runway and is thought to have been carried there by the crosswind (which was blowing right-to-left) after it departed the aircraft. The flap, as it was found, is pictured in Figure 15. The FedEx inboard flap was found on a taxiway to the right of the runway (Figure 16); note there was little or no crosswind present when the FedEx accident occurred.

Figure 15. Right Inboard Flap from Ship 518 (China Airlines)

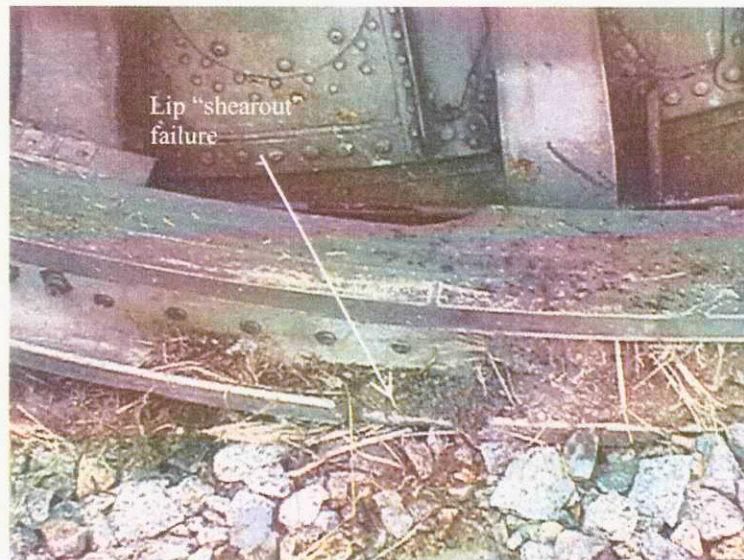
The local shear-out failure of the flap track is evident in a photograph taken at the accident site (Figure 17). The location of this failure is consistent with the position of the side rollers for the reported flap setting of 35 degrees. The same type of failure is observed in the photograph of the inboard flap from the FedEx-Newark aircraft (Figure 18); in this case the failure location is consistent with the reported flap setting of 50 degrees.

Figure 17. Right Inboard Flap track from Ship 518 (China Airlines)

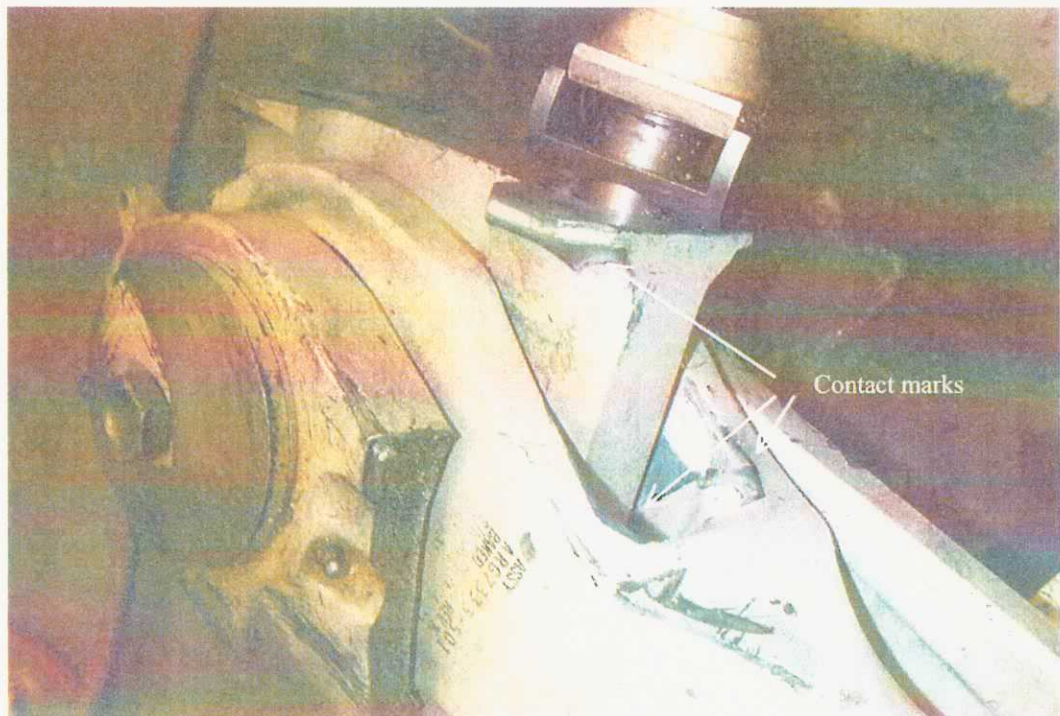
Figure 23. Evidence of contact between the fixed brace and the side brace fitting

The presence of a large prying load at the S-B-F-T-T-P joint results in severe distress to this joint. This manifests itself as localized high bending (flexure) at the outboard end of the fixed brace, and a large tension load on the inboard of the two tension bolts attaching the side brace fitting to the trap panel. Evidence of flexural distress of the fixed brace was observed in parts taken from both the China Airlines and FedEx-Newark accident aircraft. The fixed brace from the China Airlines aircraft failed completely (Figure 24). The fixed brace from the FedEx-Newark aircraft was bent and suffered a stress corrosion fracture (Figure 25). The stress corrosion fracture is attributed to residual stress resulting from a high flexural load. Note also in Figure 25 the evidence of local contact with the side brace fitting.

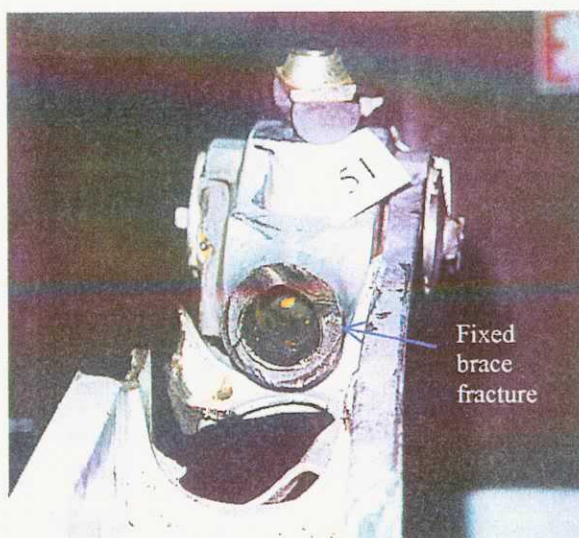
Figure 24. Outboard end of the fixed brace from Ship 518 (China Airlines) [left]

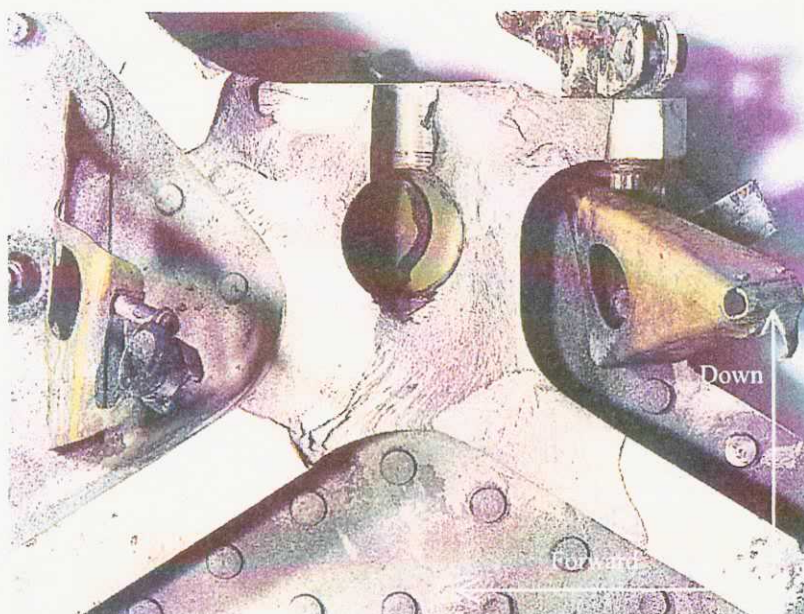
The outboard tension bolt did not fail. Instead a portion of the outboard face of the trap panel appears to have "split off", releasing the outboard barrel nut and tension bolt (Figure 26). This is thought to have occurred *after* the inboard bolt had failed and appears to have been the result of a prying load applied by the outboard tension bolt, the prying load resulting from the folding side brace pulling outboard on the side brace fitting. (Note the photograph is upside-down relative to the normal position in the aircraft).

Figure 26. Outboard trap panel failure at the S-B-F-T-T-P joint

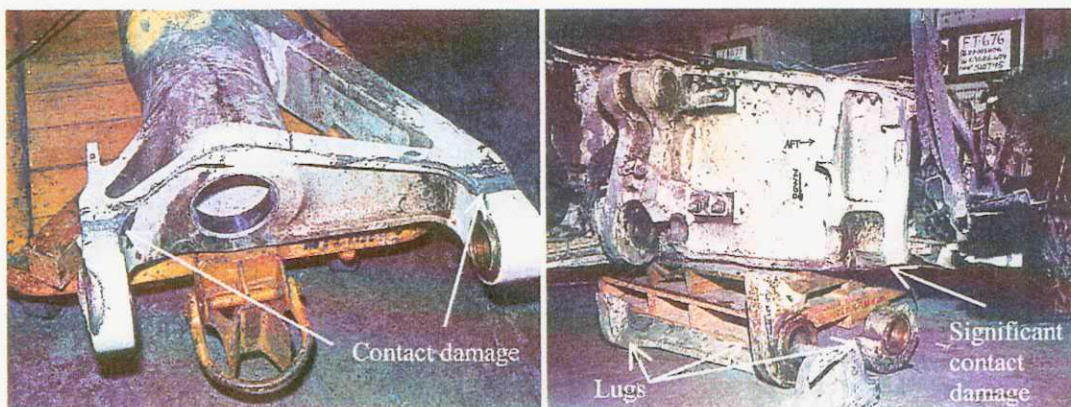
There is clear evidence that the right main landing gear strut, once released at the S-B-F-T-T-P joint, rotated outboard and contacted its wing attach fitting. Similar observations were made for the parts from the FedEx-Newark accident aircraft (see Figures 27 and 28). This type of contact creates a “short couple” prying action that easily breaks the gear loose from the fitting.

Figure 27. Right main landing gear strut from Ship 553 (FedEx-Newark) [left]
 Figure 28. Right MLG-to-wing attach fitting from Ship 553 (FedEx-Newark) [right]

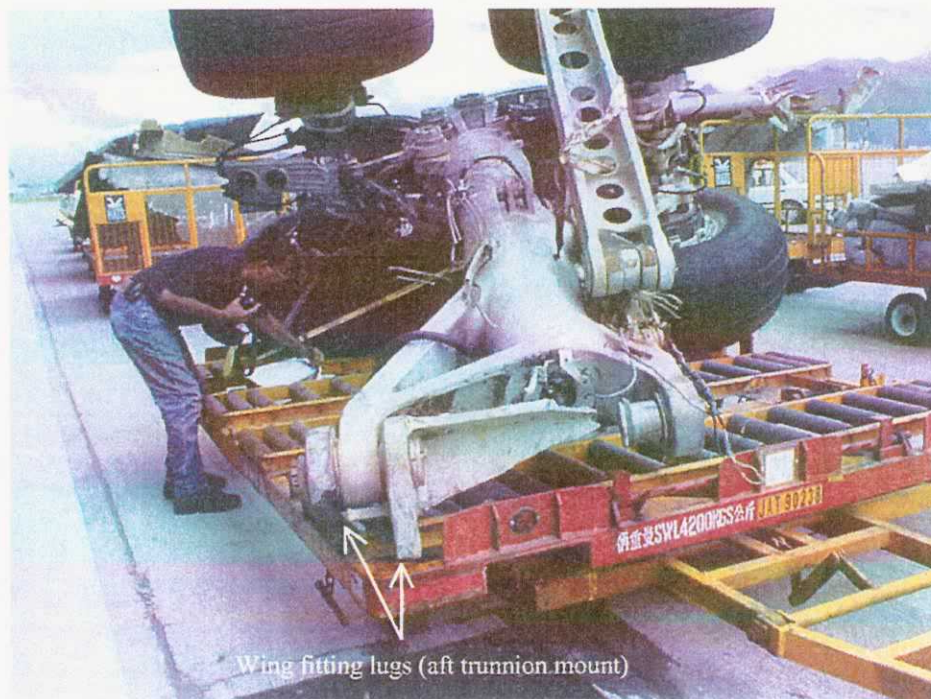
cracked off as a result of the gear rotating outboard (Figure 31). This separated the right main landing gear from the aircraft. The contact area on the aft trunnion arm is shown in Figure 32. A photograph of the wing fitting, showing the mating area for the two aft trunnion support lugs, is included as Figure 33.

Figure 31. Right main landing gear assembly

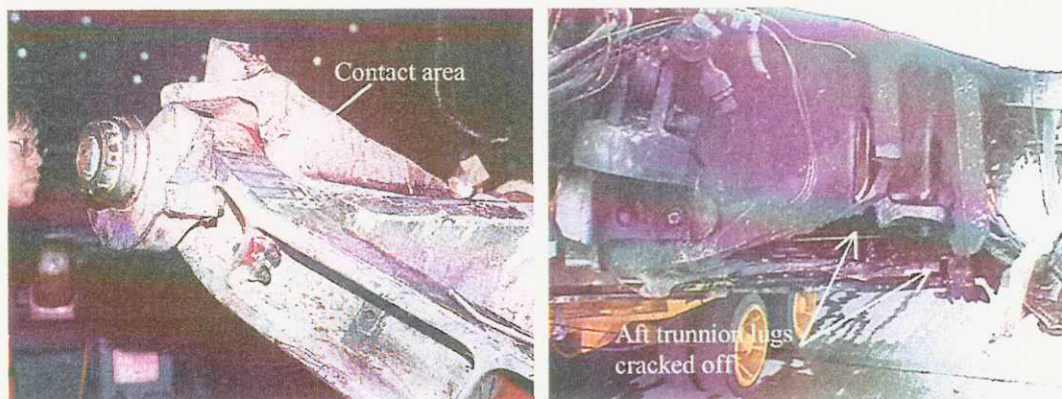
Figure 32. Aft trunnion arm of the right main landing gear strut [left]

Figure 33. Right MLG-to-wing attach fitting from Ship 518 (China Airlines) [right]

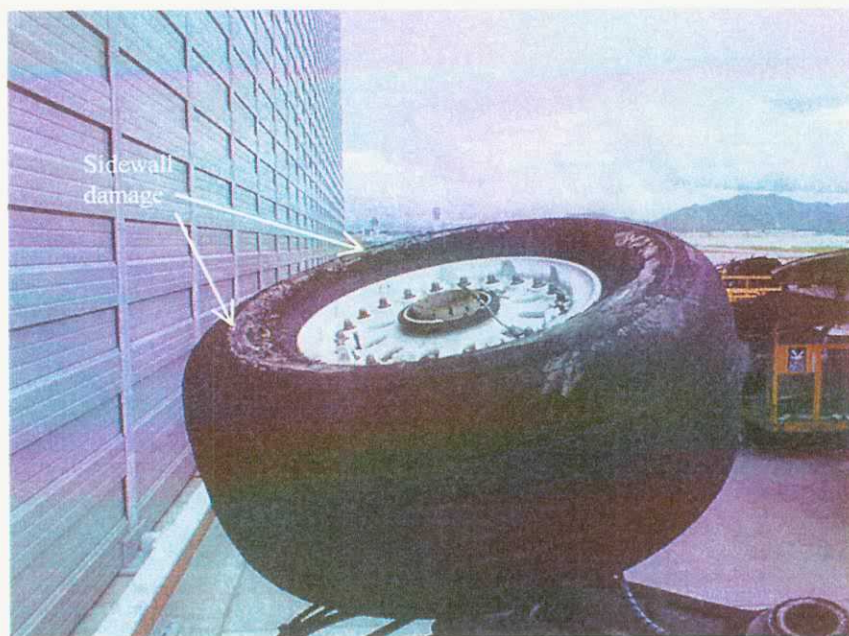
Substantial sidewall abrasion was noted on the inboard sidewall of the aft inboard tire on the right main landing gear truck (Figure 34). This evidence further supports the theory that the gear rotated outboard putting the inboard sidewalls of the inboard tires in contact with the ground.

Figure 34. Inboard aft tire from the right main landing gear
