**AIRCRAFT ACCIDENT REPORT 1/2005**

**Report on the accident to  
Airbus A330-342 B-HYA  
Within the Manila Flight Information Region  
on 18 July 2003**

Operator : Hong Kong Dragon Airlines Limited

Aircraft Type : Airbus A330-342

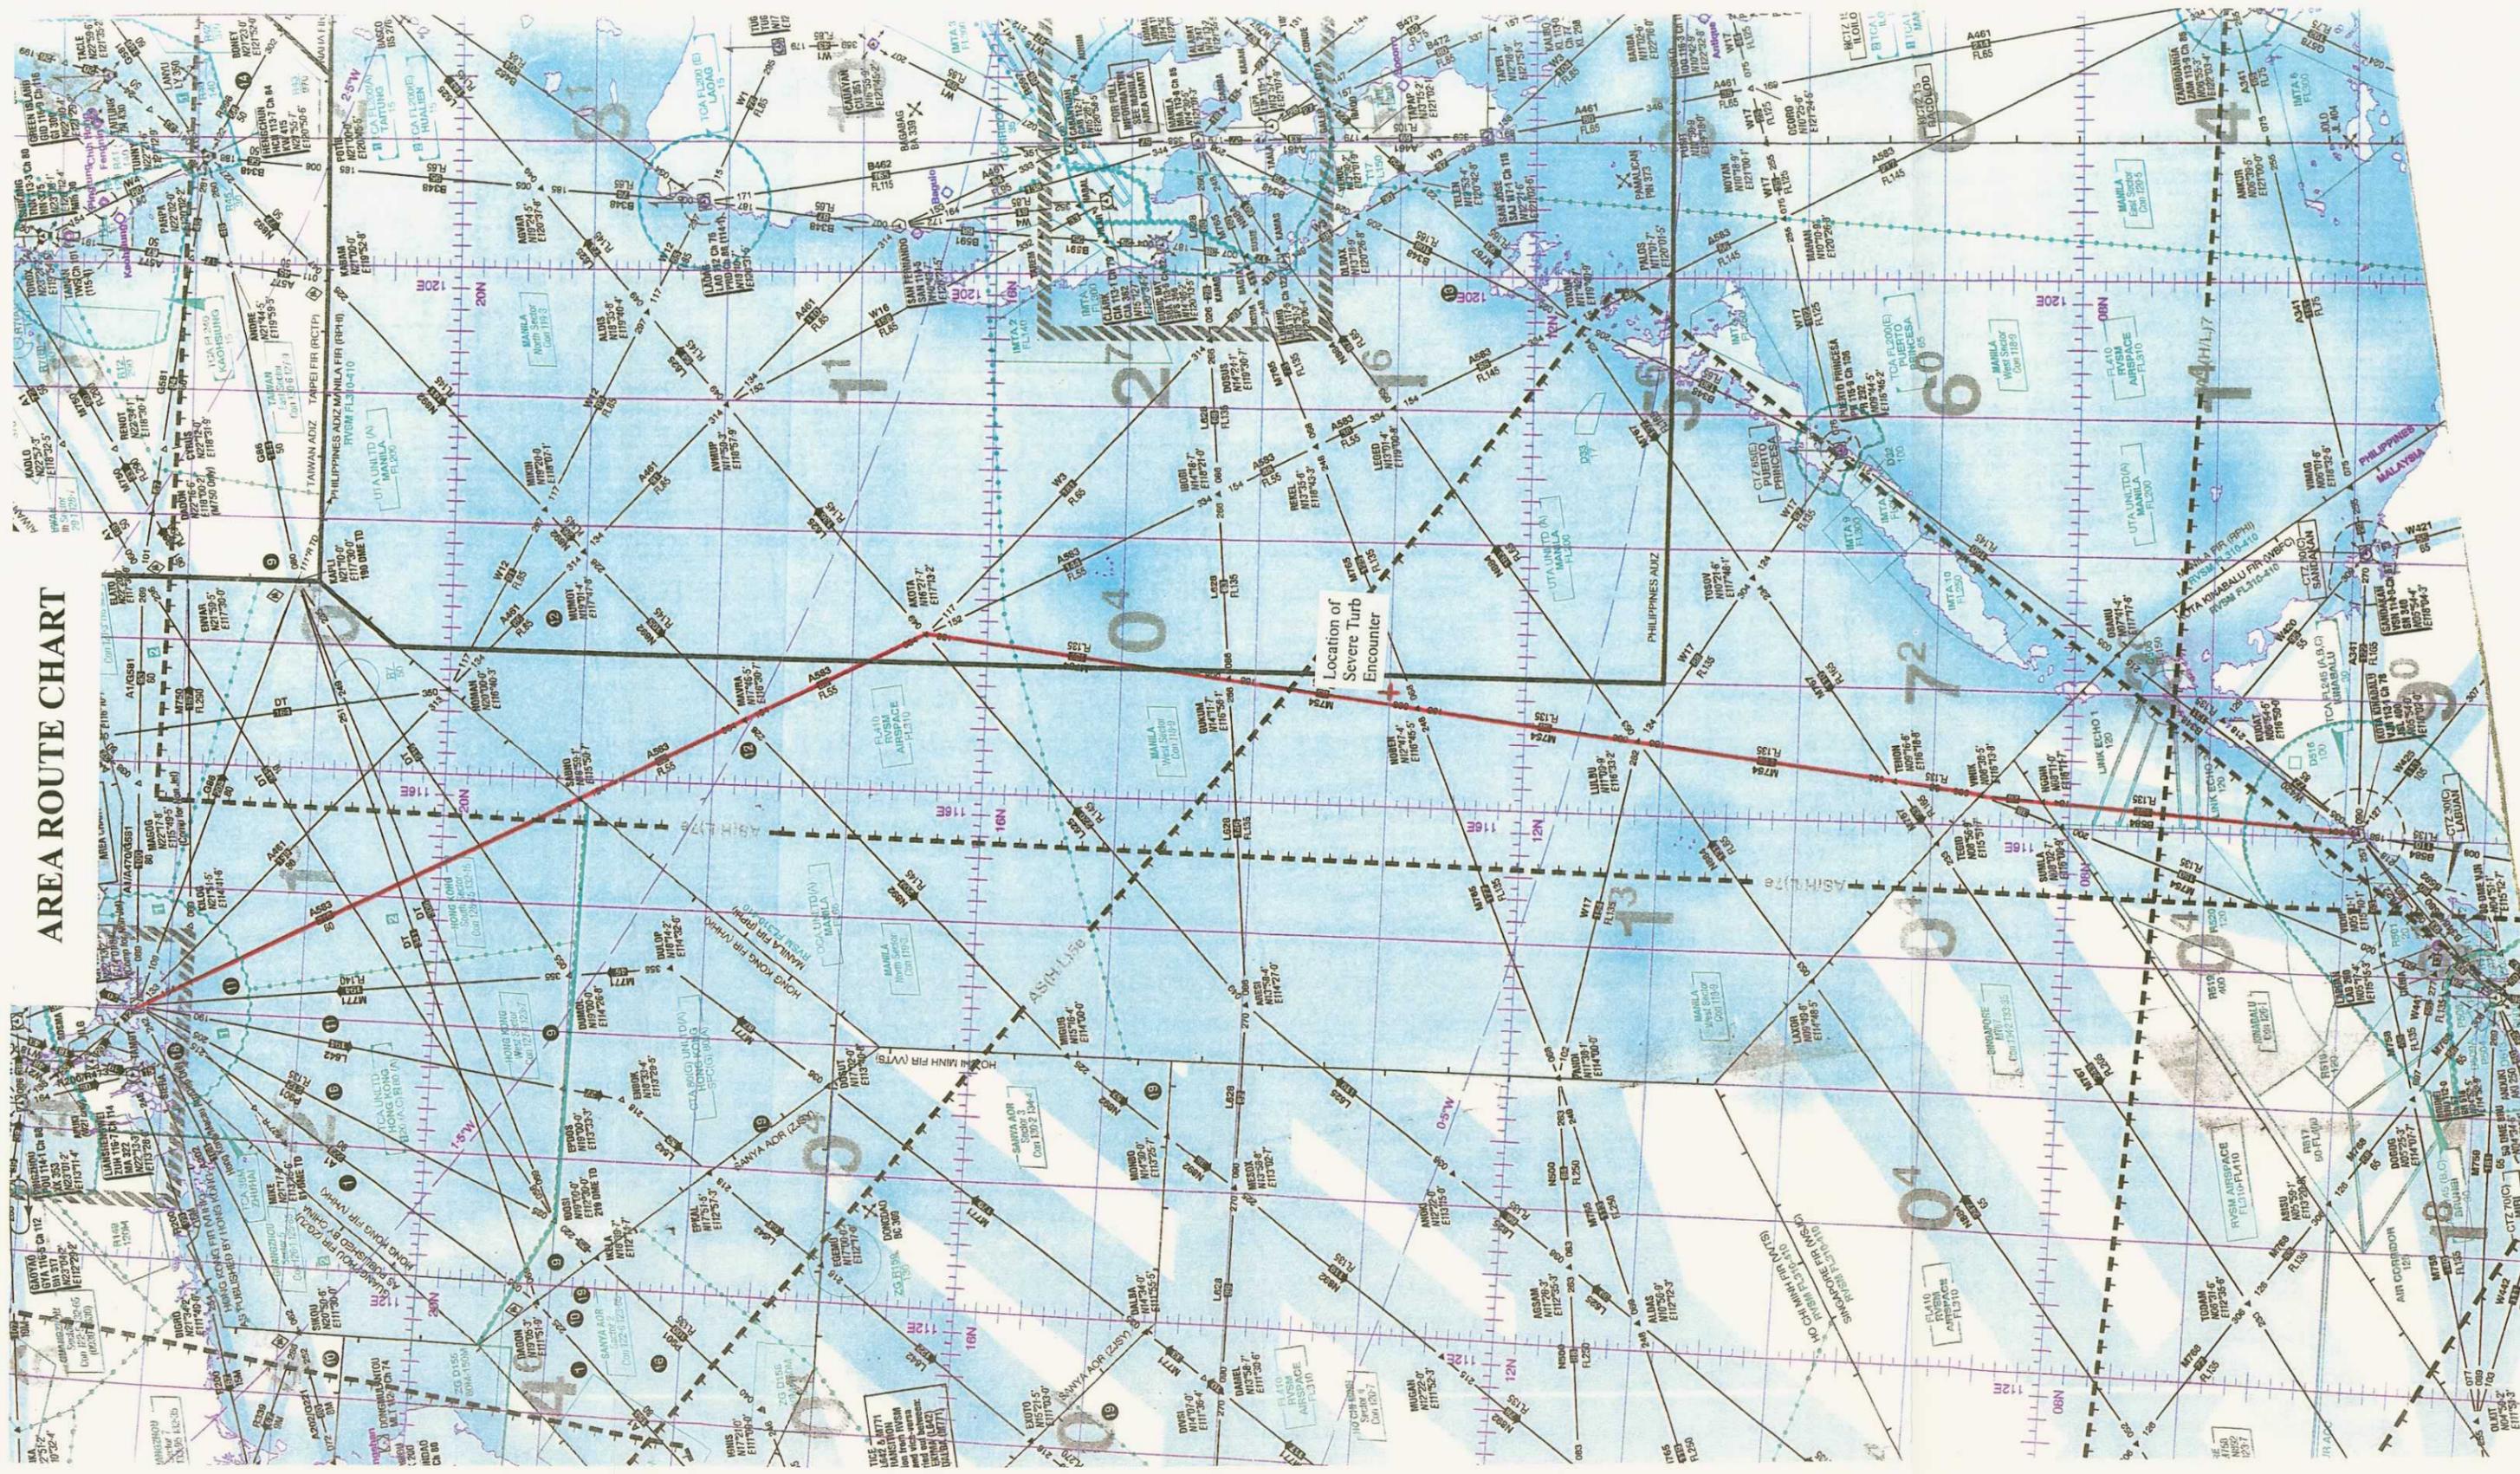
# PLOT OF AIRCRAFT TRACK

Prior to NOBEN, with yellow and green weather returns observed on the radar, they requested permission from Manila ATC to deviate 10 NM to the right of track for weather avoidance. At 0510, shortly after commencing track deviation, the aircraft encountered severe turbulence. (Appendix 2 depicts the aircraft track at around the time of the turbulence encounter.)

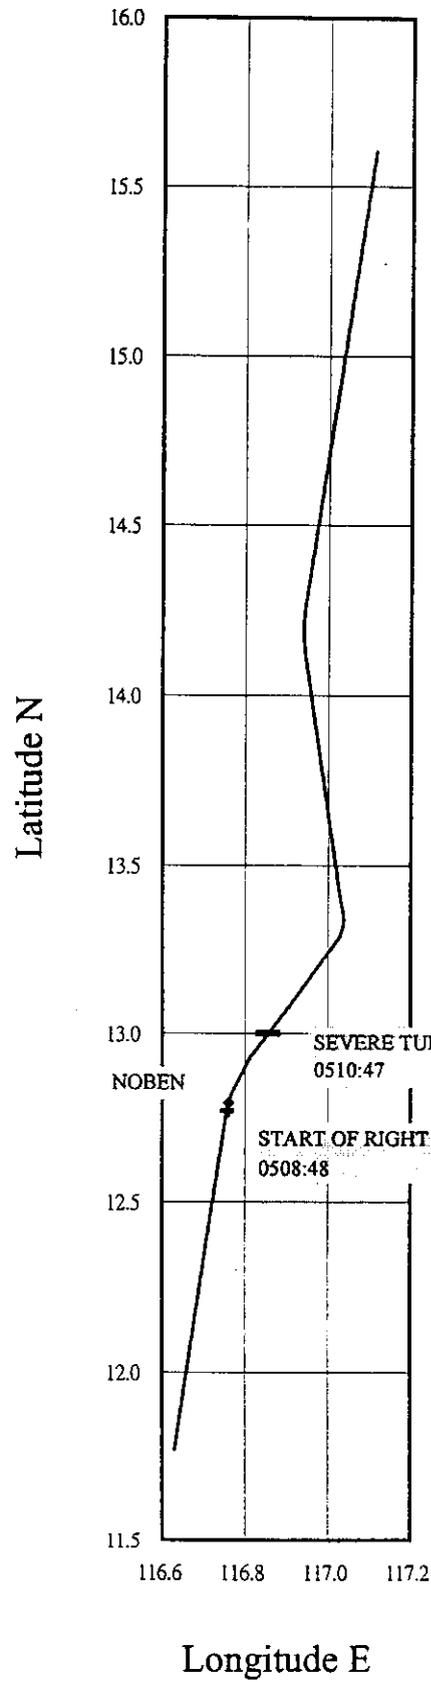
# PLOT OF DFDR DATA

1.3.2. The sudden jolts experienced inside the cabin were indicated by excursions of vertical acceleration in the positive (+) and negative (-) sense recorded by the DFDR. The maximum vertical acceleration encountered was + 1.89 'G' during the first gust, while during the second gust the acceleration reached a maximum of + 1.27 'G' and a minimum of - 0.52 'G'. These excursions occurred over a period of 17 seconds. An engineering inspection was carried out after landing and revealed no structural damage to the aircraft. (Appendix 3 shows the DFDR Data Plot during the period of turbulence encounter.)

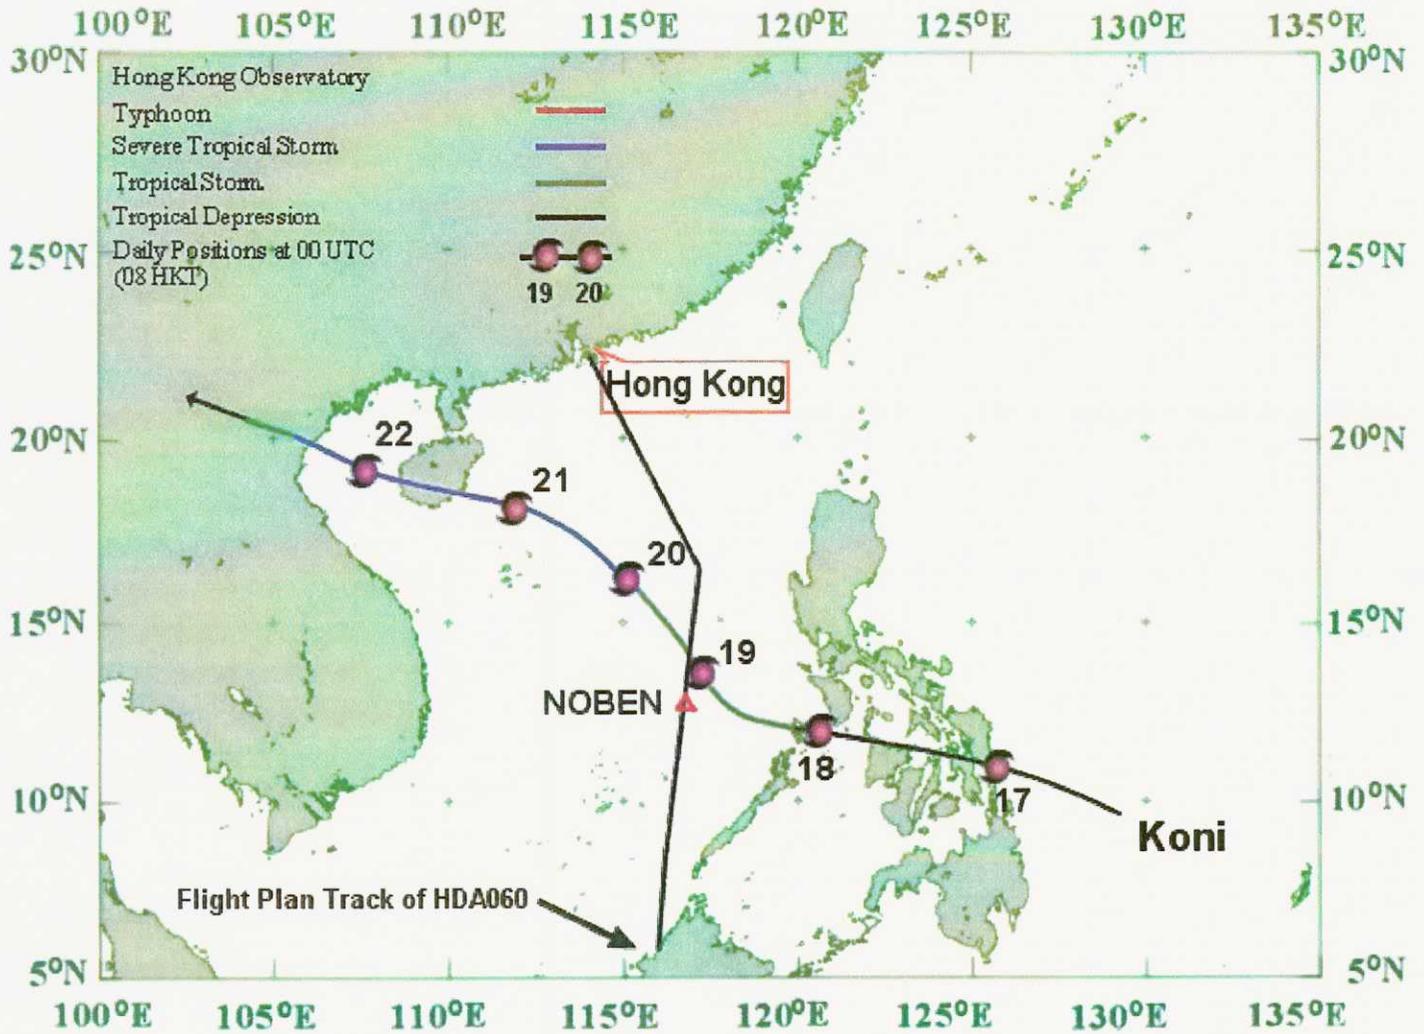
## GOES-9 INFRA-RED SATELLITE PICTURE

The satellite imagery was captured with GOES-9 operated by the joint effort of Japan Meteorological Agency (JMA) and United States National Oceanic and Atmospheric Administration National Environmental Satellite Data and Information Service (US NOAA NEDIS). Position of “KONI” is a post-analysis position for 0600 UTC 18 July 2003.
