AIRCRAFT ACCIDENT REPORT 2/2015

**Report on the accident to Cessna 172P
Registration B-HRH operated by the
Hong Kong Aviation Club Limited
at Shek Kong Airfield, Hong Kong
on 28 September 2013**

**Hong Kong
March 2015**

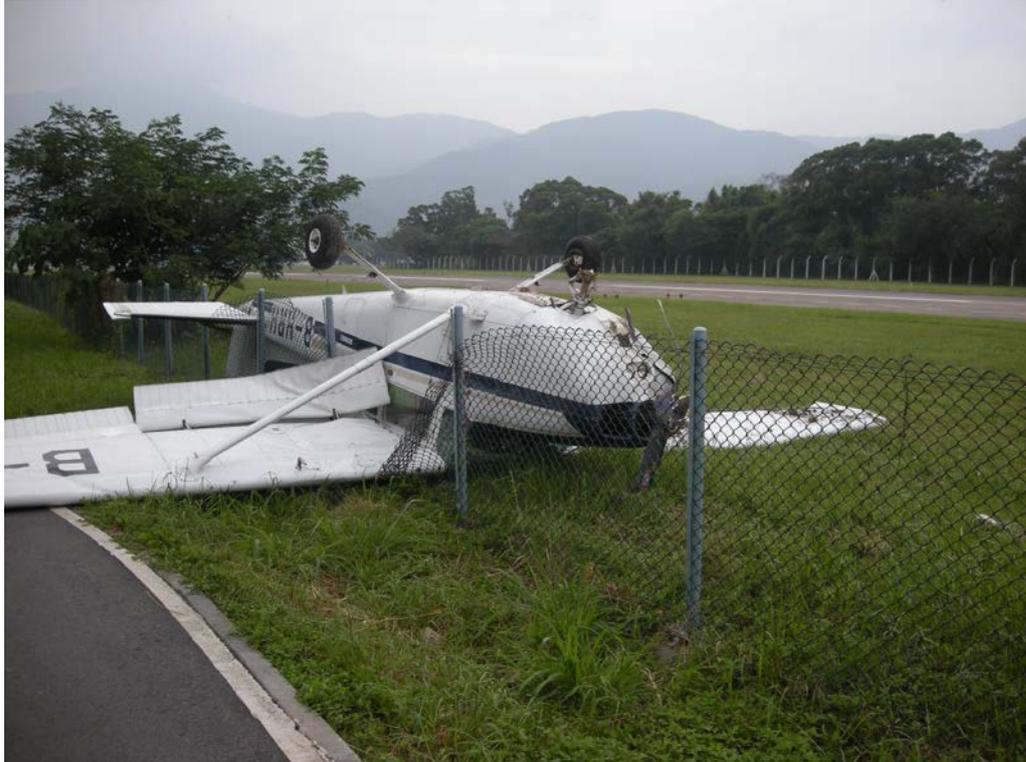
The aircraft B-HRH (front left view)

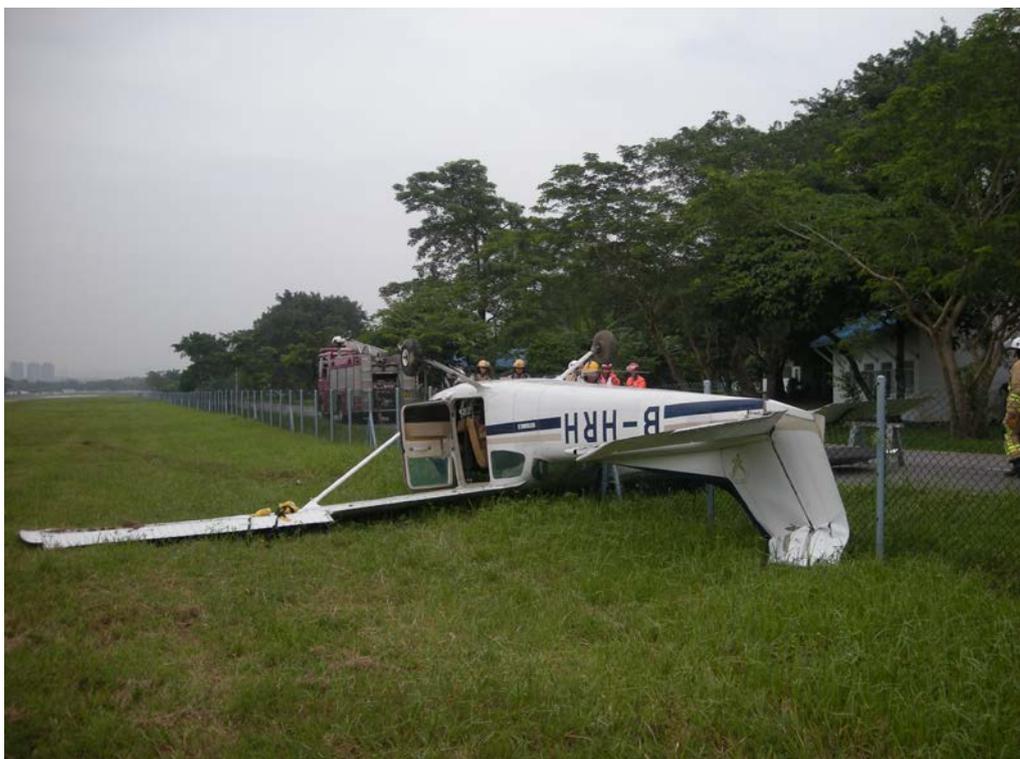
The aircraft B-HRH (rear right view)

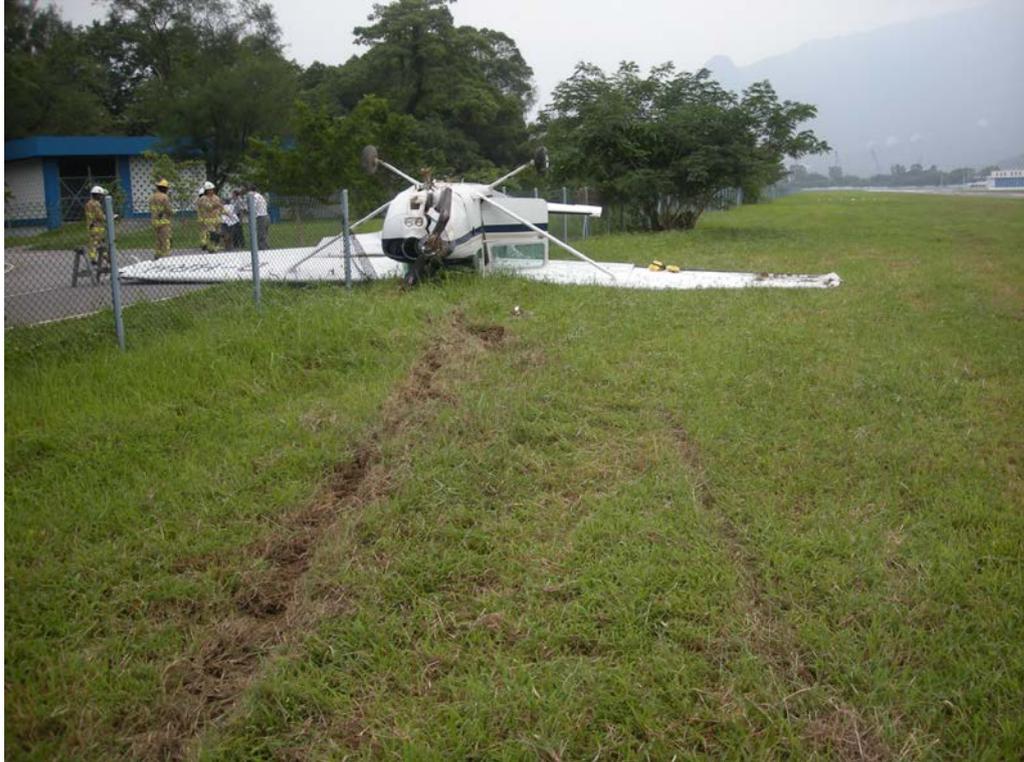
- 1.12.1.3 Two wheel marks caused by the nose wheel, 35 m long and the right hand main wheel, 30 m long, were observed behind the main wreckage. The depth of the nose wheel mark was deeper than that of the right hand main wheel mark.

2.4.6 The depth of the nose wheel mark increased towards the wreckage indicated that the nose gear was ploughing through into the soil until the aircraft was bogged down and overstressed the nose wheel fork, causing it fracture.

The markings on ground – front wheel and right main wheel

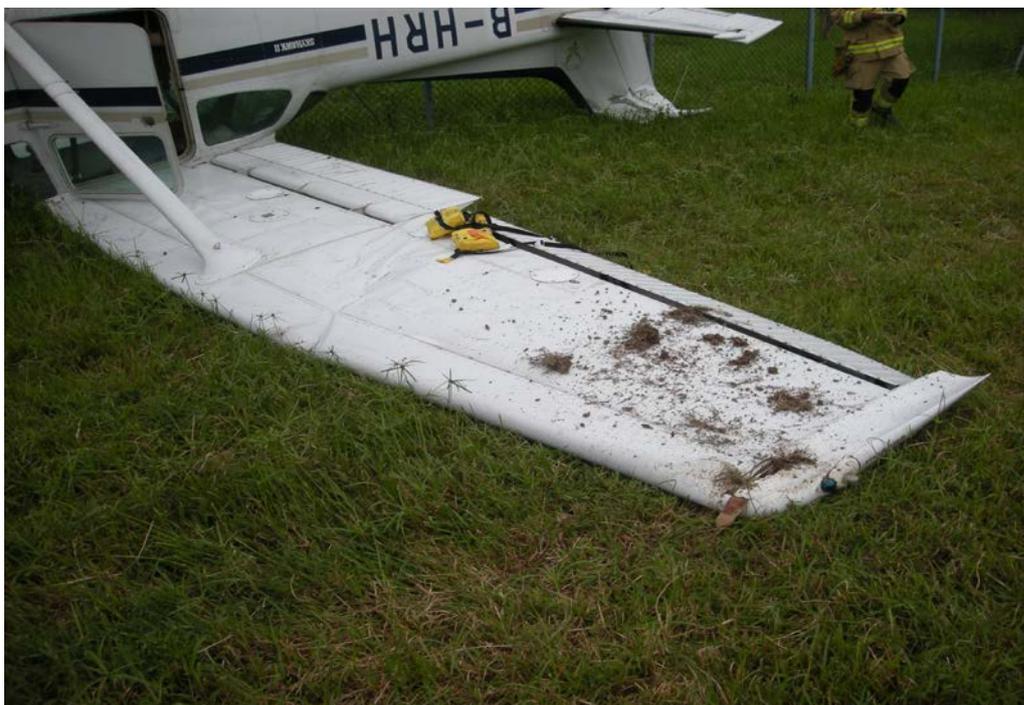
- 1.12.2.1 The wings suffered from impact damage on the upper and bottom surfaces of both wings. The left-hand wing at the wing root area was severely damaged. Part of the left-hand wing trailing edge, near the wing root, was also twisted and detached from the aircraft.

The right Wing

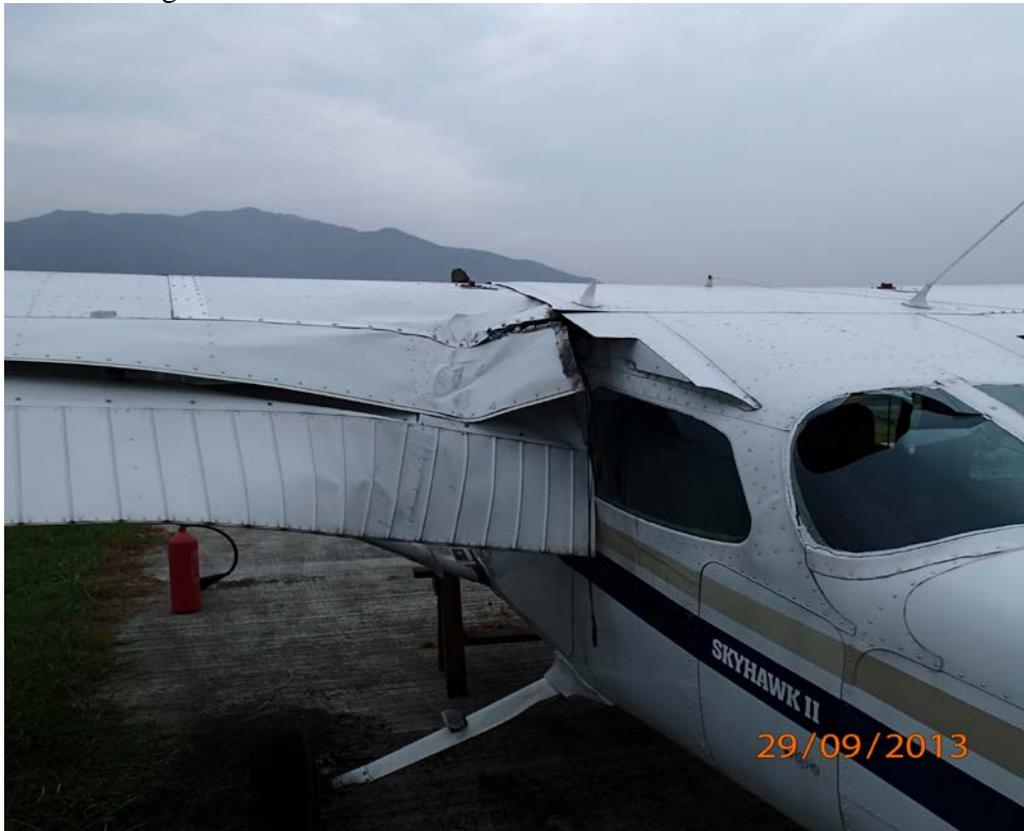
The left wing

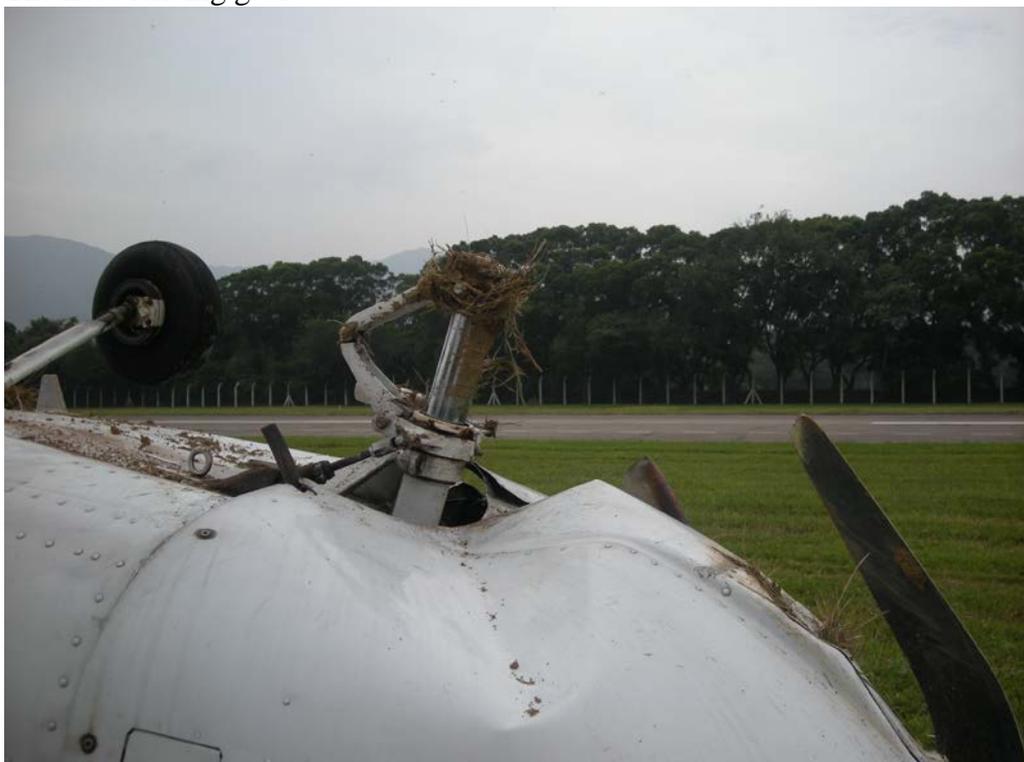
- 1.12.5 Landing Gears
 - 1.12.5.1 The nose wheel was detached from the nose gear at the wheel fork. On the detached nose wheel, the right hand side of the nose fork was slightly distorted. A large amount of mud was found trapped between the distorted nose fork and the nose wheel. The nose gear oleo and the undetached part of the nose fork were surrounded by the mud.

The nose landing gear

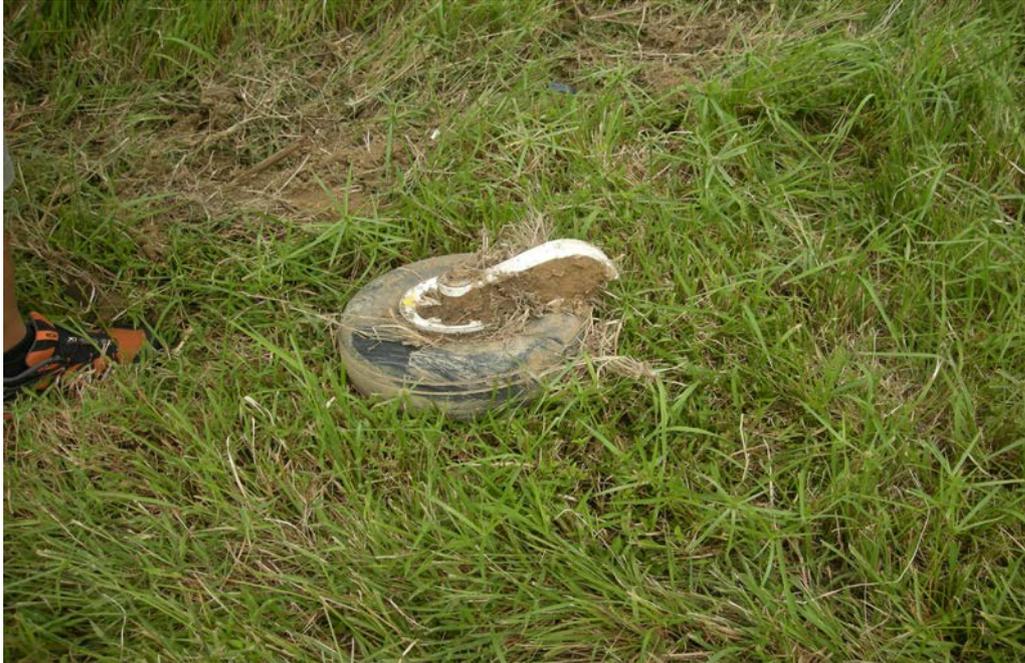
2.4.3 Nose wheel was almost jammed by the mud and could hardly be rotated. Both main landing gear wheels and brakes were in good conditions.

The nose wheel

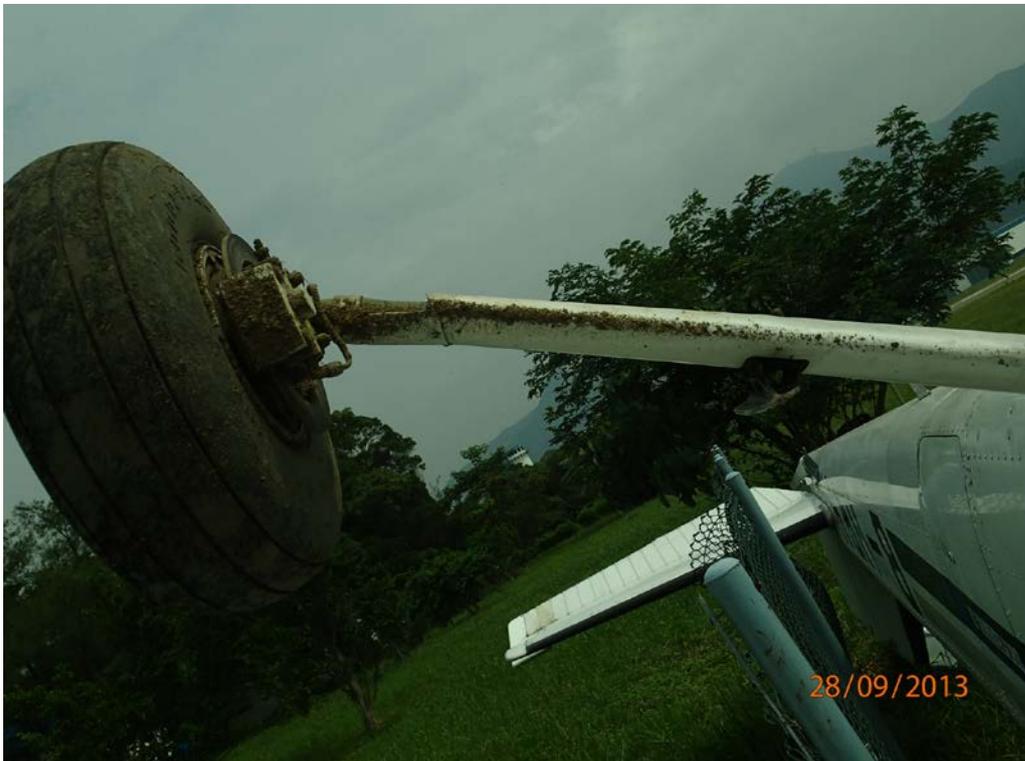
- 1.12.5.2 There were no damage on both main landing gear and wheels. The left hand wheel, frontal area of the brake and leading edge of the left hand landing gear strut were heavily contaminated with mud. Only a small amount of mud was found on the left hand main wheel.

The left wheel

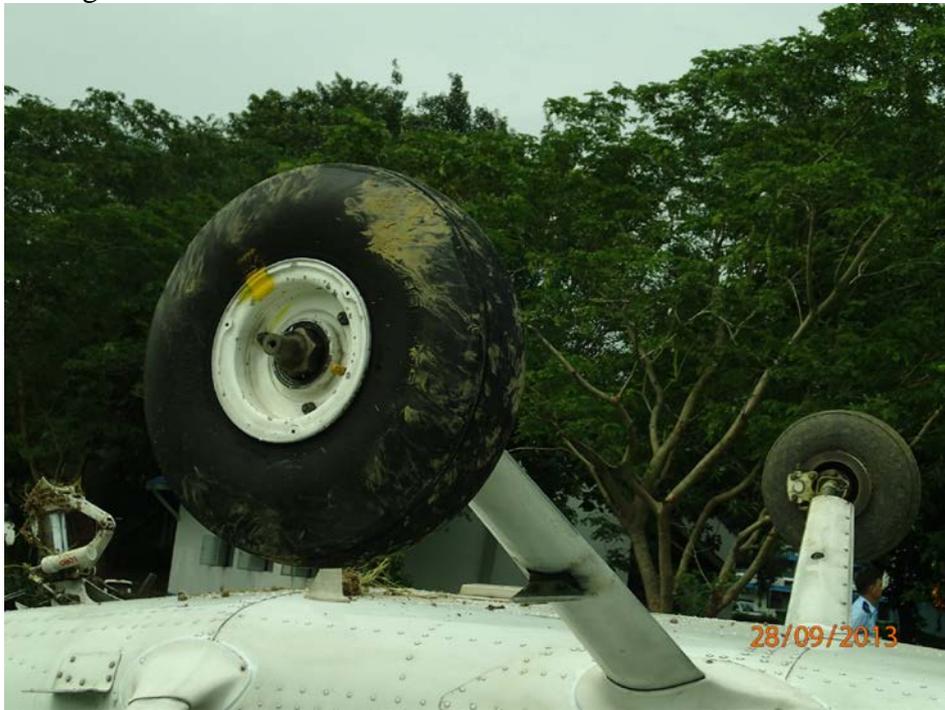
The right wheel

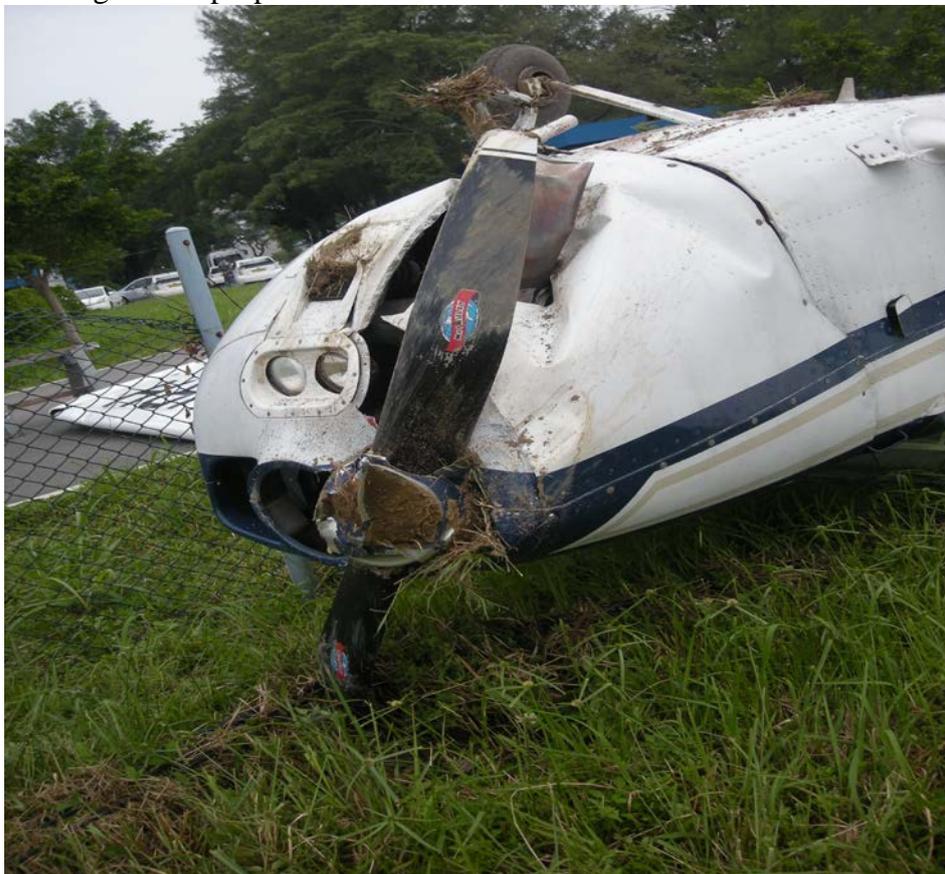
- 1.12.7 Propellers
 - 1.12.7.1 Both propeller blades exhibited impact damage and were bent rearward. Local damages were found on the propeller tips. The propeller spinner was also collapsed. There was no propeller ground mark observed.

The engine and propeller

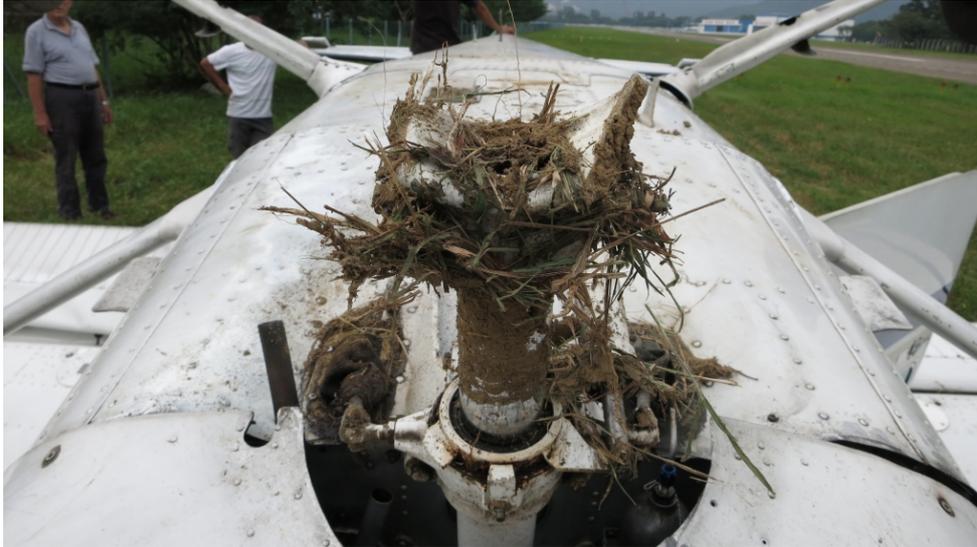
Detailed inspection and microscopic inspection were employed to determine the failure of the nose wheel fork. The fractured surface of the failed nose wheel fork did not identify any premature failure. The microscopic inspection revealed that the unit failed as a result of brittle failure due to overload.

2.4.7 The microscopic inspection of the fracture surfaces of the nose wheel fork confirmed that it was fractured in overload condition.

- 3.1.3 The mechanical failure of the nose wheel fork was due to overload as a consequence of the aircraft stall upon its impact on the grass area in a nose down attitude and ploughed into the mud.

The nose landing gear damage

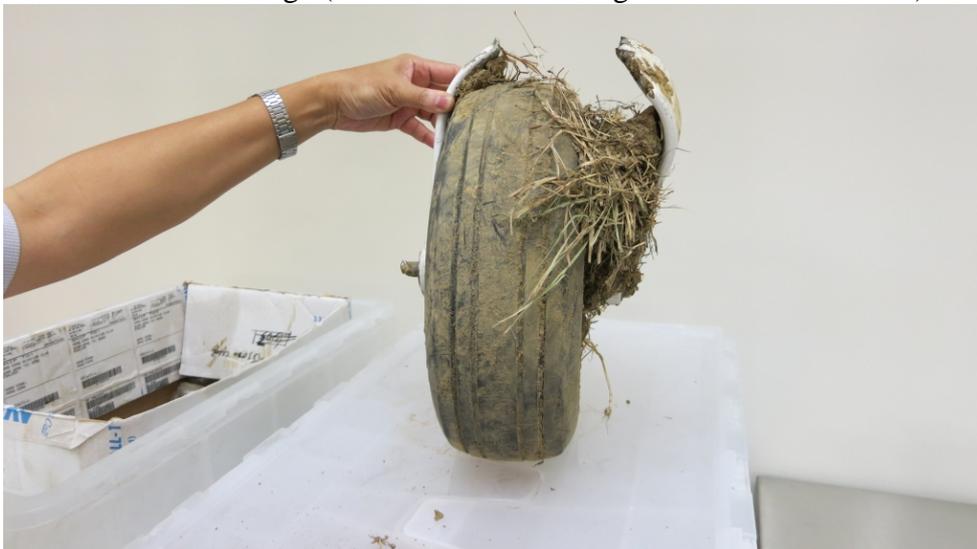
2.4.2 There were significant amount of mud found between the right hand side of the nose wheel and the nose wheel fork. There was much less amount of mud on the left side. Both main landing gear wheels collected more mud debris on the right hand side as compared to the left hand side. The evidence indicated that the aircraft was side-slipping and ploughing into the soil on the grass area before somersault.

The nose wheel damage (view from behind – right hand side with mud)
