A Newsletter for Aviation Safety Professionals 1

A Newsletter for Aviation Safety Professionals

Manage the Weather

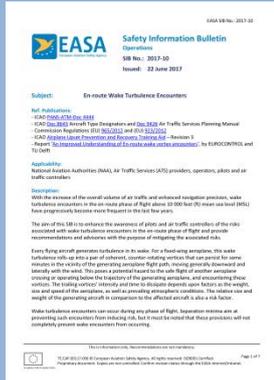
The trailing vortices' intensity and time to dissipate often depend upon factors such as the weight, size and speed of aircraft, and prevailing atmospheric conditions. The relative size and weight of generating aircraft in comparison to the affected aircraft is also a risk factor.

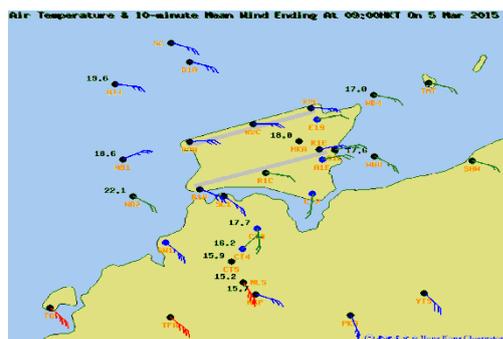
Figure 1: Strong and gusty easterlies on surface of the airport with strong to gale south to south-easterlies over the hilltops over Lantau Island in the morning of 5 March 2015

Runway 07 was in use at the time. Owing to the temperature inversion layer at altitude of 1,500 to 3,500 feet, vertical flow was inhibited, forcing the strong southerly winds to pass through the mountain gaps of Lantau Island and brought rather frequent windshear and turbulence over the airport (Figure 1). Windshear reports were received starting from 3 am in the morning and lasted for **18** hours until the evening, which means **1** to **9** reports per hour (Figure 2). Among the reports, some pilots reported windshear loss of more than **30 kt**, comparable to the headwind loss brought by a microburst. A few pilots also reported moderate to severe turbulence encounters during the period.

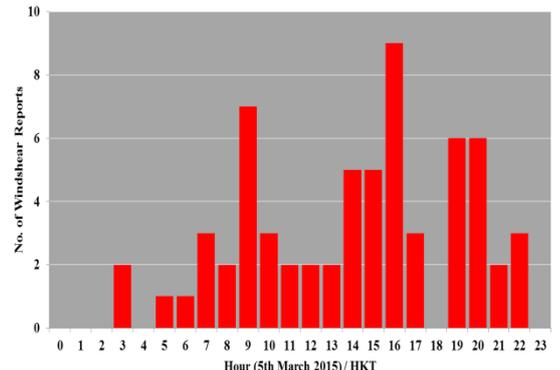
Figure 2: On 5 March 2015, windshear reports were received from pilots for 18 hours.

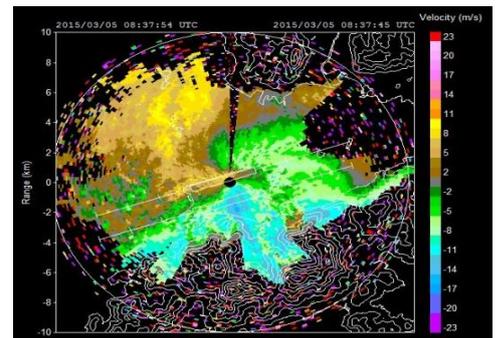
Figure 3: Green inbound flow in the midst of yellow and brown outbound flow was detected by LIDAR

As the windshear and turbulent conditions persisted during the day, more than **10** arrival flights were diverted and more than **20** aircrafts had to go around. In total, **64** arrival and **10** departure aircrafts reported significant windshear and turbulence on that particular day. Among them, **3** aircrafts reported windshear loss of 30 kt. The WTWS successfully detected windshear and made timely alerts over HKIA on that day (Figure 3). All arrival pilot reports received were covered either by the WTWS alerts or windshear warnings.
