AIRCRAFT ACCIDENT REPORT 1/2007

**Civil Aviation Department
Hong Kong**

**Report on the accident to
Robinson R44 helicopter, B-HJS,
operated by Topjet Aviation Limited at Pak A, Sai Kung, Hong Kong
on 11 June 2005**

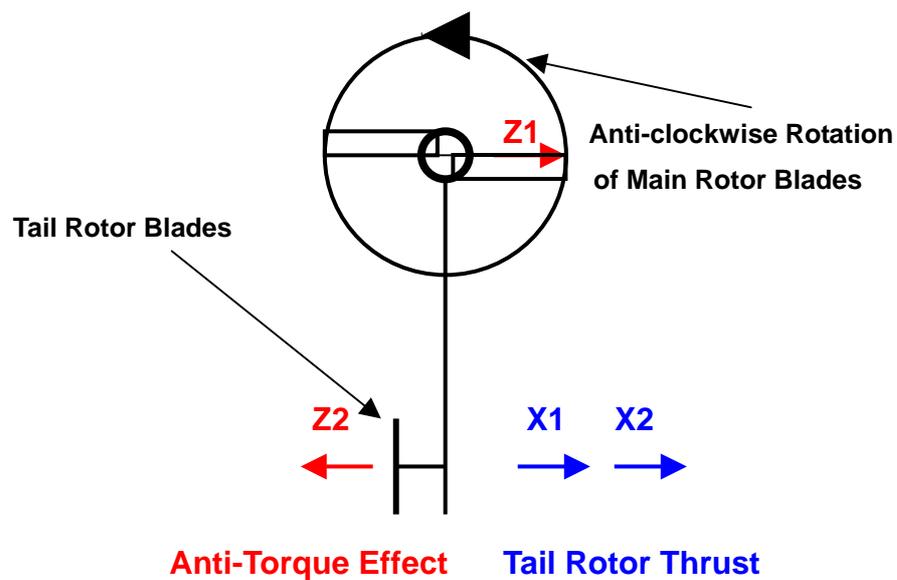
Figure 1 Anti-Torque Effect and Tail Rotor Thrust

Figure 1 is an illustration of the Anti-Torque Effect of the helicopter in the hover. With the main rotor blades rotating anti-clockwise, the helicopter would have a tendency to turn clockwise. This phenomenon is known as the Anti-Torque Effect, which can be seen as Force $Z1$ and $Z2$ (of equal magnitude) acting on the fuselage and forcing the helicopter to yaw to the right. To prevent the helicopter from yawing to the right, the tail rotor of the helicopter would produce a Tail Rotor Thrust (i.e. Force $X1$ and $X2$) to counter the effect of $Z1$ and $Z2$.

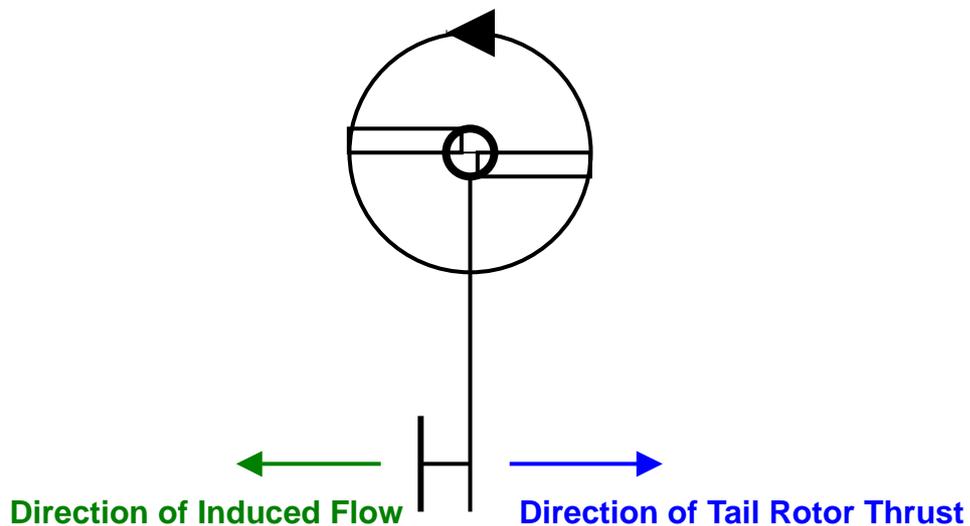
Figure 2 Induced Flow and Tail Rotor Thrust

As a result of the Tail Rotor Thrust, an Induced Flow of air mass in the opposite direction would be produced as shown in Figure 2.

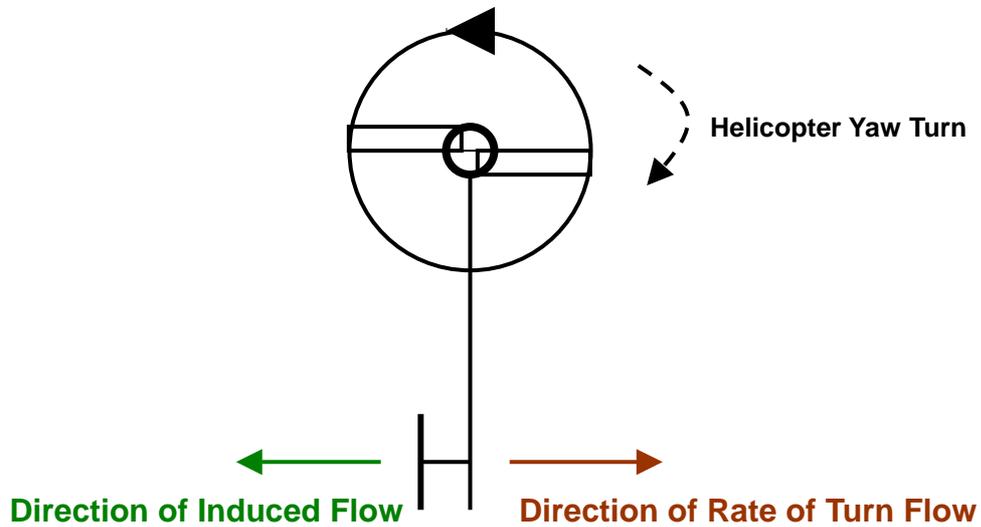
Figure 3 Induced Flow and Rate of Turn Flow during the Yaw Turn

As the helicopter turns right in the yawing plane, an air flow acting on the tail rotor blade in the opposite direction of the Induced Flow as shown in Figure 3 will be produced. This air flow is referred to as the Rate of Turn Flow in the following analysis. The magnitude

of the Rate of Turn Flow will vary with the rate of turn of the helicopter.

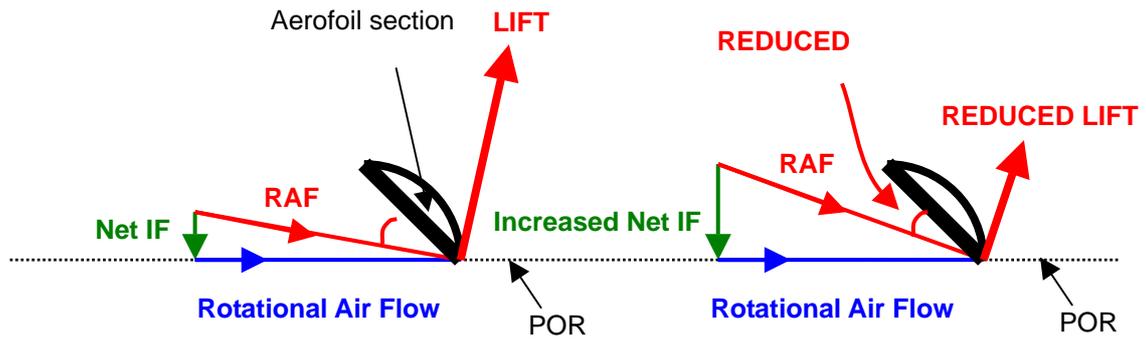
Figure 4 Aerodynamic Relationship between Induced Flow and Lift

The Induced Flow (IF) had a major effect on the aerodynamics of a helicopter. The Relative Air Flow (RAF) is the resultant of the Induced Flow, Rate of Turn Flow and Rotational Air Flow along the Plane of Rotation (POR) of the rotor blades. In the following analysis, the Net Induced Flow will be resulted when the Induced Flow is greater than Rate of Turn Flow. An increase of the Net Induced Flow would result in a decrease in the Angle of Attack (i.e. the angle between the RAF and the chord of the rotor blades), which would in turn result in a decrease in the Lift. Consequently, the Tail Rotor Thrust would be reduced as shown in Figure 4.

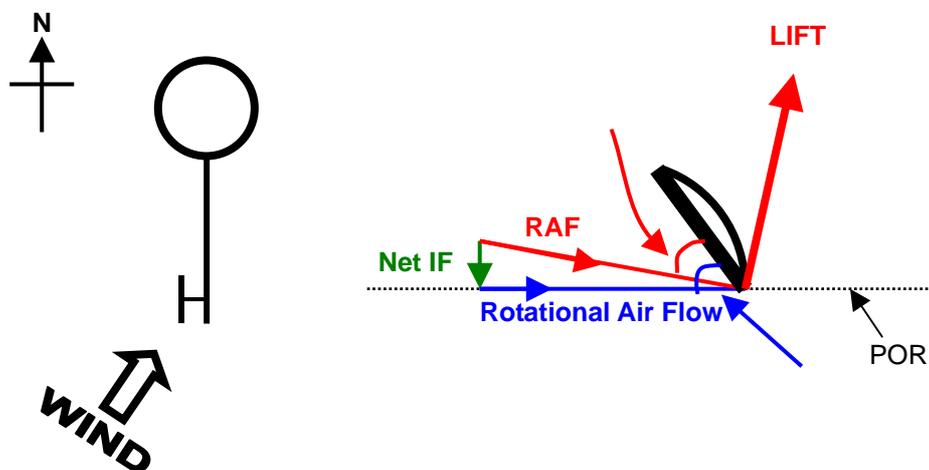
Figure 5 Hovering Tailwind with a High All Up Weight

2.1.9.5.1 With a high all up weight of approximately 2,200 lb (see Paragraph 1.6.3) and in a tailwind condition, the tail rotor of the helicopter had to produce more Tail Rotor Thrust. This would require a high Pitch Angle (i.e. the angle between the tail rotor blades and the POR) of the tail rotor blades, resulting in a high Angle of Attack, as shown in Figure 5.

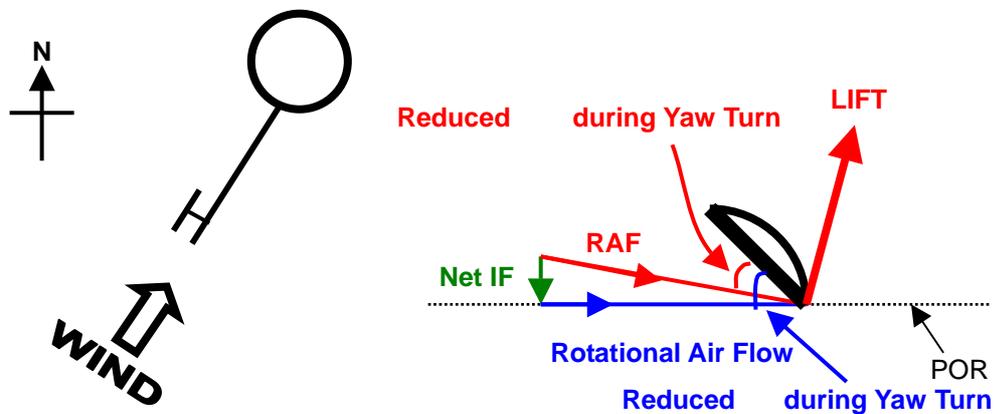
Figure 6 Application of Right Yaw Pedal to Turn Right

2.1.9.6.1 Having established into a tailwind hover with a component of wind from the left, the pilot initiated a slow 180° spot turn to the right, as stated in his statement: “... *I then came up to a five-foot steady hover facing north. I did the hover checks including the RPM. I initiated a slow 180° spot turn to the right. ...*”. To do this, he would have to further apply additional right yaw pedal, which would result in a reduction of the Pitch Angle and the Angle of Attack in the tail rotor. As the helicopter started to turn to the

right, the relative wind gradually changed to a direct tailwind position as shown in Figure 6. At this time, the weathercock effect trying to turn the helicopter to the left in the yawing plane would disappear. Under the circumstances, the pilot would need to apply some left yaw pedal to compensate the right yaw pedal originally applied as discussed in Paragraph 2.1.9.5.2, in order to control the rate of turn of the helicopter.

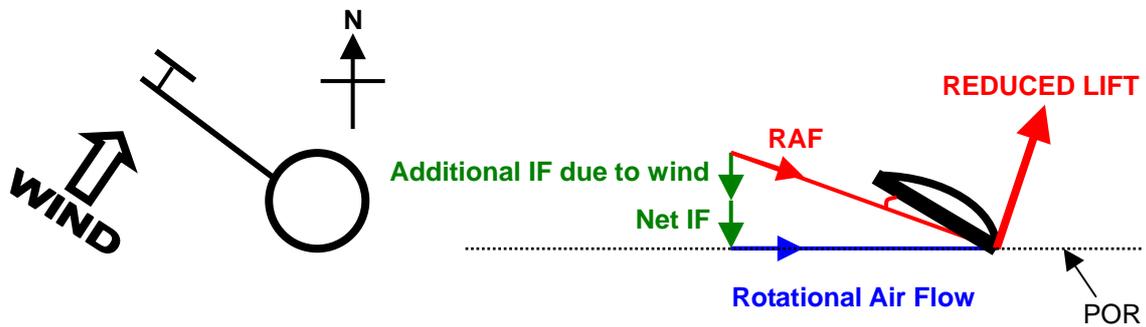
Figure 7 Wind from 3 o'clock Position

2.1.9.6.2 As the helicopter continued to turn right, the relative wind would now change from a tailwind position to a crosswind position with a crosswind component acting on the tail rotor from the right. This crosswind component would act in the same direction of the Induced Flow, thus increasing the magnitude of the Induced Flow. This would result in a further decrease of the Angle of Attack, and thus the Tail Rotor Thrust.

With the decrease in Tail Rotor Thrust, the rate of yaw to the right would increase even without any application of right yaw pedal. At the same time, the helicopter would be affected by the weathercock effect as mentioned in Paragraph 2.1.9.1.2, resulting in further acceleration in the rate of turn. The combined effect of the additional Induced Flow and weathercock effect would be at its maximum when the wind was from the 3 o'clock position as shown in Figure 7. The rate of turn of the helicopter would then continue to increase until the helicopter turned into wind. This phenomenon of the uncommanded increase and accelerating rate of turn is commonly known as Loss of Tail Rotor Effectiveness (LTE).^{Note 3} Had the limitation of the maximum rate of turn of the helicopter been available to the pilot in the R44 POH, the pilot would have been better alerted to the development of LTE and possibly the subsequent Loss of Tail Rotor Thrust (LTT) arising from an uncommanded, rapid and accelerating rate of turn.

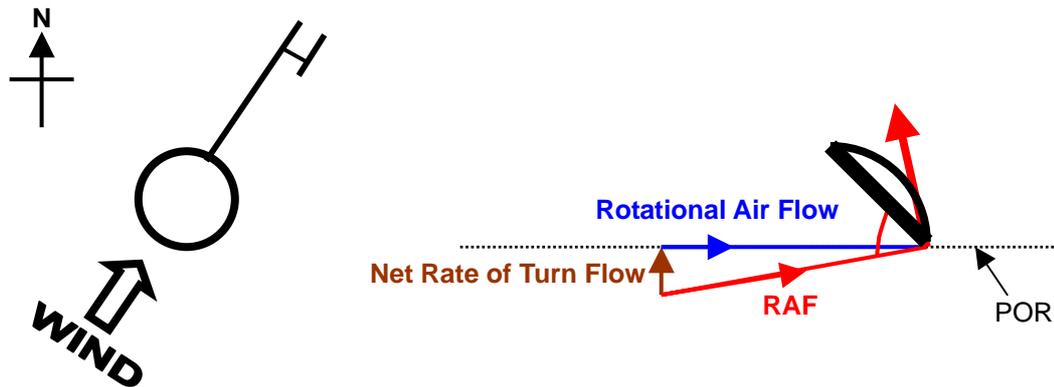
Figure 8 Helicopter Facing the Wind

2.1.9.9.2 As the helicopter continued to yaw to the right, the wind direction relative to the helicopter changed from 3 o'clock position to 12 o'clock position. The additional Induced Flow due to wind would decrease to zero when the helicopter was into wind. In the meantime, the increasing rate of turn generated a progressively stronger Rate of Turn Flow. Consequently, the Rate of Turn Flow might be larger than the Induced Flow so that there would be a Net Rate of Turn Flow acting on the other side of the POR as shown in Figure 8. As

shown in the same figure, the RAF might then act on the other side of the POR. As a result, the Angle of Attack would significantly increase, approaching the Critical Angle of Attack (Stalling Angle of Attack).

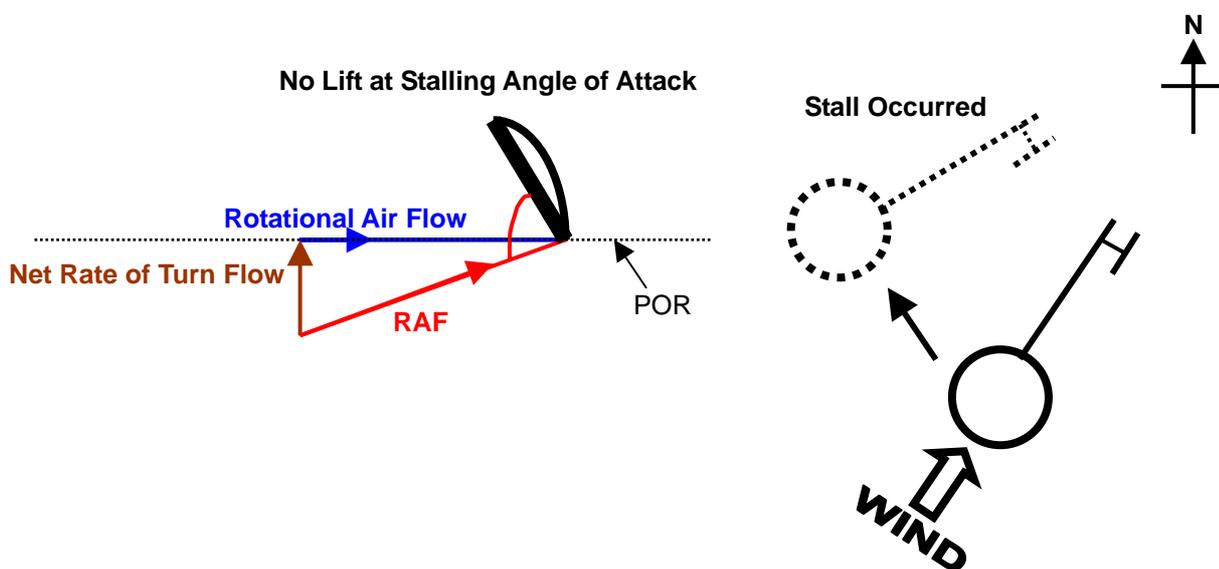
Figure 9 Tail Rotor Stall

The pilot stated in his statement that when the helicopter was into wind, he applied left yaw pedal to stop the turn: “... *I applied left pedal, intending to stabilize the helicopter in a hover facing south before transitioning forward. However, the helicopter seemed not to respond to my pedal input. The helicopter did not stop turning on a southerly heading. The rate of turn was building up, getting faster and faster. ...*”. It was believed that the pilot under the circumstances had applied a substantial amount of left yaw pedal in an attempt to arrest the high rate of turn. This explained the finding that the left yaw pedal was found in the full

forward position in the post-accident examination. This application of the left yaw pedal at this stage however could have inadvertently caused the Angle of Attack to exceed the Critical Angle of Attack as shown in Figure 9. As a result, the tail rotor entered into a state of incipient stall, and had eventually stalled, resulting in a LTT situation.

- 3.3.4 The timing and the magnitude of left yaw pedal input applied by the pilot, when the helicopter was into wind, to arrest the rapid and increasing rate of turn inadvertently caused the tail rotor to stall, resulting in LTT. (Paragraphs 2.1.9.7, 2.1.9.8, 2.1.9.9 and 2.1.9.10)

It is recommended that the personnel providing helicopter ground school training should strengthen pilots' awareness of LTE phenomenon, in particular the risk associated with a fast uncontrolled spot turn in a LTE situation, and the possibility of LTE developing into LTT due to the stalling of the tail rotor. (Paragraphs 3.3.1, 3.3.2, 3.3.3, 3.3.4 and 3.3.5)

It is recommended that the aircraft manufacturer specifies in the R44 POH the maximum rate of turn permitted for the helicopter in the yawing plane. (Paragraphs 3.1.24 and 3.3.4)

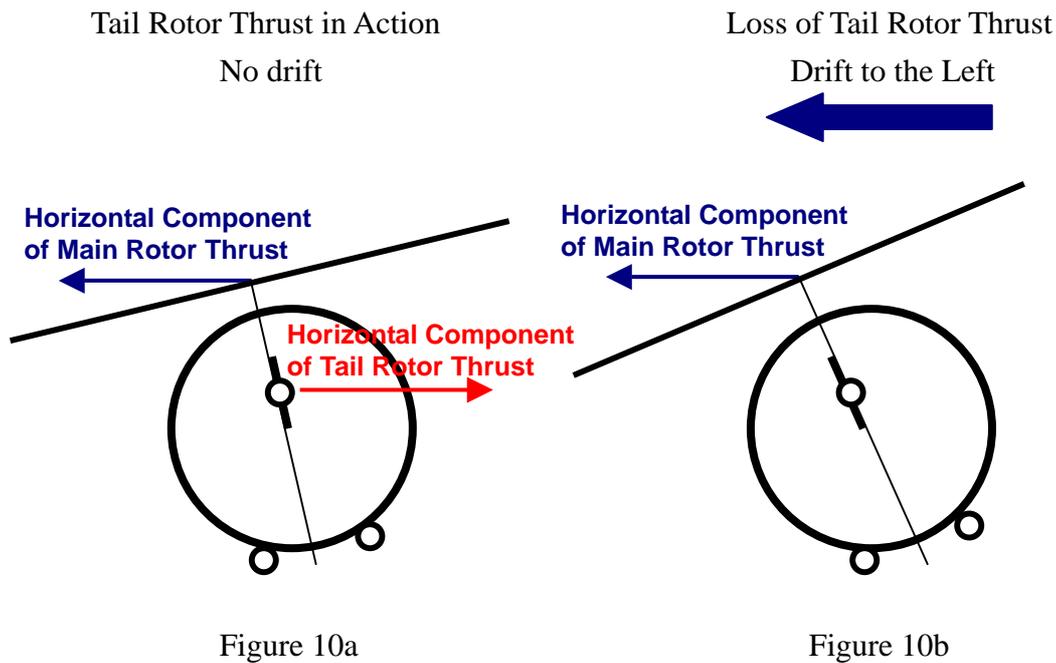
Figure 10 Left Drift of the Helicopter due to Loss of Tail Rotor Thrust
(Viewed from the rear of the helicopter)

Judging from the toppling of the helicopter wreckage on its left side and the damage to the left skid, it was believed that whilst the helicopter was yawing to the right, it had also been drifting to the left at the impact. Aerodynamically, the horizontal component of the main rotor thrust would compensate the horizontal component of tail rotor thrust to prevent the helicopter from drifting as shown in Figure 10a. The helicopter would therefore hover with left skid low. However, if there was a loss of tail rotor thrust, the helicopter would drift to the left after it had executed the first 180° turn to the right in the yawing plane, due to the horizontal component of the main rotor thrust as shown in Figure 10b. From the left drifting of the helicopter, it could be substantiated that the helicopter had experienced a loss of tail rotor thrust during the accident.
