**AIRCRAFT ACCIDENT REPORT 1/2005**

**ACCIDENT INVESTIGATION DIVISION**

**Civil Aviation Department  
Hong Kong**

**Report on the accident to  
Airbus A330-342 B-HYA  
Within the Manila Flight Information Region  
on 18 July 2003**

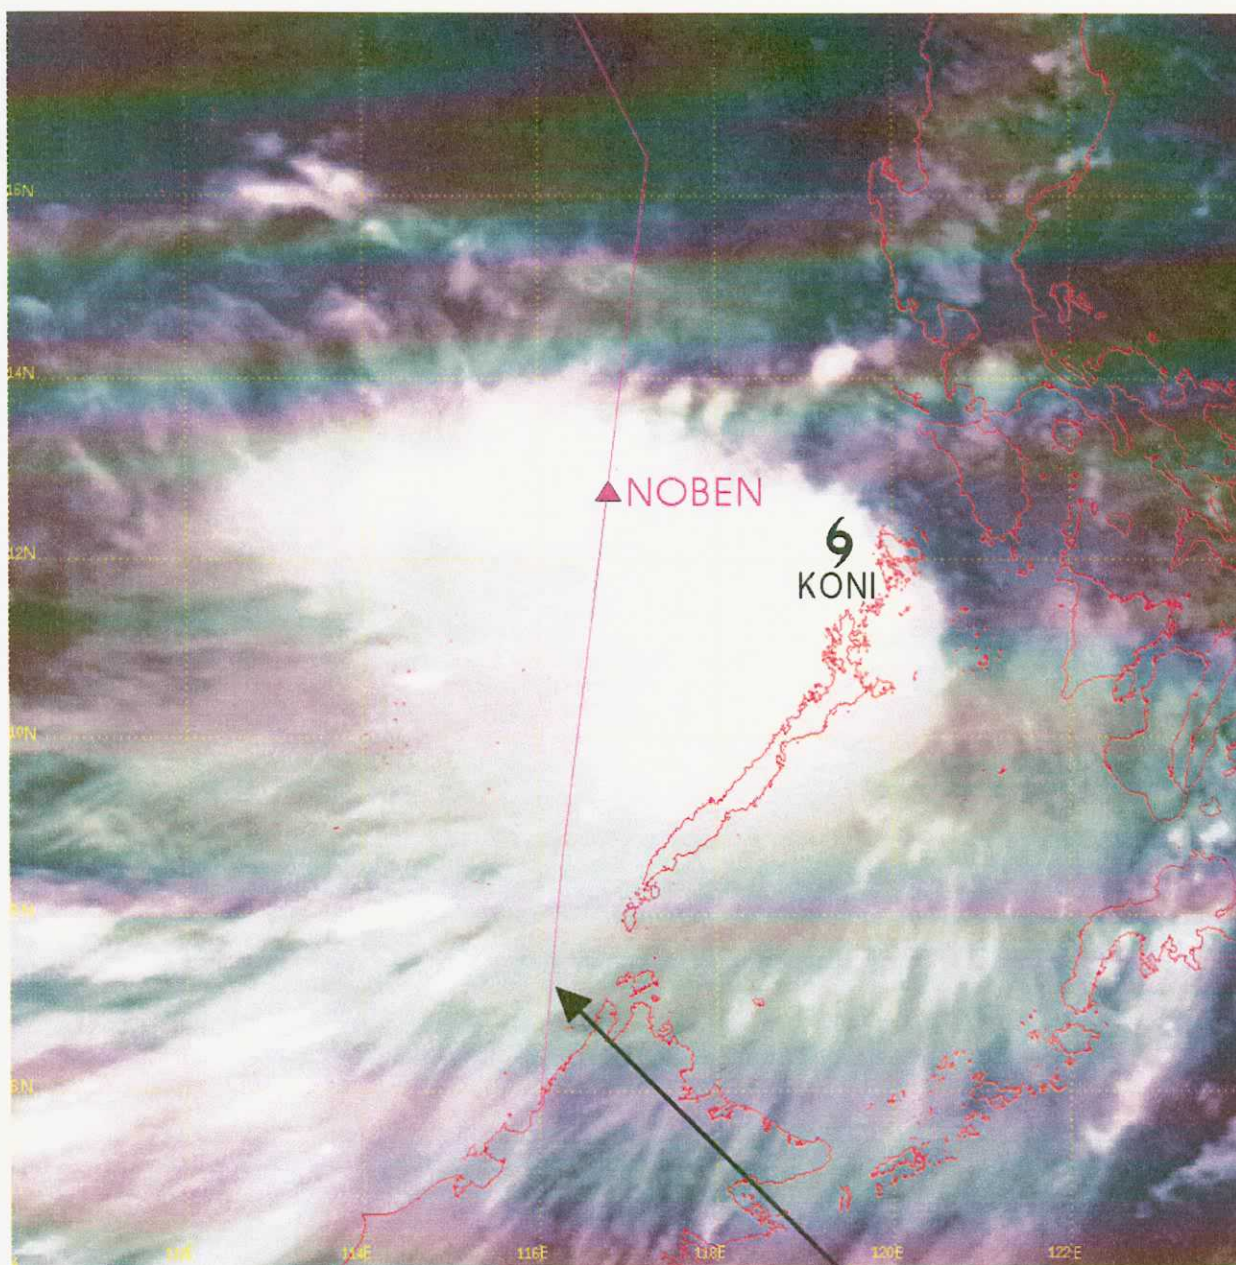
## GOES-9 INFRA-RED SATELLITE PICTURE

0525 UTC 18 July 2003

Flight Plan Track of HDA060

The satellite imagery was captured with GOES-9 operated by the joint effort of Japan Meteorological Agency (JMA) and United States National Oceanic and Atmospheric Administration National Environmental Satellite Data and Information Service (US NOAA NEDIS). Position of “KONI” is a post-analysis position for 0600 UTC 18 July 2003.
