AIRCRAFT ACCIDENT REPORT 1/2014

**Report on the accident to Aerospatiale SA 315B LAMA
Registration B-HJV operated by Heliservices (Hong Kong) Limited
on the hillside of Kau Lung Hang Lo Wai, Fanling, Hong Kong
on 3 January 2011**

**Hong Kong
January 2014**

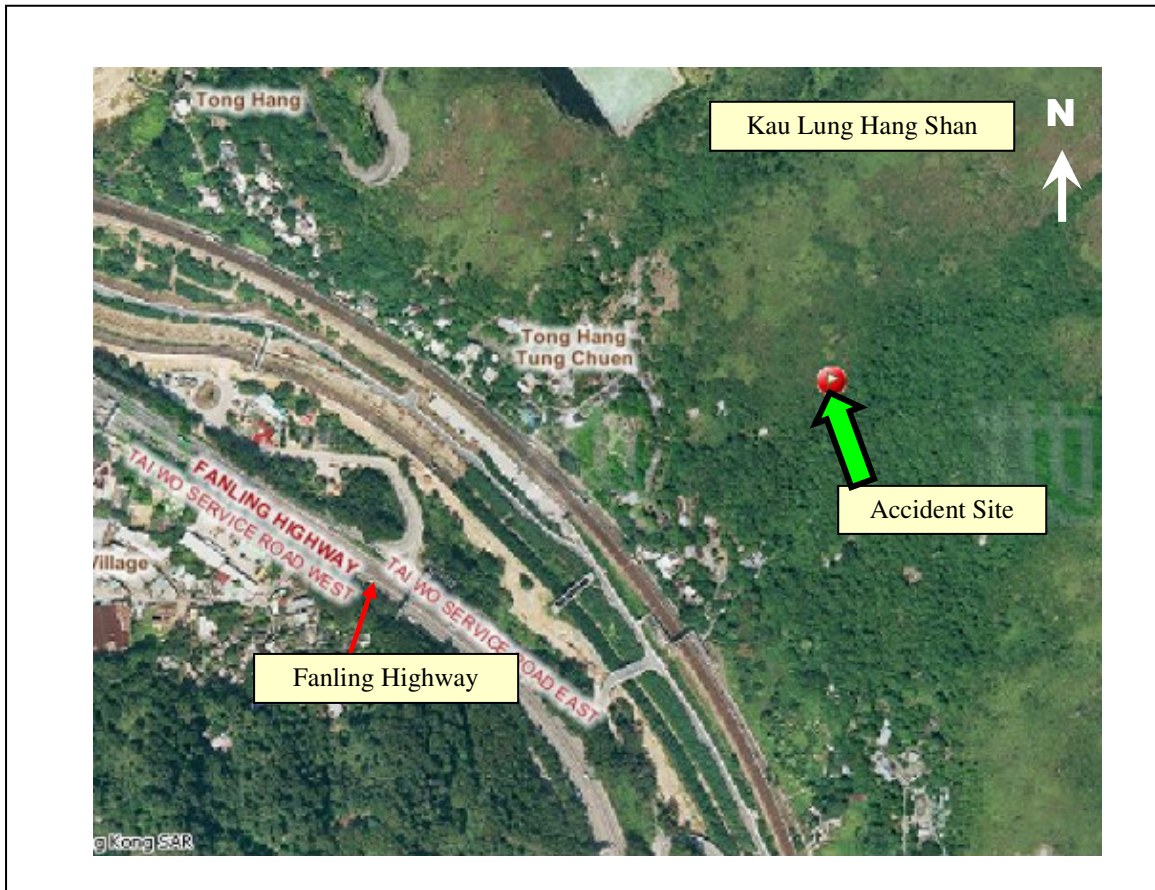
- 1.1.6 In Zone 3, the drop-off site was selected by the Gearwin ground workers on the morning of 3 January 2011. It was located on a steep slope, downhill from Pole 9 of the FNL-TKR No. 1 Circuit (See Photos 1 and 2). It was a clearing of approximately 6 by 8 metres in dimension, surrounded by tall trees and vegetation.

Photo 1 : An aerial view of the location of the accident site

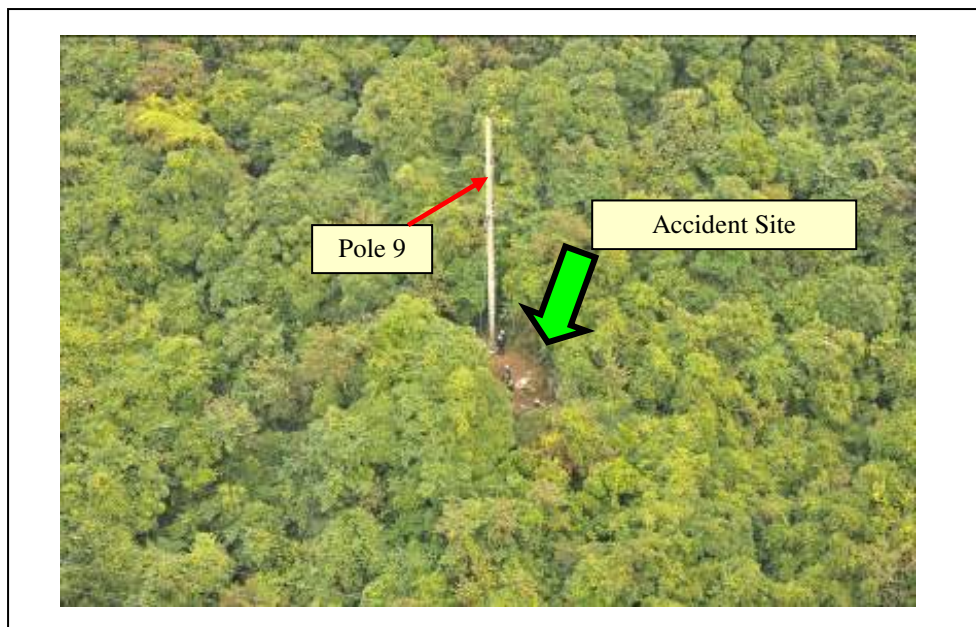
Photo 2 : A closer aerial view of the accident site
(Note : Photo 2 was taken 2 days after the accident when some tree(s) surrounding the accident site had been cut back.)

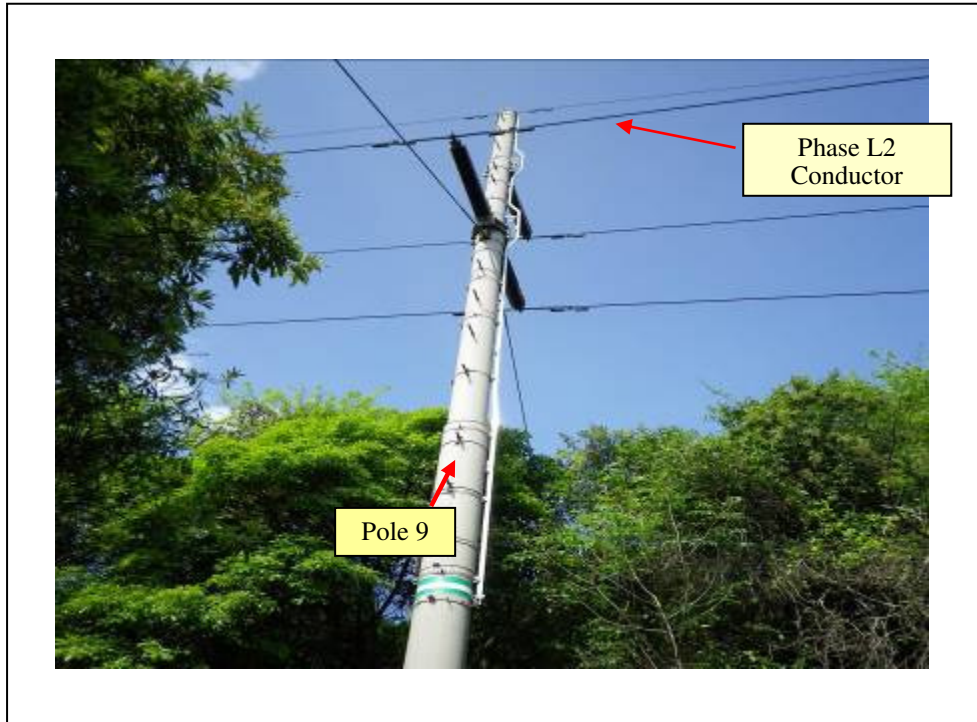
- 1.1.8 The accident site was inaccessible by road vehicles.
- 1.1.9 At Pole 9, there were three live overhead lines located on the two sides of the line pole, namely Phase L1, Phase L2 and Phase L3. Phase L2 was located at the side on which the underslung operation was conducted. The load drop-off point was at a horizontal distance of approximately 3.9 metres downhill from Phase L2 (See Photos 3 and 4).

Photo 3 : Pole 9 of the FNL-TKR No. 1 Circuit

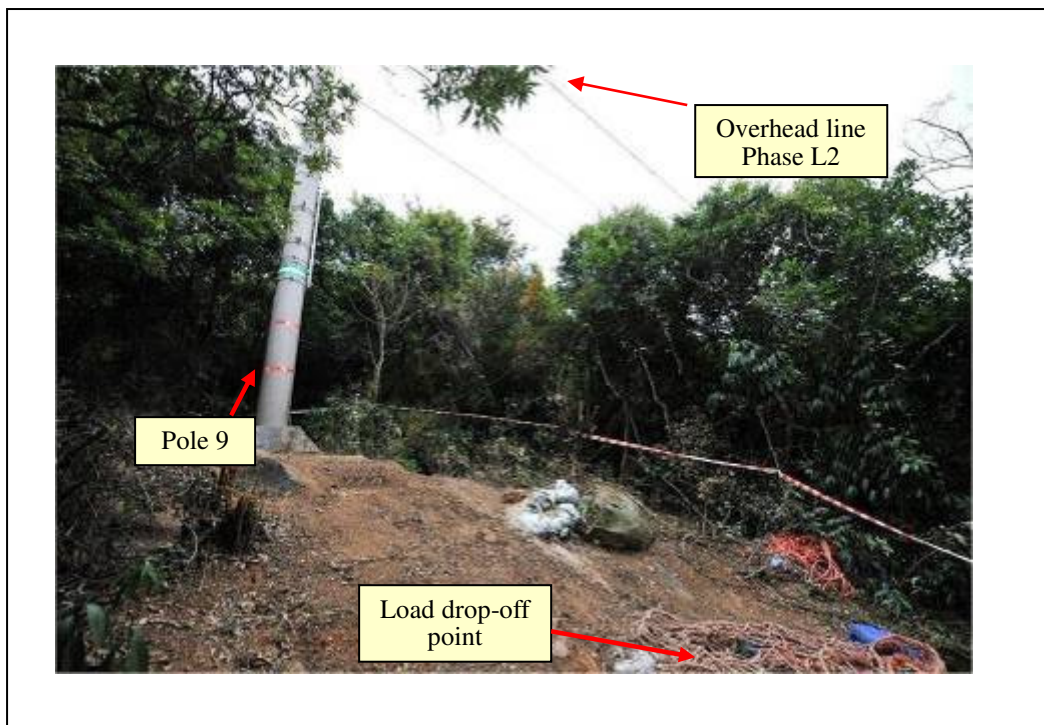
Photo 4 : The relative location of Pole 9 and the accident site

- 2.1.1.4 As he approached west of the site, he came to a hover and visually located the drop-off point which was situated on the downhill side of Pole 9, at the bottom end of the site (see Photo 4). From there, he noticed that the drop-off site was not *really big* and that it was a clearing surrounded by vegetation. He also noticed that there was a Stay Wire on one side and three ground workers present at the site. As revealed from other evidence collected by the investigation team that there were a total of four workers at the site at the time, one worker was not sighted by the Pilot.

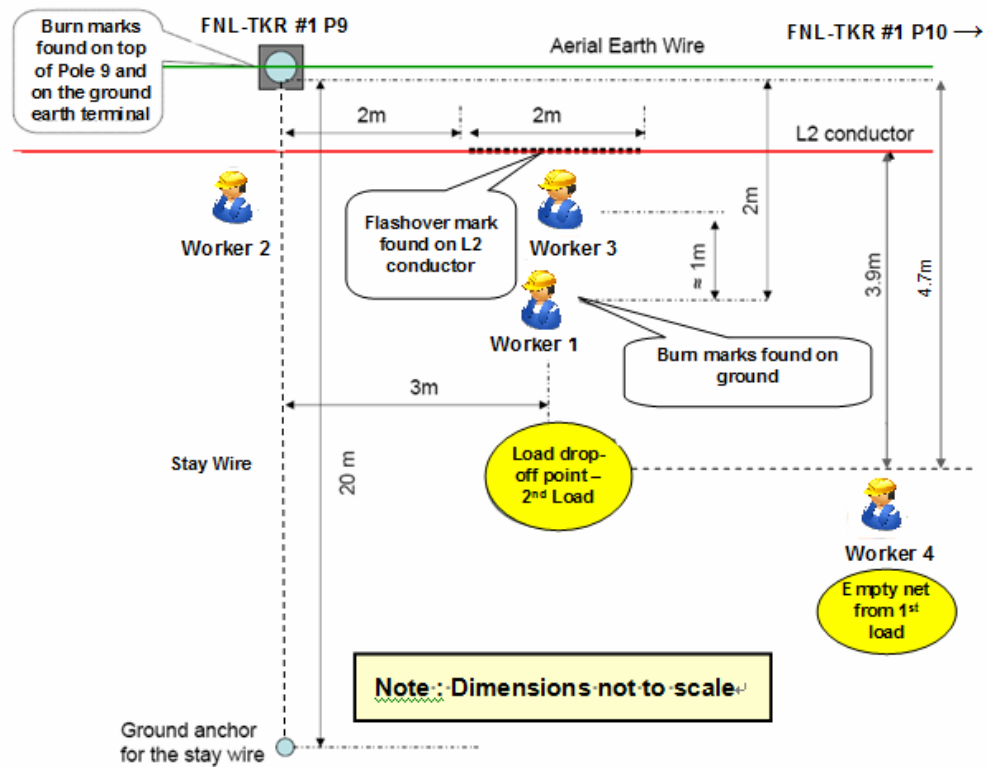
Worker 1	Worker 1 was standing about 1 to 2 metres uphill of the load drop-off point, responsible for giving hand signals to the Pilot. He attended Heliservices ground safety training in August 2010. He suffered serious burn injuries as a result of the accident.
Worker 2	Worker 2 was standing underneath the Stay Wire at the site boundary, some distance away from the load drop-off point. He was responsible for holding up a coloured board, to indicate the exact location of the drop-off site to the Pilot. He attended Heliservices ground safety training in August 2010. According to Worker 2's description, he had turned around to put away the coloured board when the accident took place. He therefore did not witness the accident. He did not suffer any injury from the accident.
Worker 3	Worker 3 was standing about 1 metre uphill of Worker 1. He was responsible for assisting in relocating the load contents after the load was delivered. He suffered minor injuries as a result of the accident.

1.5.4.2 A diagram depicting the relative positions of the workers at the time of accident is given at Figure 3.

Figure 3 : Schematic diagram showing the relative positions of the workers at the site at the time of the accident

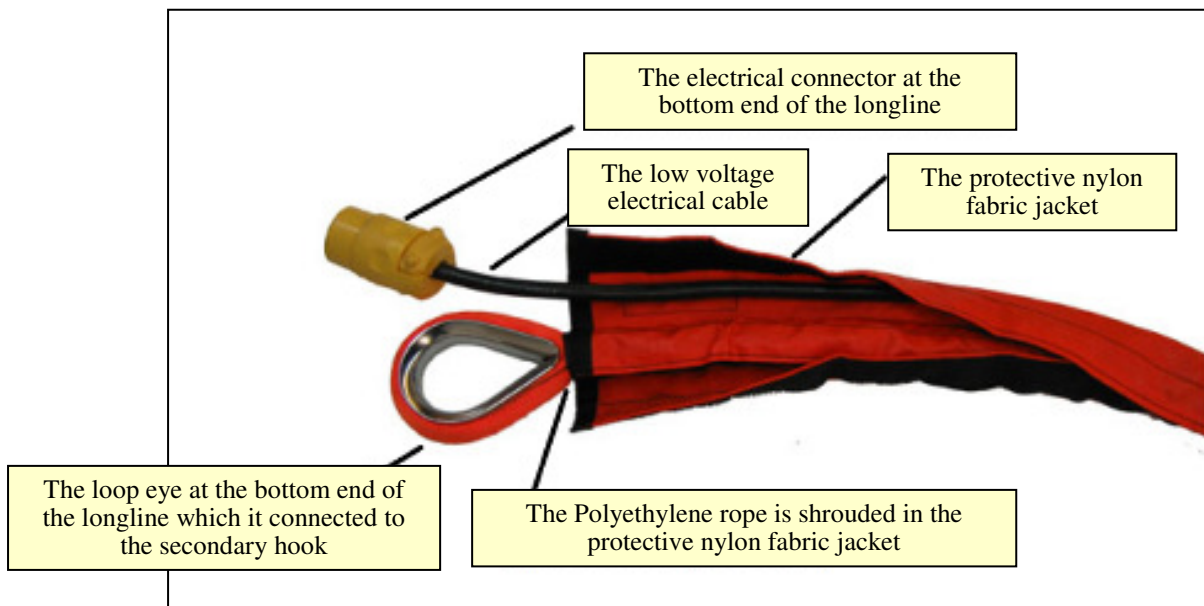
1.6.4.2.1 For the subject underslung operation on 3 January 2011, the underslung assembly used on the helicopter was connected to the helicopter primary hook at its Sek Kong base before commencement of the underslung operation. It included a 30.5-metre (100-foot) longline and a remote-controlled hook (also called the “secondary hook”). The longline comprised a high modulus Polyethylene rope and a 300 Volt (V) low voltage electrical cable, shrouded in a protective nylon fabric jacket (See Photo 19). Fitted to the bottom end of the longline was the secondary hook. Loads could be unhooked manually from the secondary hook by the ground crew, or electrically released by the pilot through the activation of a push-button in the cockpit with the mission toggle switch armed.

Photo 19 : Basic structure of the longline

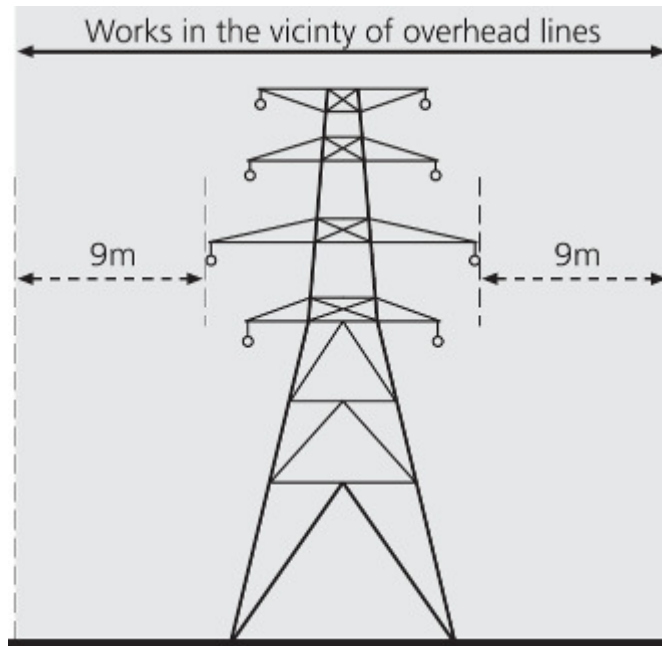
- 1.18.1.3 Upon review of the applicable COP, it is noted that “works in the vicinity of overhead lines” is defined as any works, except for blasting works, found

within a horizontal distance of 9 metres from the outermost conductor of an overhead line (see Figure 4).

Figure 4 : Works in the vicinity of overhead lines (except blasting works) – extracted from the Code of Practice on Working near Electricity Supply Lines (2005 Edition)

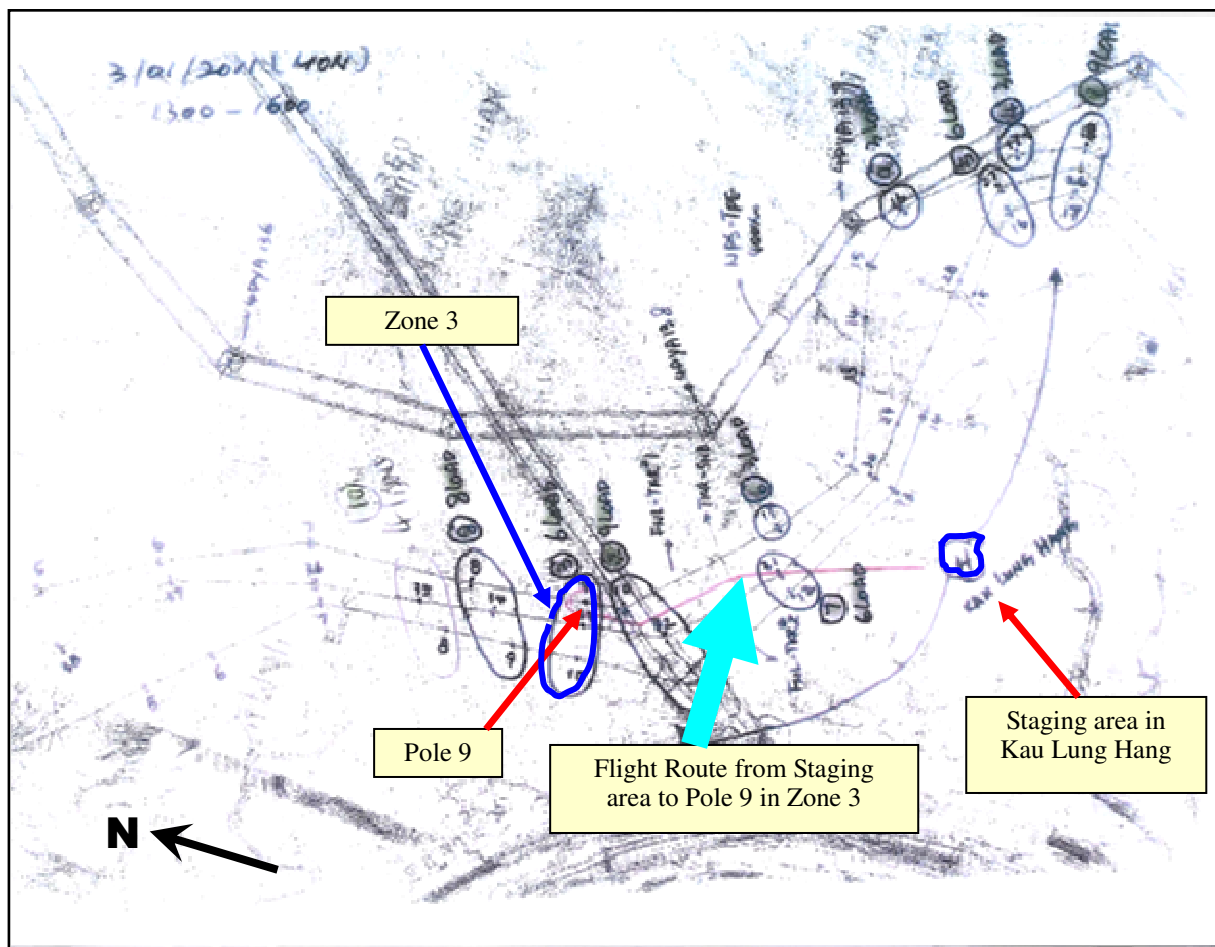
2.1.1.2 According to the Pilot, he took a north-westerly to northerly path from the staging area and flew towards Zone 3. He positioned the helicopter in between two sets of overhead lines and then tracked along this path to the drop-off site (See Figure 5).

Figure 5 : The Flight Route taken by the Pilot from the Staging Area to the Accident Site (Sketch of the flight route provided by the Pilot)

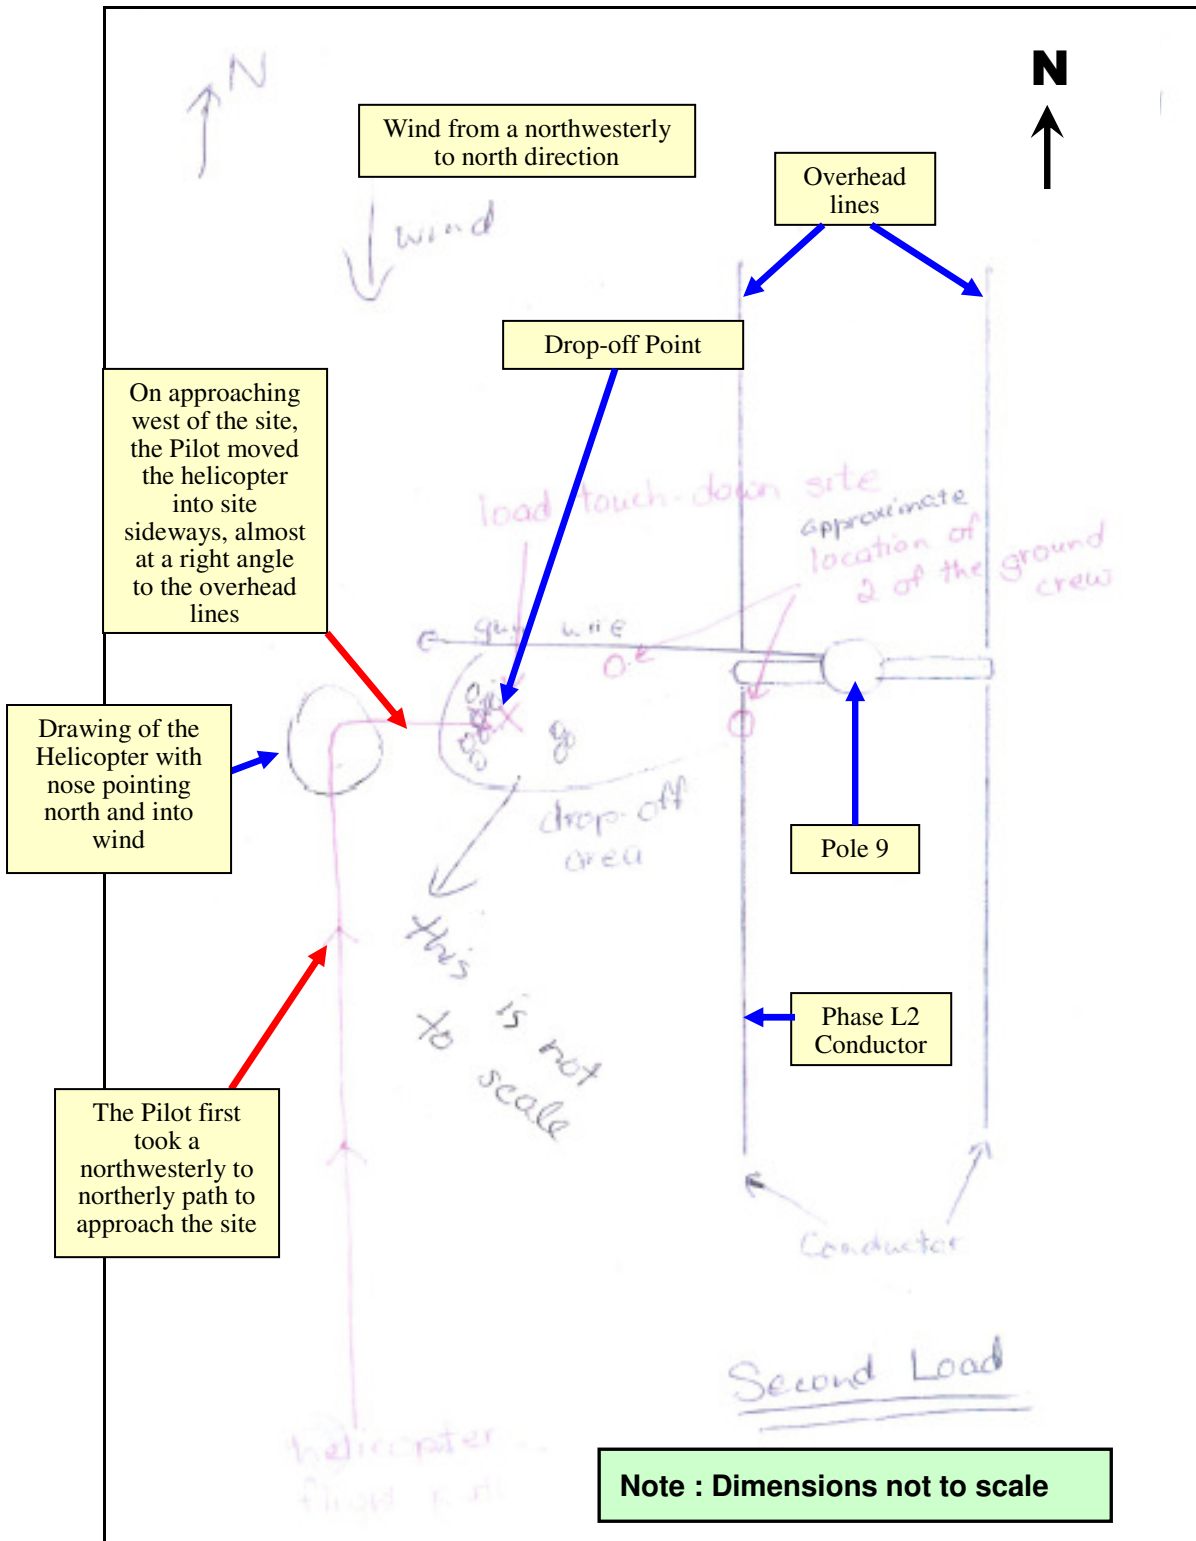
- 2.1.1.5 After the assessment, the Pilot slowly manoeuvred the helicopter towards the site. He set the helicopter up by turning the nose a little to the right to keep the line pole and overhead lines in sight. He flew the helicopter in sideways, almost at a right angle to the overhead lines, with the helicopter

nose pointing north and into wind. Figure 6 is a sketch of the approach path provided by the Pilot after the accident.

Figure 6 : The Pilot's Approach Path (Sketch provided by the Pilot)

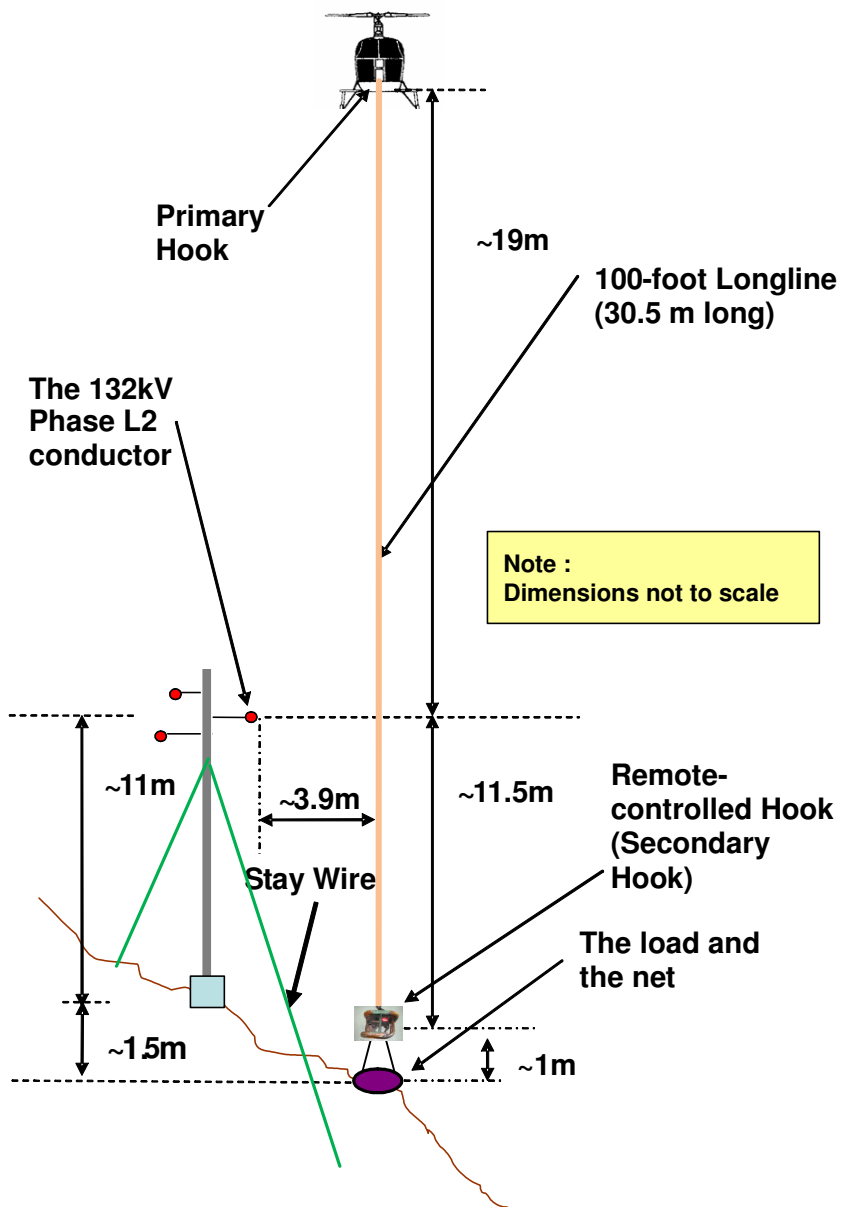
- 2.1.1.7 From the site measurements and the descriptions above, the investigation team analysed that if during the unloading process, the helicopter had stayed vertically above the drop-off point with the longline hanging vertically from the helicopter, it would be at a level of approximately 19 metres above the overhead lines with the longline at a horizontal distance of around 3.9 metres from the Phase L2 conductor. Figure 7 provides a sketch of the side view of the operation with approximate dimensions.

Figure 7 : A sketch of the side view of the planned unloading operation at Zone 3 with approximate dimensions

2.2.2 The analysis in Paragraph 2.1.1.7 further shows that if the helicopter had stayed vertically above the drop-off point with the longline hanging vertically straight down from the helicopter, the longline would have been at a horizontal distance of about 3.9 metres from the Phase L2 conductor (see Figure 7) and the accident and flashover would not have occurred.

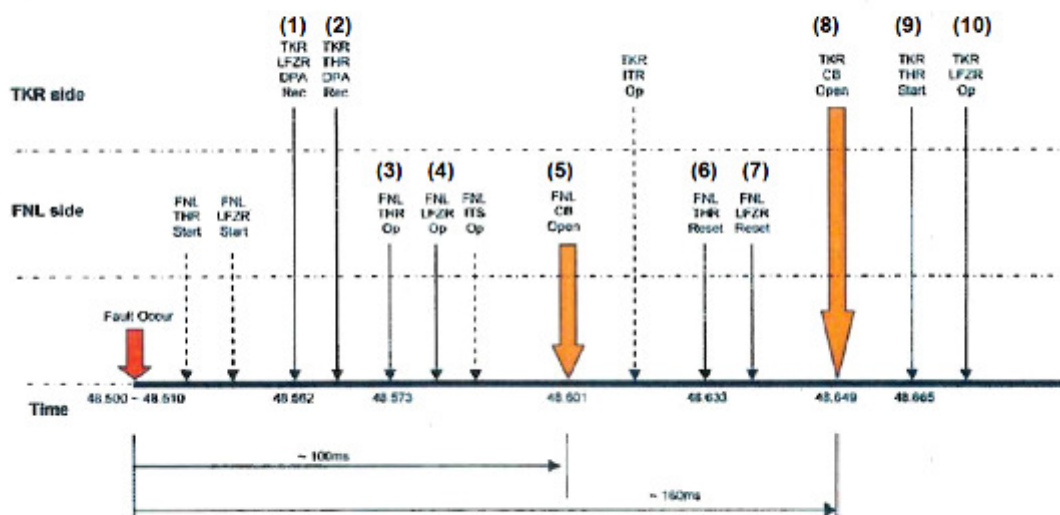
Fault Chart as recorded in the TKR Sub-station

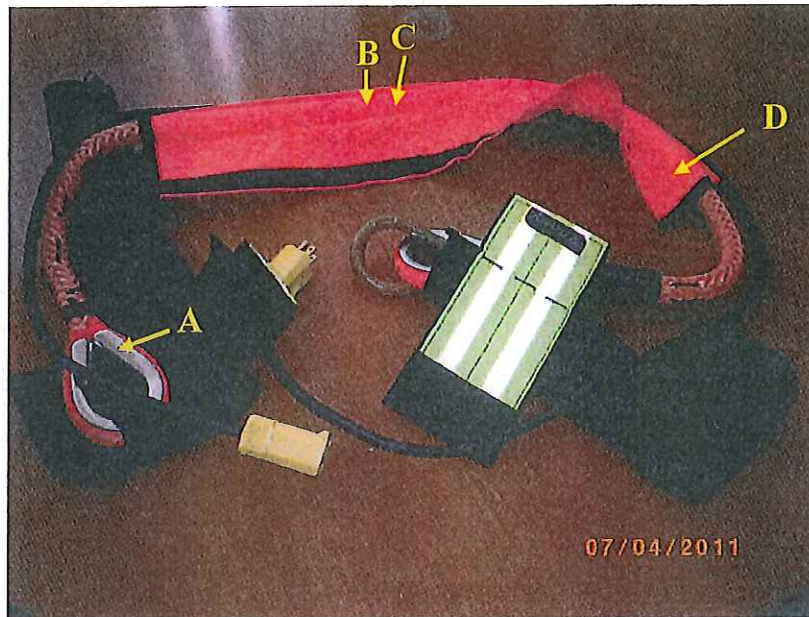
To verify whether the polyethylene Longline would fail in the inadvertent event of it getting very close into the vicinity (i.e. with a distance much shorter than 0.2 m or even in the order of mm) of live conductors, the following test was carried out:

Fig. F2 The Longline being assessed

- The low voltage electric cable was moved away from the main body of the Longline.
- Tin foils were wrapped on location B with the separation between locations A and B being 0.5 m and A was connected to the low voltage side of the high voltage source.
- The voltage was increased between A and B slowly in steps of around 10 kV until breakdown occurred.
