AIRCRAFT ACCIDENT REPORT 1/2013

**Report on the accident to Eurocopter AS332 L2 Super Puma
Registration B-HRN operated
by the Government Flying Service of Hong Kong
at Shing Mun Reservoir on 27 December 2010**

**Hong Kong
April 2013**

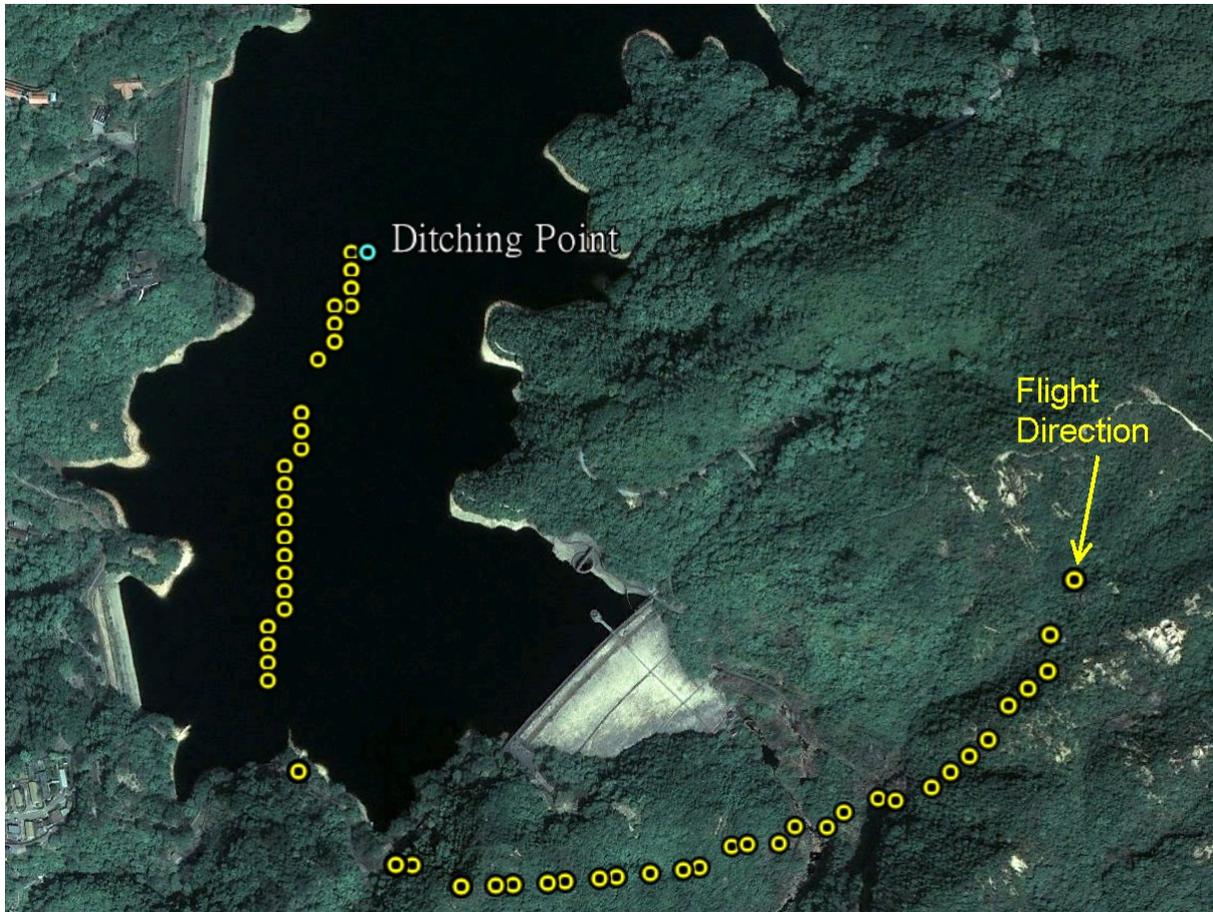
Figure 12 Aerial View of the Accident Site and the Helicopter Route

On the other hand, the flight data recorder (FDR) showed that the helicopter was in a downwind approach to the southern part of the reservoir to pick up water. It could be concluded here that the helicopter, when picking up water, was in a light downwind position, and when in the transition to forward flight, when it passed the western dam wall, at the demarcation line, the helicopter would be in an into wind condition.

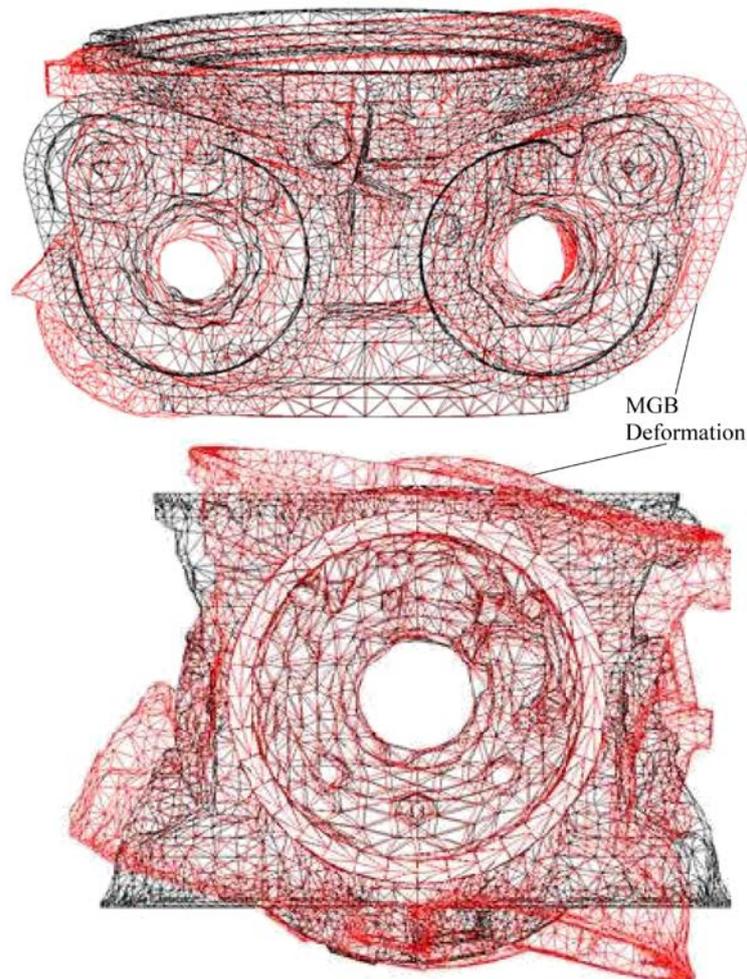
Figure 21 MGB Casing Deformation under Flight Loads (Distortion X 200)

Through computational analysis and also Eurocopter's experience on the MGB characteristics, it can be known that the main gearbox casings are subject to deformation under normal loads, such as carrying external underslung loads. Although both the left and the right freewheel units transmit the same level of power, the level of deformation is significantly higher in the area of the right freewheel unit. The black lines in the following figure show an undistorted MGB casing, while the red lines show the deformation of the casing under load.

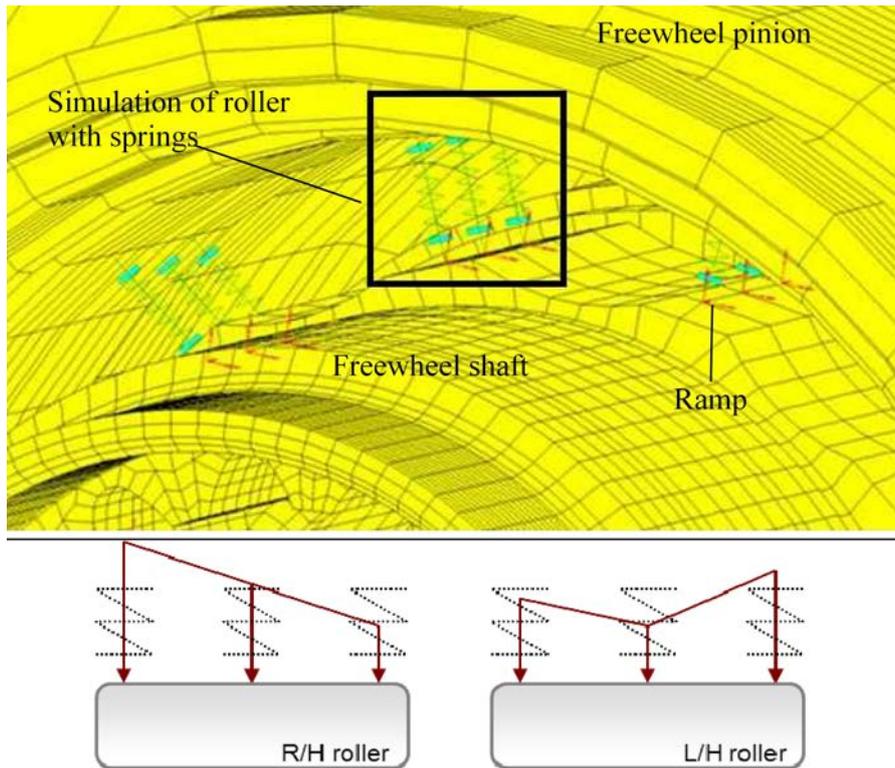
The results of the finite element analysis confirmed that freewheel rollers sustain heterogeneous loads, and the distribution of the loads was different between the left and the right freewheel rollers. In addition, the results indicated that the greater the flight loads due to the flight spectrum and hence the MGB casing deformation, the greater the misalignment between the rollers and the ramps. This explained why most of the wear patterns were not parallel on the ramps.

Vertical arrows indicate the load distribution on the rollers.

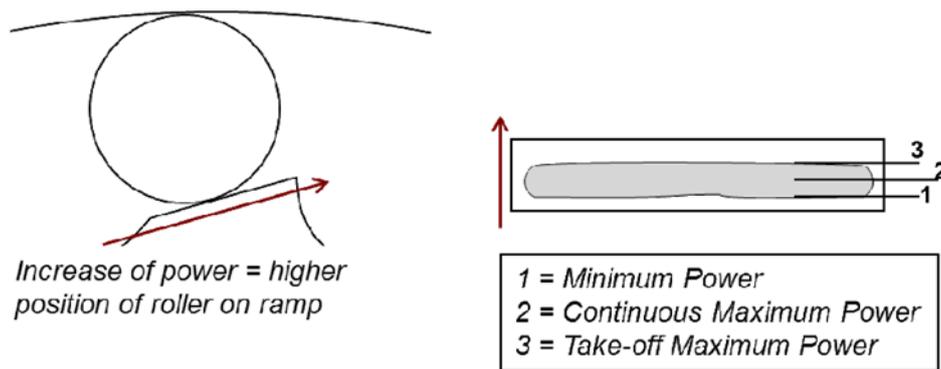
Figure 23 Roller Positions on Ramp Corresponding to Levels of Power

The position of a roller riding on a ramp depends on the level of power transmitted through the freewheel unit. The higher the power, the higher the position of a roller on a ramp. It should be noted that when the helicopter is used for operations involving frequent torque variation, such as carrying water bucket for firefighting in the accident flight, there were significant roller movement on the ramp surfaces. The figure below shows a typical wear mark and its areas corresponding to the levels of power.

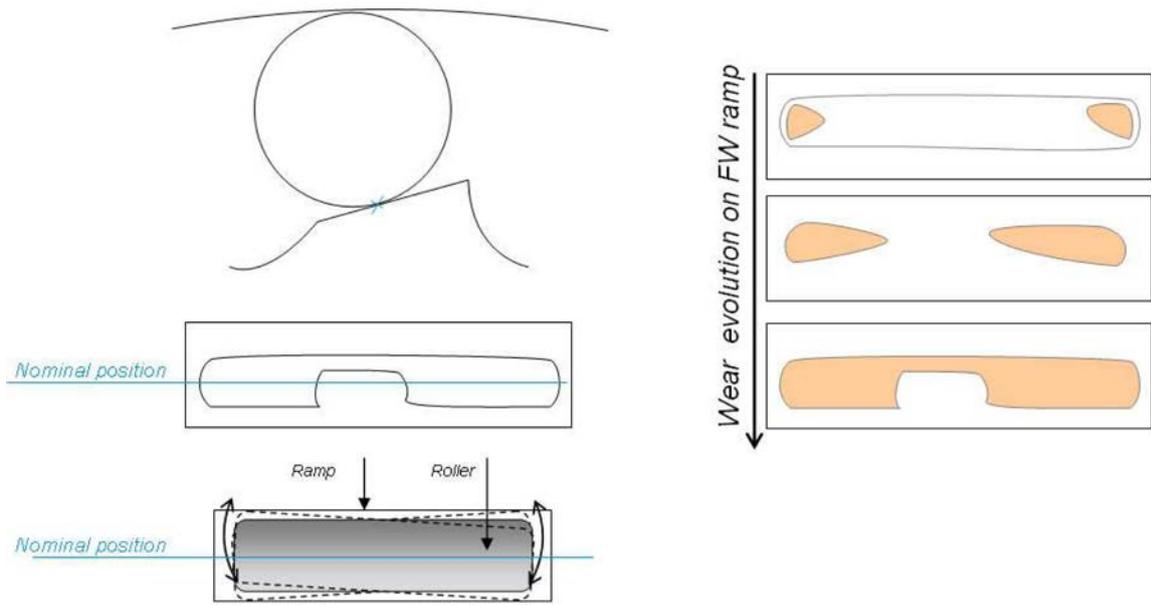
Figure 24 Micro-displacement of Ramp Rollers and Evolution of Wear

Figure 24 shows a schematic of micro-displacement of ramp rollers and the evolution of ramp wear. The roller misalignment and the heterogeneous loads on the rollers are the results of deformation of MGB casing under flight loads, and the rollers would have micro-displacement on the ramps during the flight operations. It has been mentioned earlier that the level of ramp wear depends on the number of flight hours and the flight spectrum (flight loads and torque variation cycles). Therefore, it can be understood that when the helicopter was used for firefighting operations and there were repeated cyclical rubbing between the rollers and the ramp surfaces, the amount of wear with each ramp surface increased over a period of time and at a higher rate.

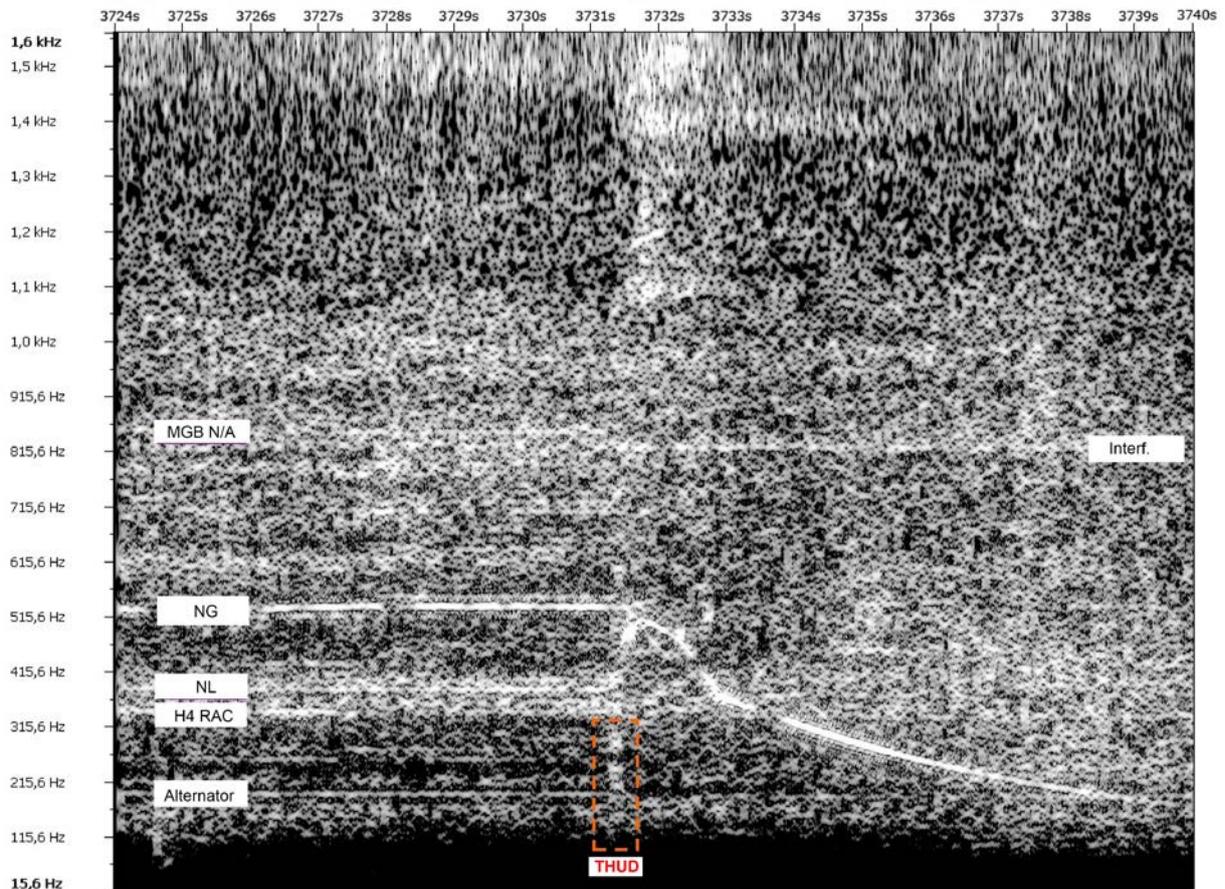
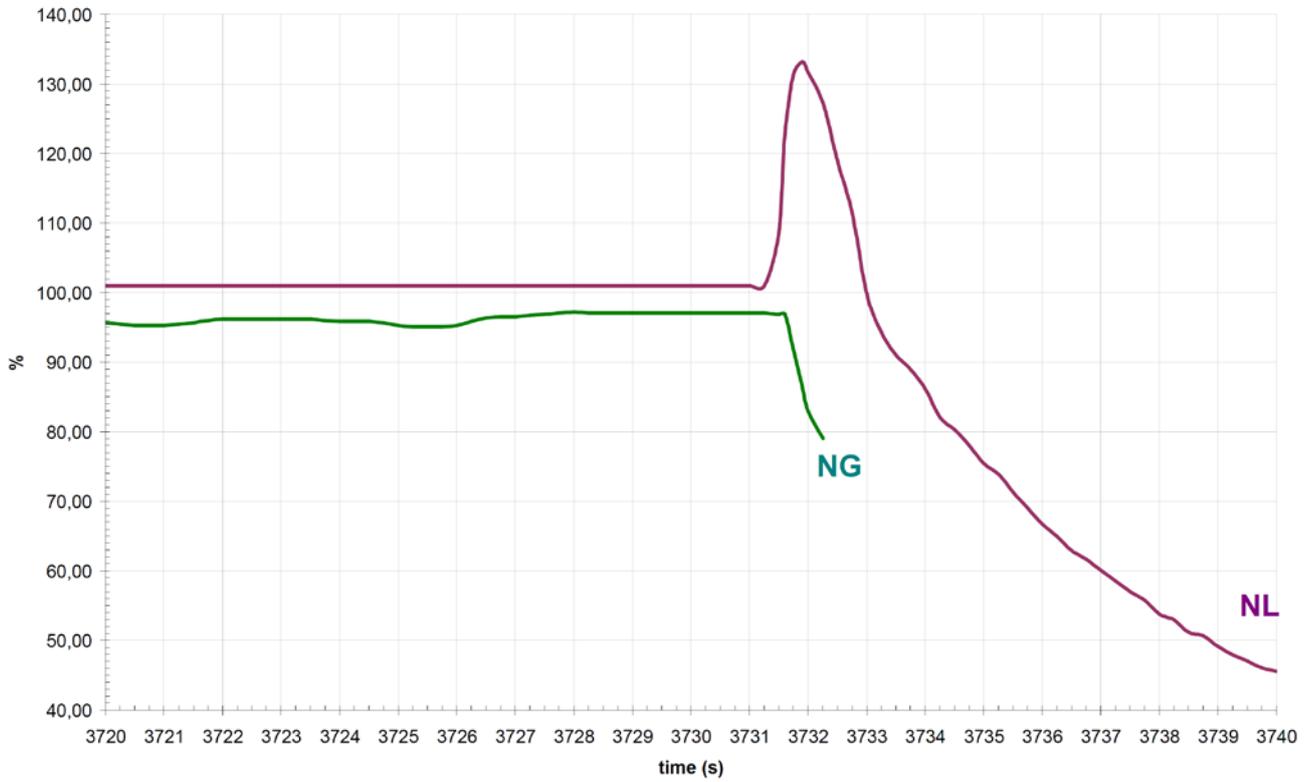
Spectral Analysis of Cockpit Area Microphone Recording

A thud is heard at time 3731.24 seconds (duration 160 to 200 milliseconds). It was followed by the increase in frequency of the NL (speed of the free turbine at the MGB entrance). At time 3731.6 seconds while the NL reached the value of 121%, the NG suddenly decreased as for an engine shutdown. The NL max value observed in the spectral analysis was 132% (see below).
