**SERIOUS INCIDENT REPORT 1/2011**

Report on the Serious Incident of an Attempted Take-off on Taxiway

Flight FIN070 Airbus A340-300 OH-LQD

at the Hong Kong International Airport

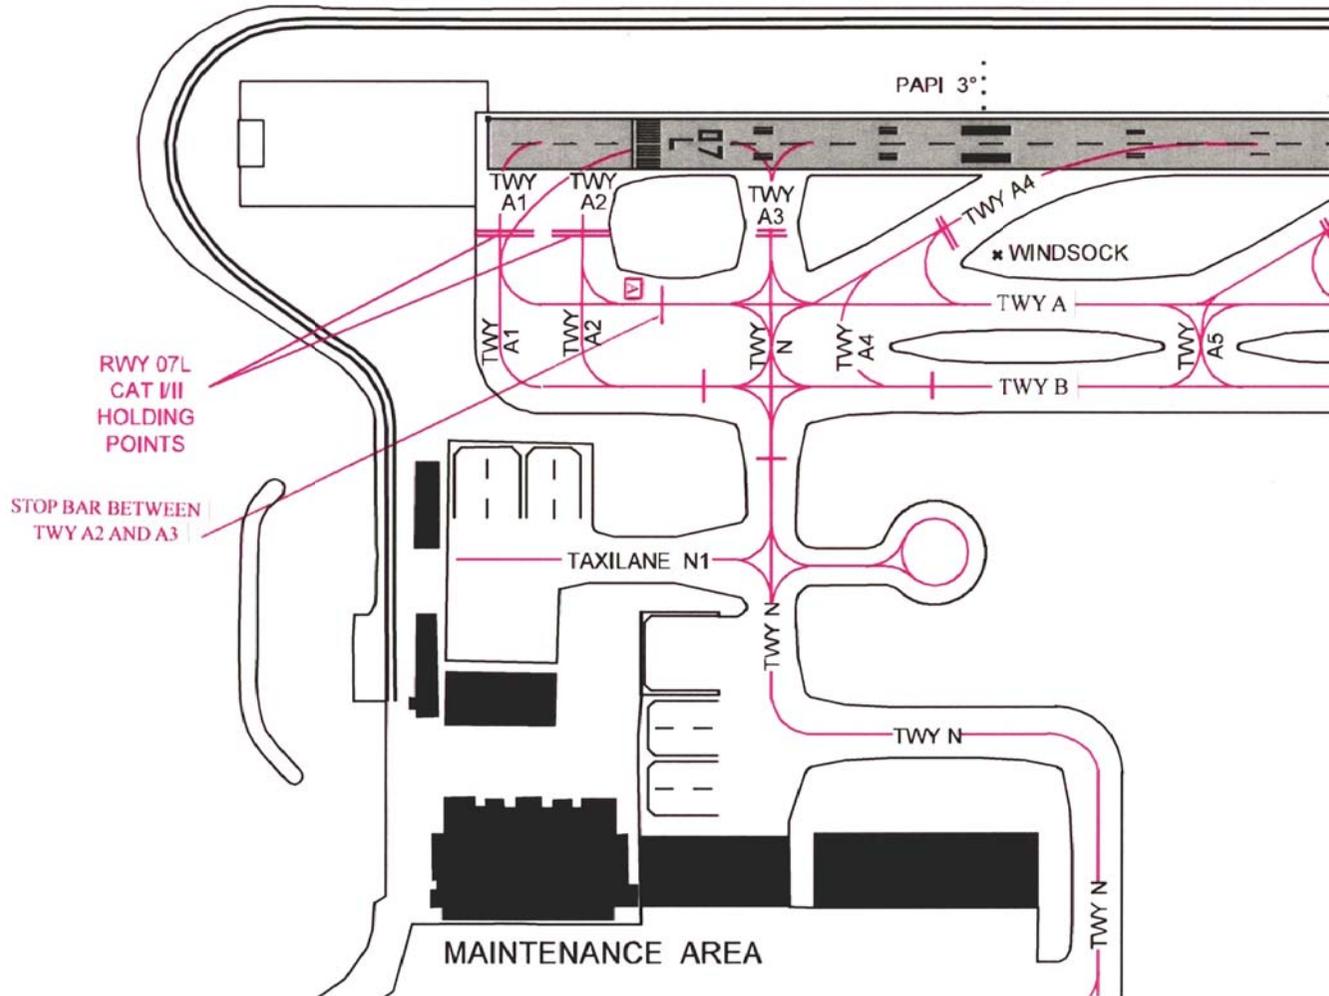
# Aerodrome Visual Marking in the Vicinity of TWY A1, TWY A2 and RWY 07L

- 3.1.9 The aerodrome surface marking, lighting, signage and visual aids were in compliance with the Standards and Recommended Practices as per Annex 14 to the Convention on International Civil Aviation and did not contribute to the incident.

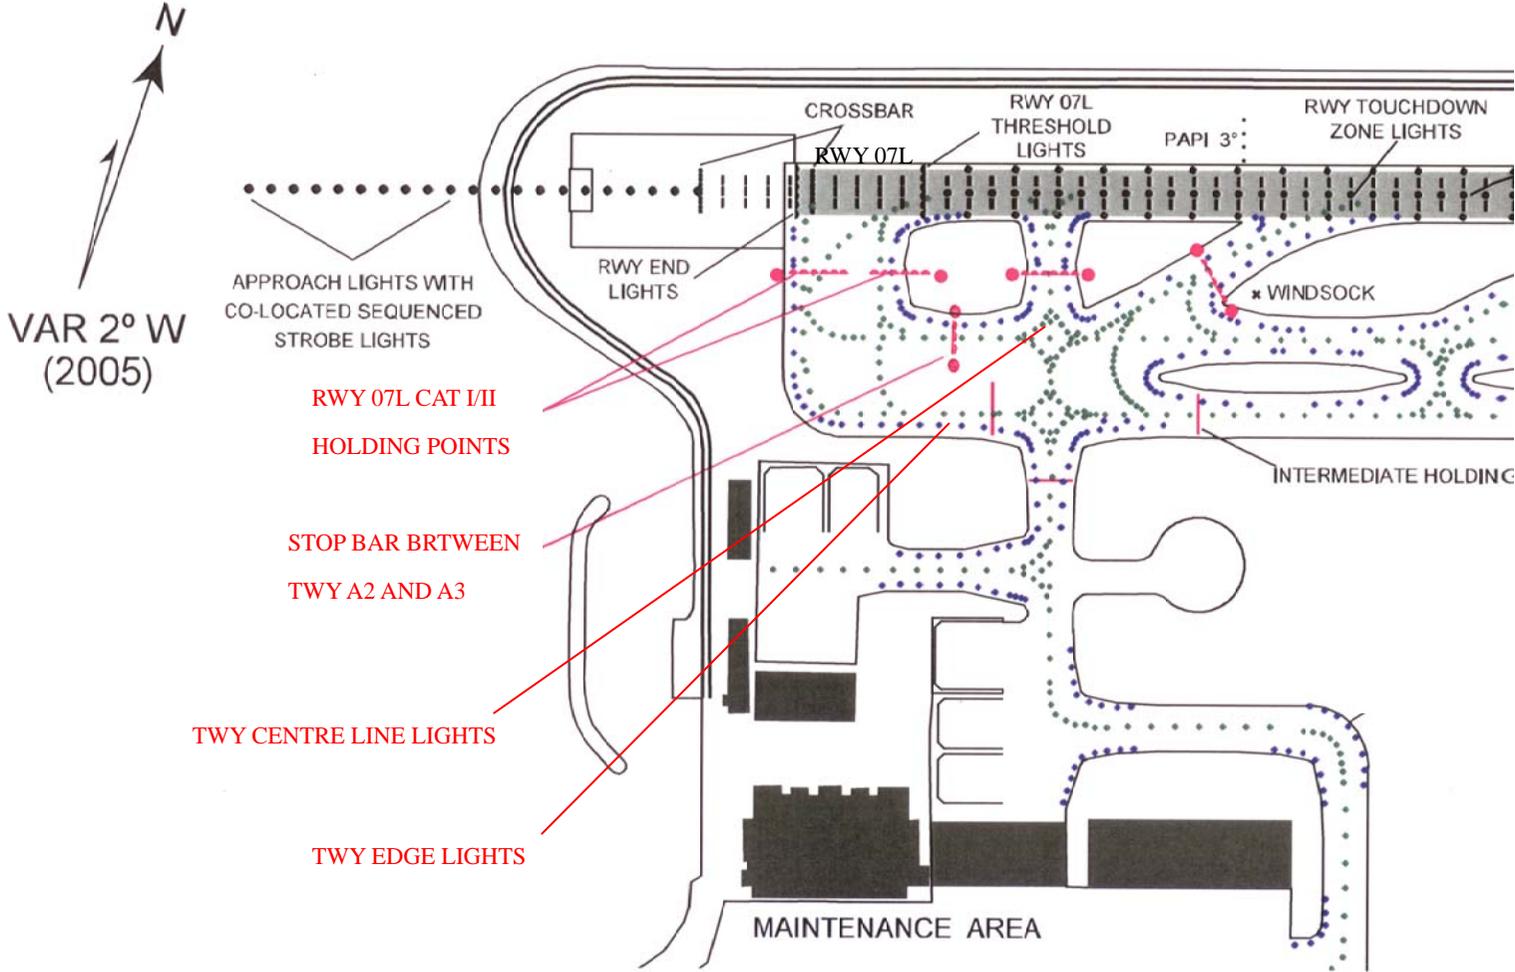
# Aerodrome Lighting in the Vicinity of TWY A1, TWYA2 and RWY 07L

- 3.1.21 Upon entering TWY A, the flight crew failed to be alerted by a number of visual cues, including a line of green taxiway centre line lights, blue edge lights and red stop bar lights ahead that should have prompted them of their mistaken position.

- 3.1.25 Both the Captain and the First Officer noticed the red stop bar lights ahead on TWY A but, in the haste of a rolling take-off, having dismissed them as part of the lighting system leading to the displaced runway threshold, failed to stop the aircraft until instructed by ATC.
- 3.1.26 The attempted take-off on TWY A was promptly detected by the GMC with the help of the A-SMGCS. The AMC immediately instructed the pilot to abort the take-off.
- 3.1.27 The RTO was initiated at 72 knots and the highest speed attained was 75 knots. It took 14 seconds for the aircraft to stop after initiation of the RTO.
- 3.1.28 There was no damage to the aircraft. However, the abrupt braking action resulted in hot brakes requiring a period of cooling down before departing again.
