AIRCRAFT ACCIDENT REPORT 1/2015

**Report on the accident to Robinson R22 Beta II Helicopter
Registration B-HJN operated by the
Hong Kong Aviation Club Limited
at Shek Kong Airfield, Yuen Long
on 6 October 2013**

**Hong Kong
February 2015**

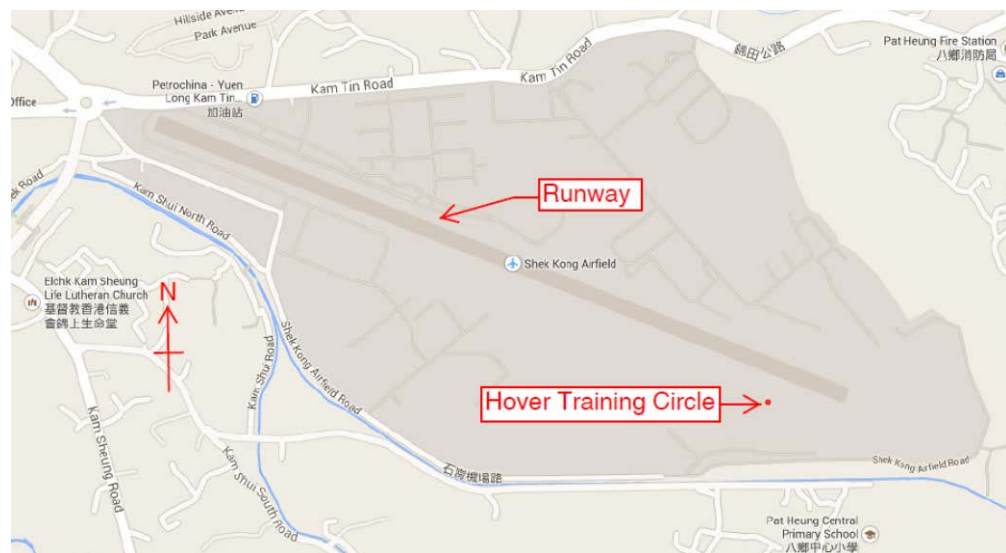
Figure 1 – The Hover Training Circle in Shek Kong Airfield

1.1.2 On that day, the Instructor was assigned with five training flights scheduled between 08:30 and 18:00. The accident happened on the fourth flight, which was a training flight on hover exercise. The hover exercise was conducted within SK, at the hover training circle located south of the runway. (See Figure 1)
