HONG KONG
INTERNATIONAL AIRPORT

WRECKAGE INFORMATION

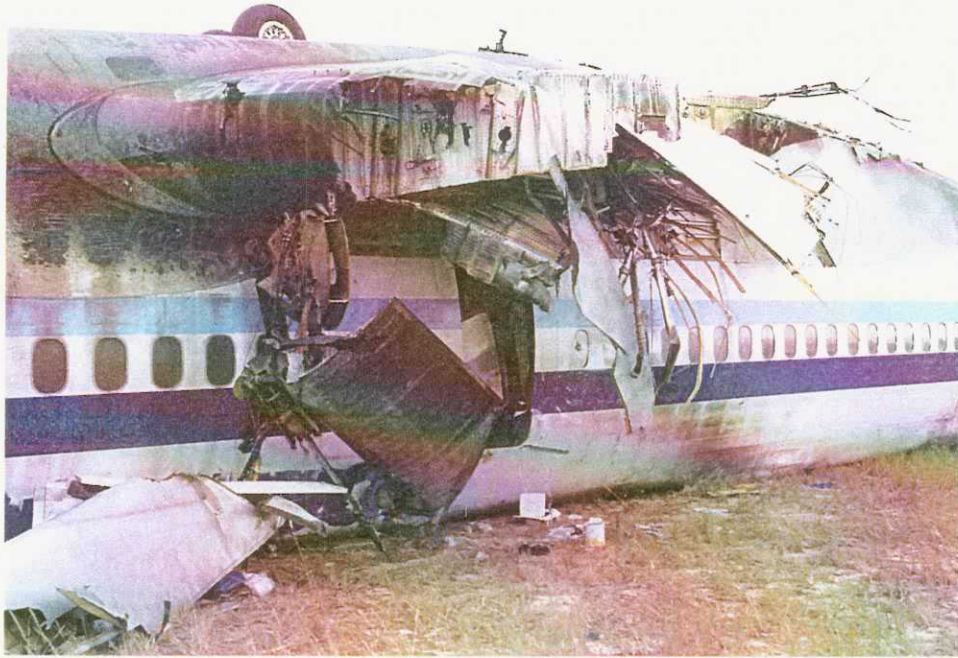
Right-hand Forward Fuselage (Figure 2)

The fuselage was found inverted at the main wreckage with severe impact damage and fire damage (Figure 1). The crown of the fuselage was crushed downward for the entire length (nose to tail). The pilot and co-pilot's windows were cracked and the side windows were pulled out and were lying outside the cockpit. There was no evidence of any bird strike or foreign object damage on the cockpit windows. The right side of the fuselage suffered slight impact damage just aft of the R1 entry door. The skin at this location was torn in the vertical direction (Figure 2).

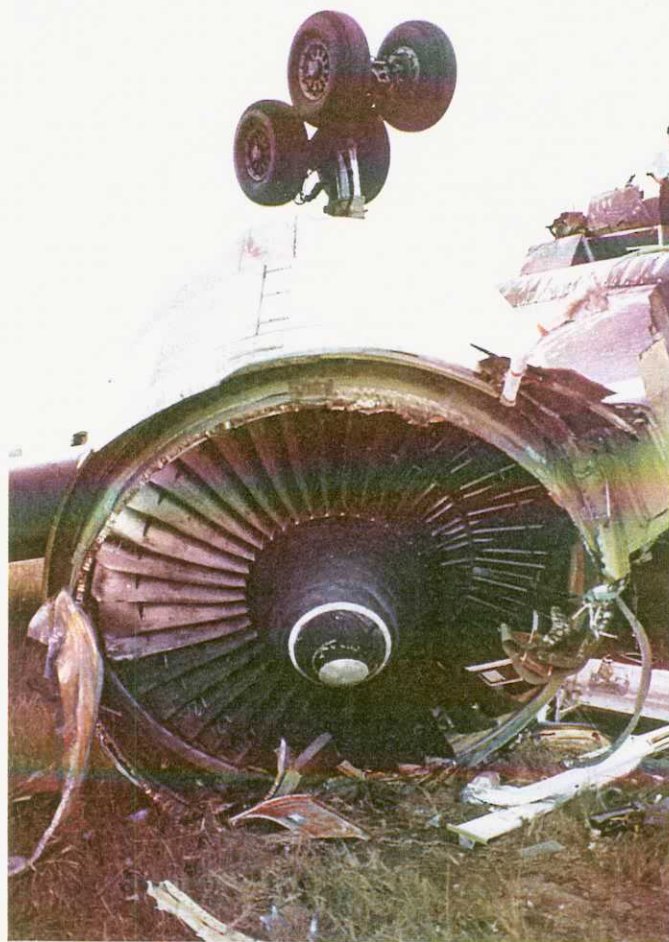
No.1 Engine (Figure 17)

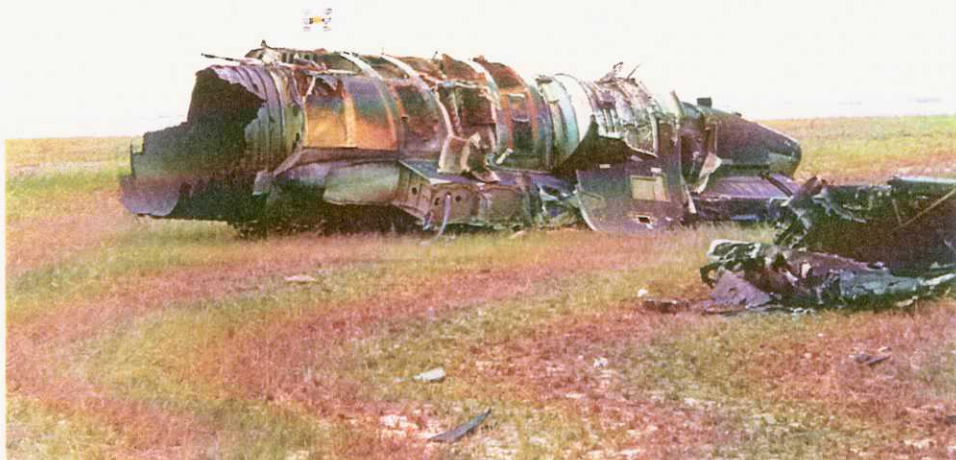
No.2 Engine (Figure 18)

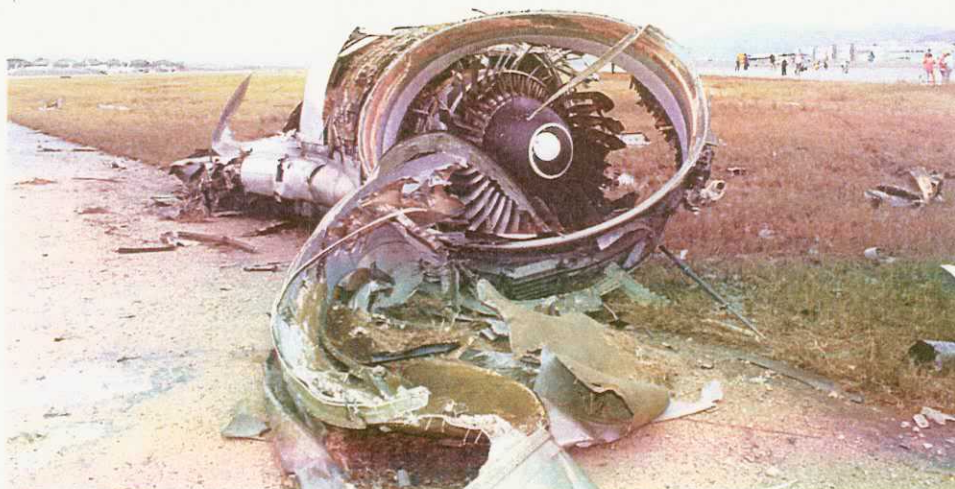
No.3 Engine (Figure 19)

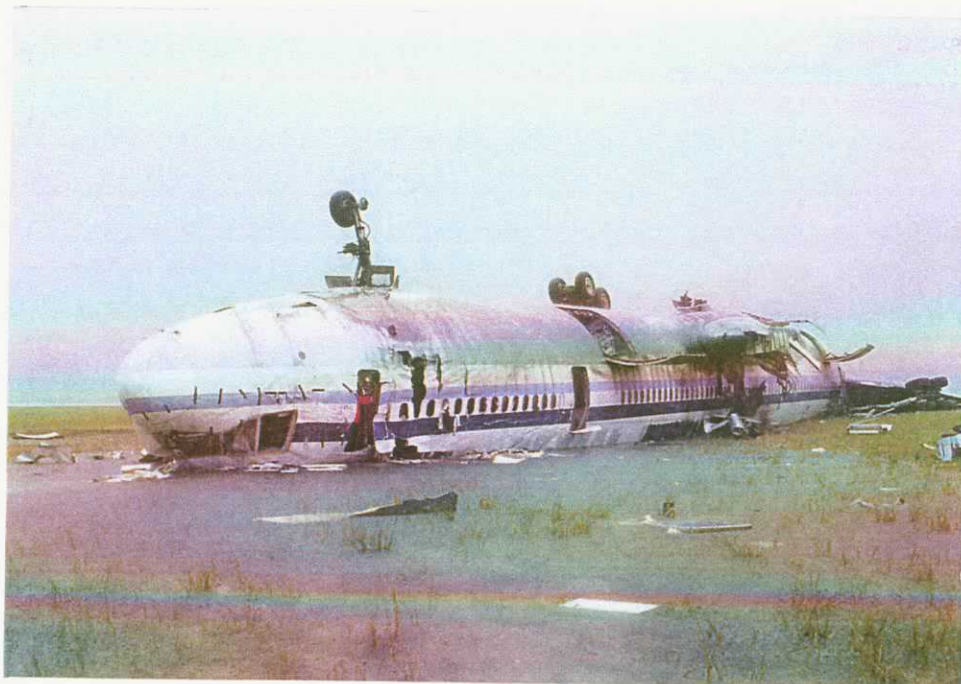
1. General view of main wreckage.

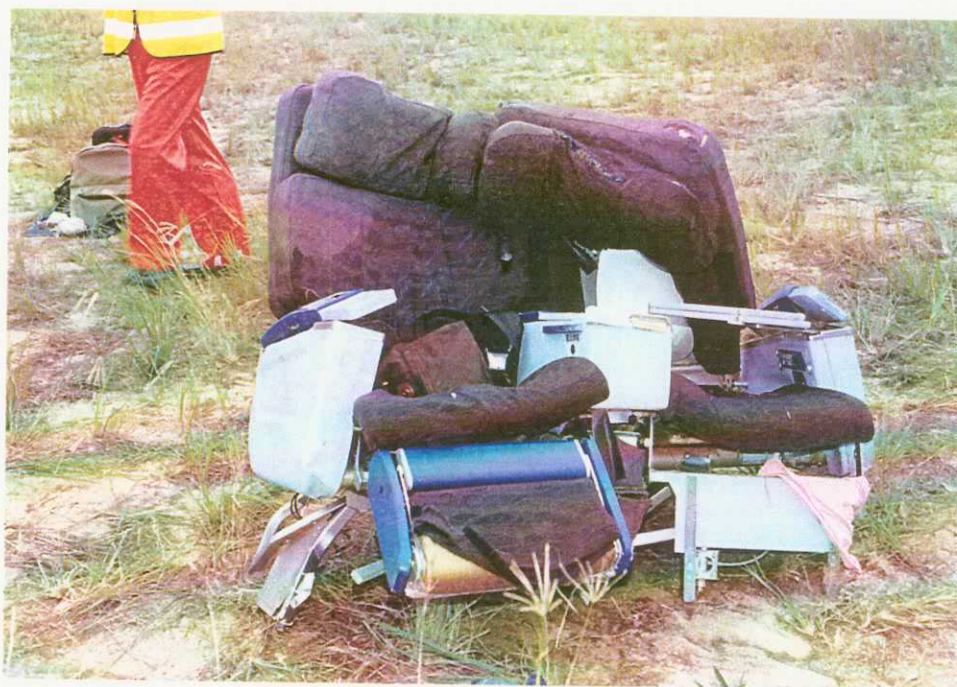
2. View of seats 1J and 1K.

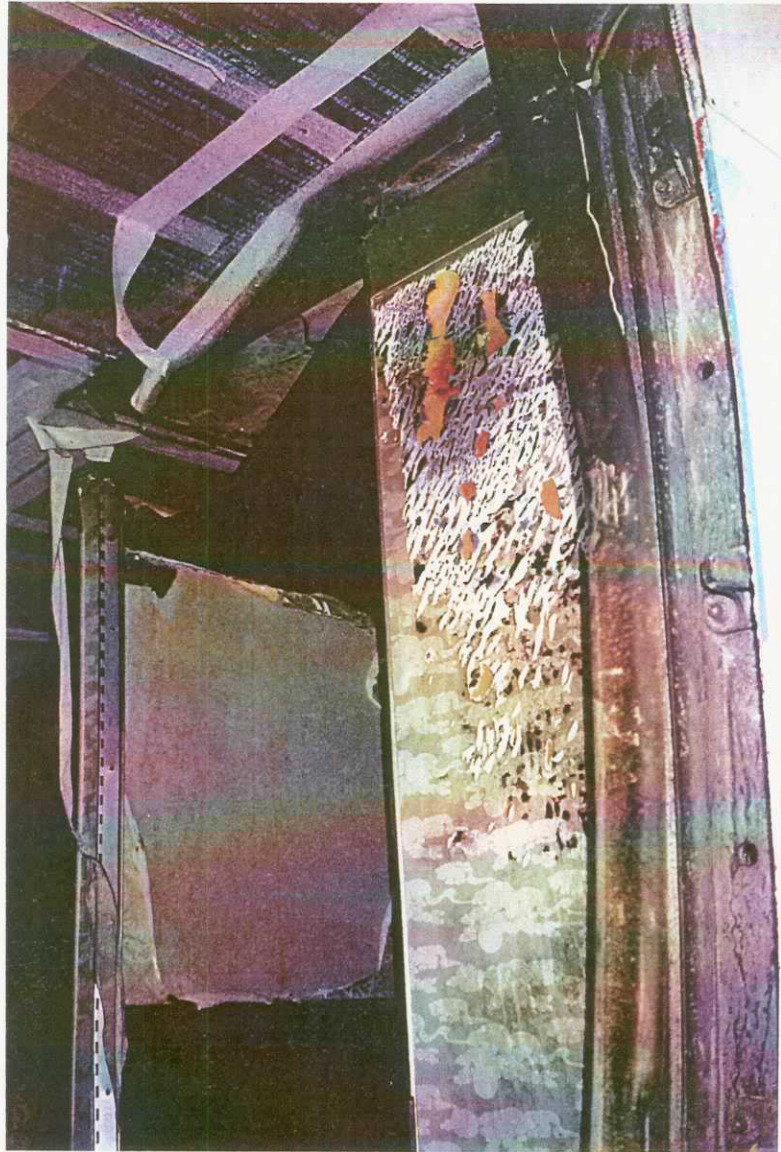
3. View of the lavatory just inside Door 3R.

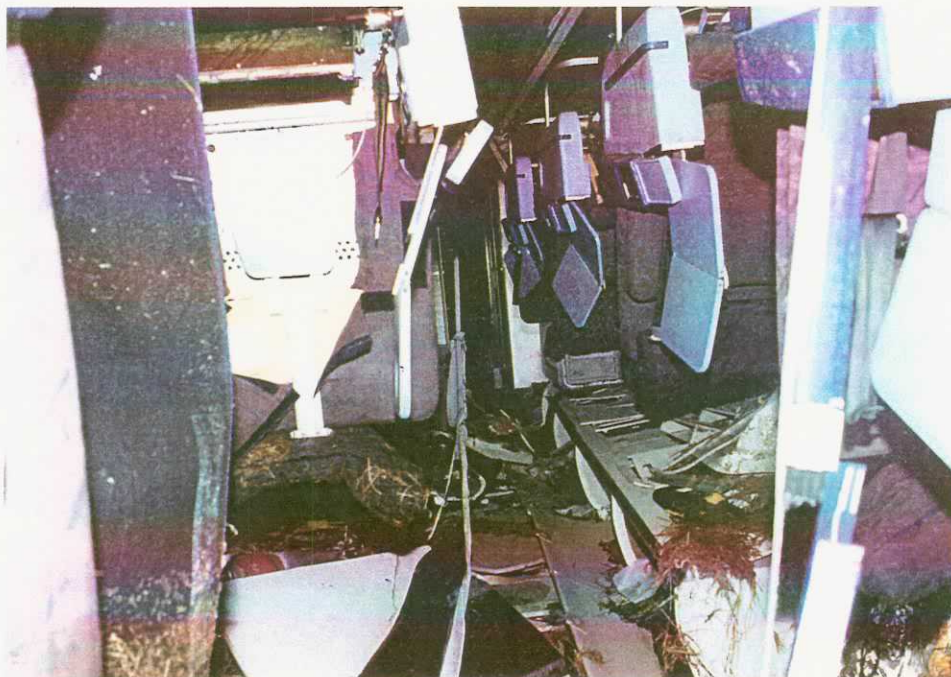
4. View of the Business Class section of the cabin.

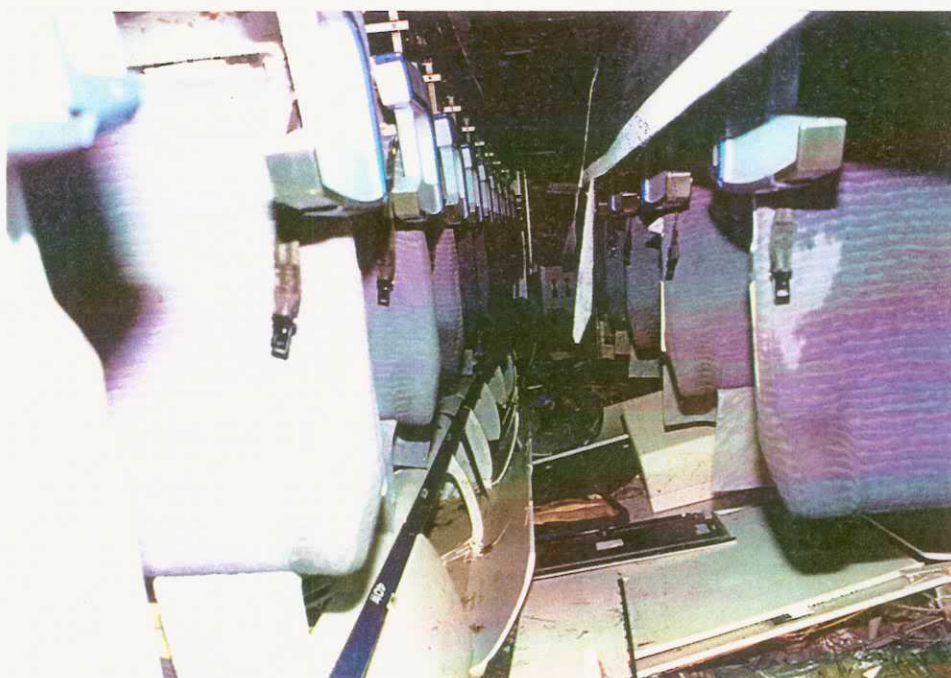
5. View of the Economy Class section of the cabin.

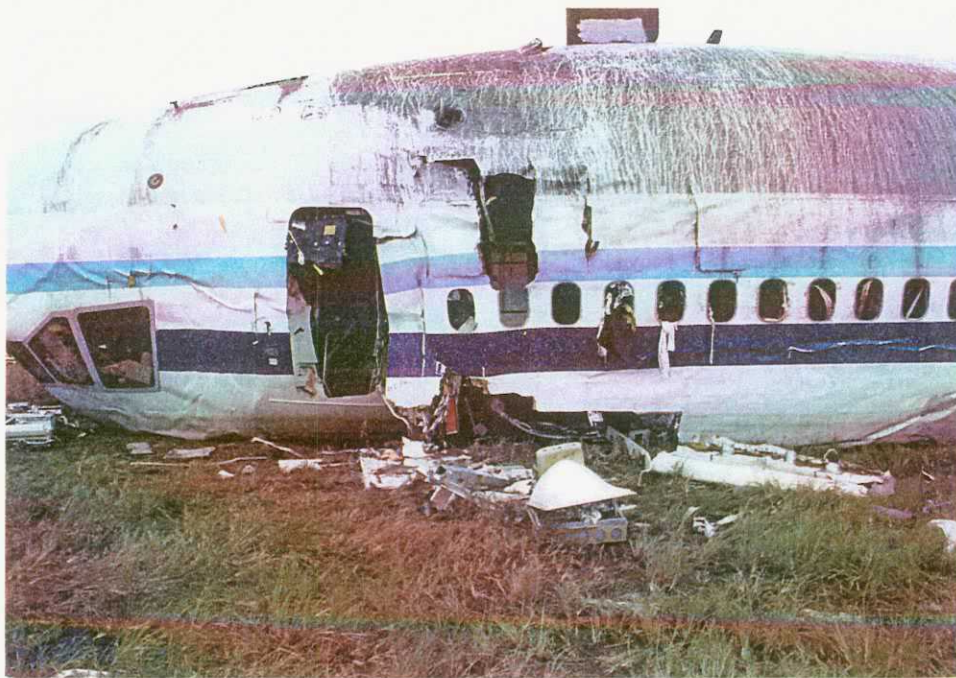
6. View of right side of fuselage including Door 1R.

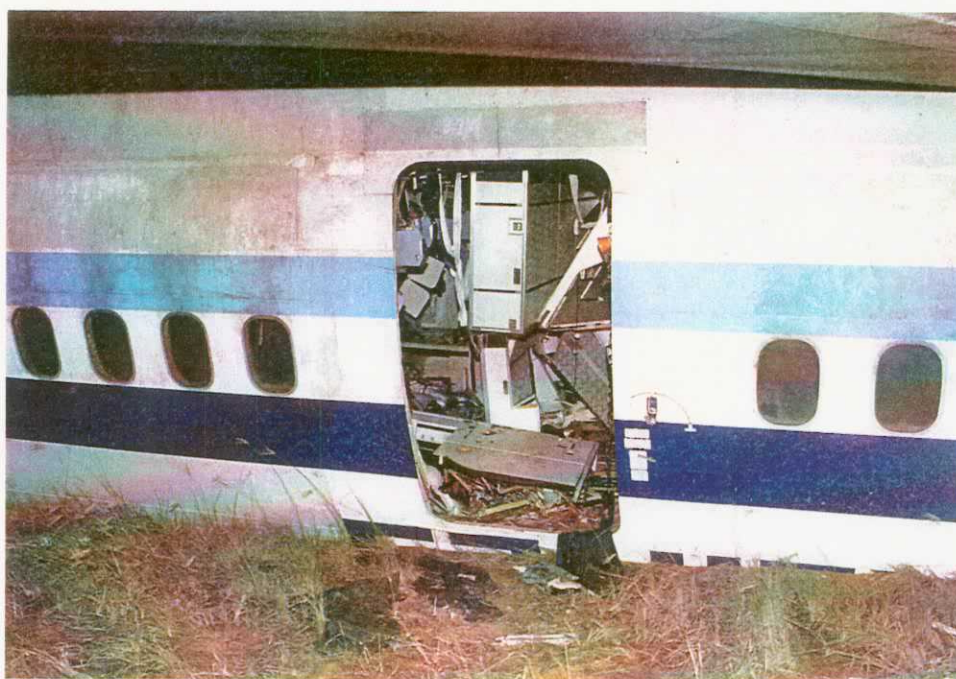
7. View of left side of fuselage including Door 3L.

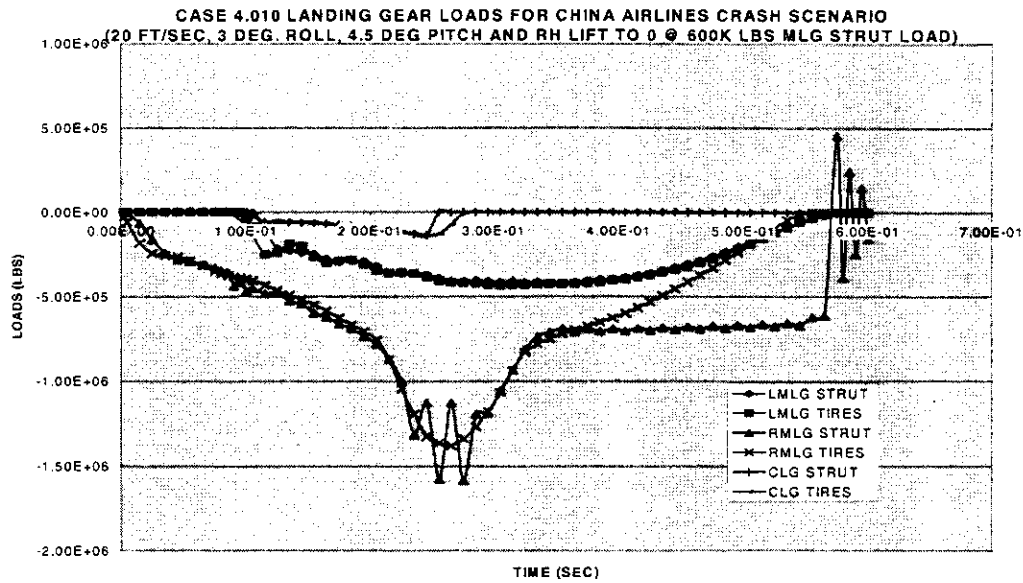
Figure 3. Case 4.010 Landing Gear Loads for China Airlines Crash Scenario

Figure 3 displays the landing gear strut and tire loads for the China Airlines baseline case (Case 4.010). The structure responds linearly for this case and it is assumed that all of the lift on the right-hand wing is lost when the right main landing gear load reaches 600,000 lbs. (This assumption is consistent with analyses that were run for the FedEx crash simulations, which used ADAMS to dynamically calculate wing lift as a function of local angle of twist). For the China Airlines analysis, both the left main landing gear and the center landing gear pick up load well before the right main landing gear reaches its peak load.

The strut and total-tire load time histories should be equal for a given gear (note that the right main landing gear strut load oscillates near its peak and separates after the peak due to NASTRAN convergence problems). These convergence problems do not have a significant effect on the time history of the other gear loads or the peak value of the right main landing gear total-tire load.

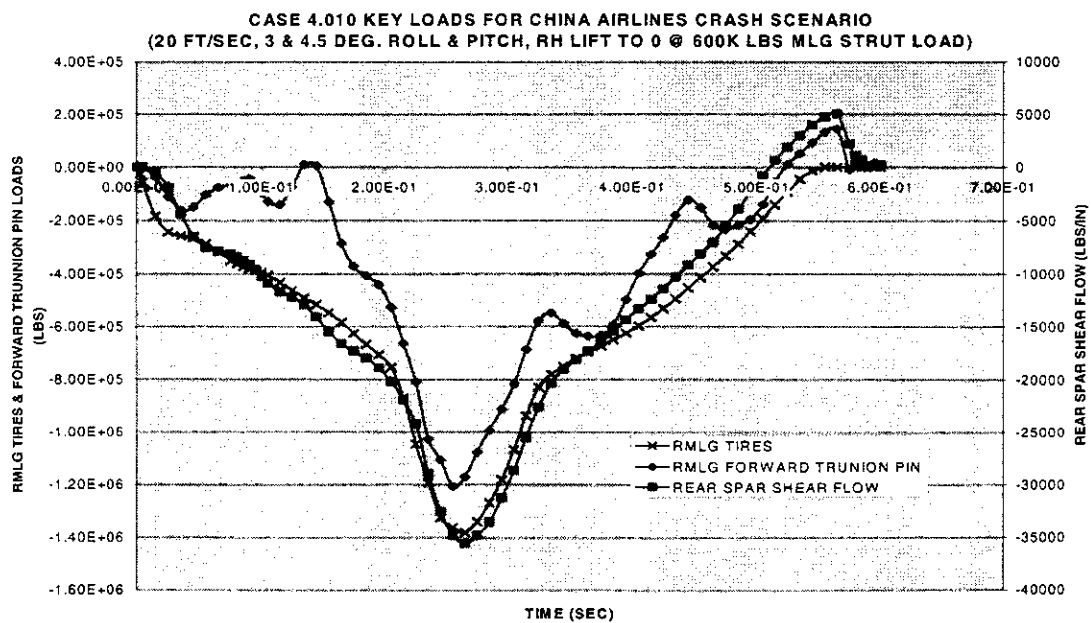
Figure 4. Case 4.010 Landing Gear Loads for China Airlines Crash Scenario

Time histories of key loads from Case 4.010 are plotted in Figure 4. From the figure, the right main landing gear strut load peaks at 1.4 million pounds, the peak rear spar shear flow is 35,000 lbs/in, and the peak load on the right main landing gear forward trunnion bolt is 1.2 million pounds. The rear spar shear flow is well in excess of what is required to fail the rear spar shear web and the forward trunnion bolt load is roughly that which is required to fail it.

The results of this analysis, although not rigorous, confirm that loads high enough to fail the forward trunnion bolt and the rear spar shear web are feasible, and that the failure sequence described in the following sections is reasonable.

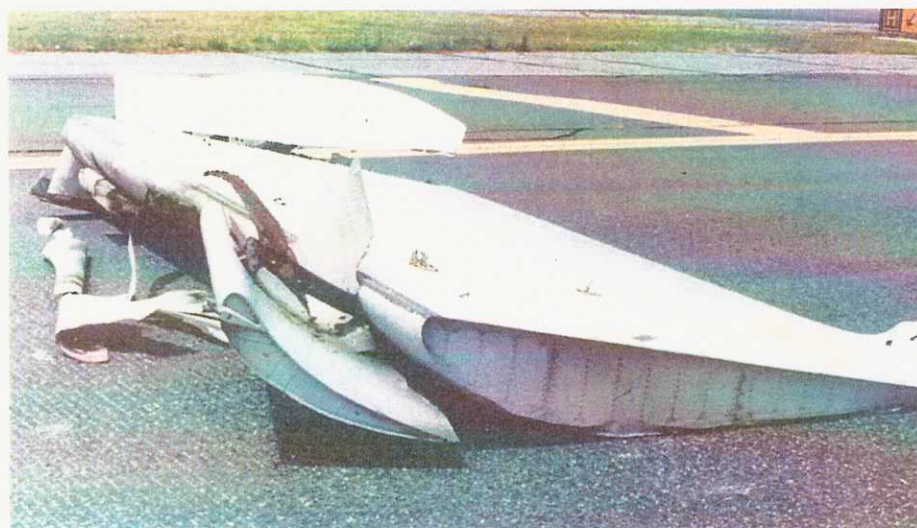
Figure 16. Right Inboard Flap from Ship 553 (FedEx - Newark)

The China Airlines inboard flap was found off to the left of the runway and is thought to have been carried there by the crosswind (which was blowing right-to-left) after it departed the aircraft. The flap, as it was found, is pictured in Figure 15. The FedEx inboard flap was found on a taxiway to the right of the runway (Figure 16); note there was little or no crosswind present when the FedEx accident occurred.

It is viewed as significant that the lower surfaces of these flaps suffered no significant damage. The inboard flap would have been directly in the path of the main landing gear had the gear separated before the flap and would have been badly damaged. It is clear then, that the main landing gear did *not* "knock" the inboard flap off the aircraft.

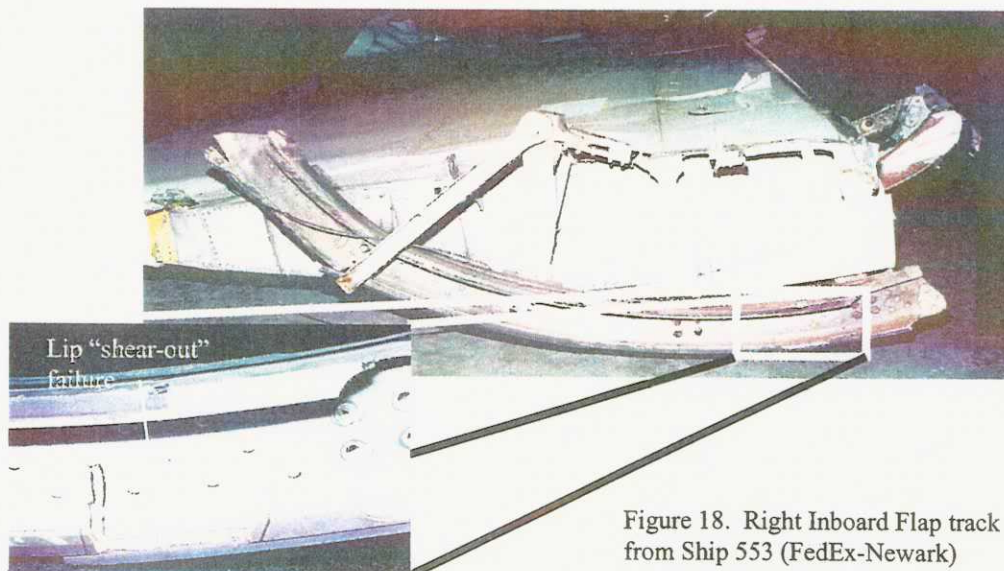
Figure 18. Right Inboard Flap track from Ship 553 (FedEx-Newark)

The local shear-out failure of the flap track is evident in a photograph taken at the accident site (Figure 17). The location of this failure is consistent with the position of the side rollers for the reported flap setting of 35 degrees. The same type of failure is observed in the photograph of the inboard flap from the FedEx-Newark aircraft (Figure 18); in this case the failure location is consistent with the reported flap setting of 50 degrees.

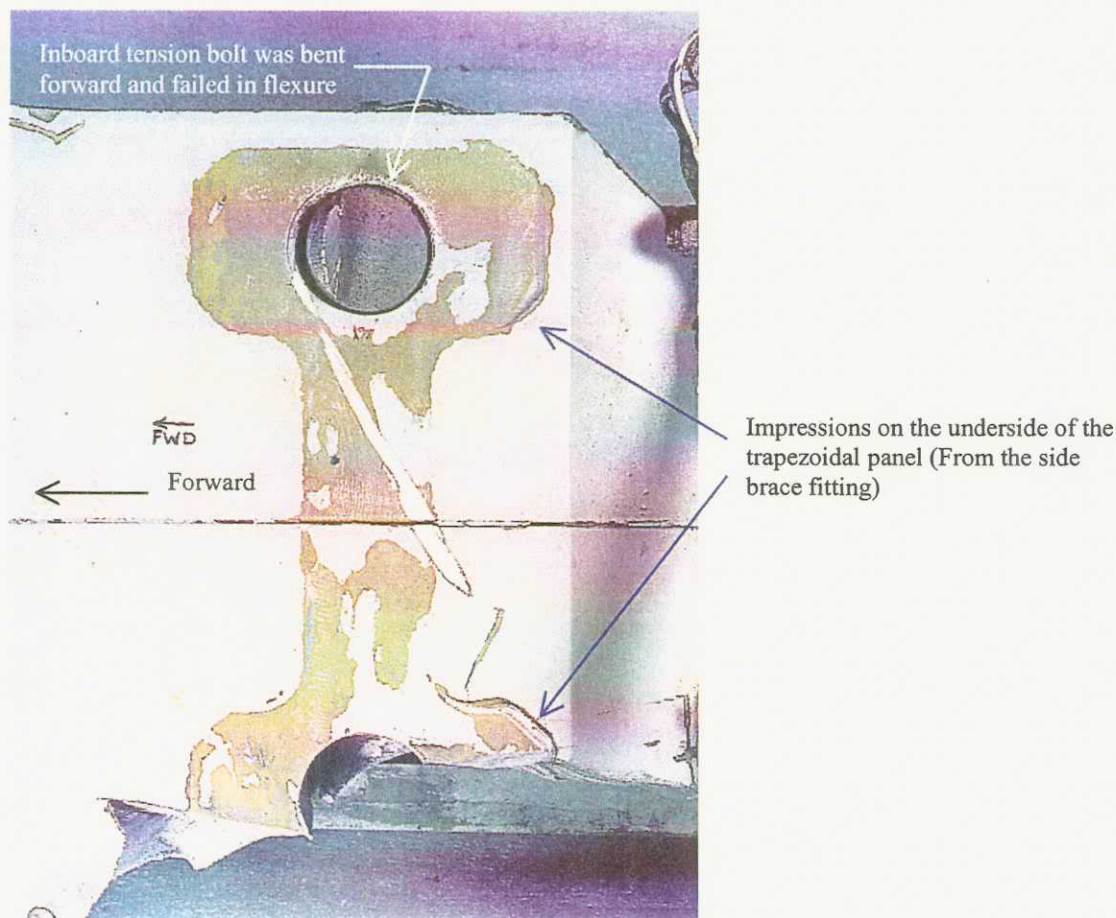
Figure 21. Underside of the right trapezoidal panel

As was the case for the inboard flap's departure, the damage to the S-B-F-T-T-P joint was the result of large relative displacements between attach points on the wing and on the fuselage. After the right wing rear spar failed, the MLG-to-wing attach fitting moved up (relative to the fuselage) and the outboard wing twisted severely nose-down. This motion effectively tilted the truss formed by the MLG strut, and the fixed and folding side braces, and applied a nose-down twist to the S-B-F-T-T-P joint. This applied twist rocked the side brace fitting (bottom-end-aft) and resulted in "impressions" on the lower surface of the trap panel (Figure 21). Similar impressions were observed on the underside of the trap panel from the FedEx-Newark accident aircraft.

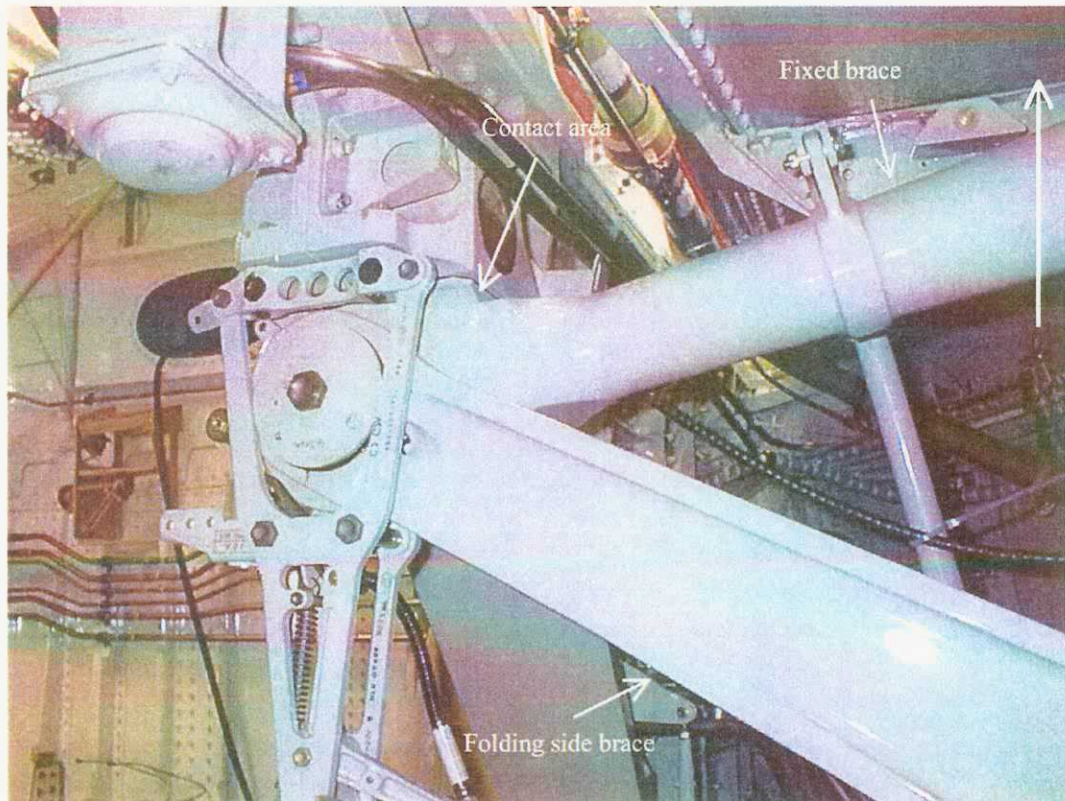
Figure 22. Side-brace-fitting-to-trap-panel joint (from aft and outside the right wheel well)

Figure 22 is another photograph of the S-B-F-T-T-P joint area. The photograph is annotated to point out the limited clearance between the clevis end of the fixed brace and the side brace fitting. Excessive upward motion of the outboard end of the fixed brace (which is connected to the MLG-to-wing attach fitting) results in contact in the noted area, and creates a "short couple" prying load at the joint. Evidence of contact in this area for parts taken from the China Airlines accident aircraft is seen in Figure 23. Similar evidence was also noted for the FedEx-Newark accident aircraft.

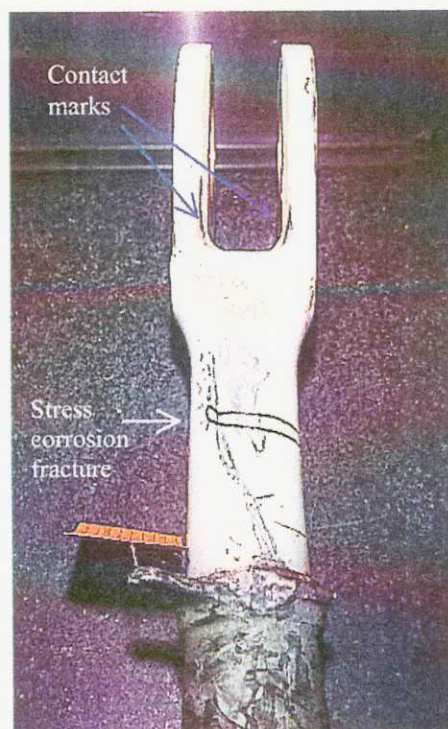
Figure 25. Outboard end of the fixed brace from Ship 553 (FedEx-Newark) [right]

The presence of a large prying load at the S-B-F-T-T-P joint results in severe distress to this joint. This manifests itself as localized high bending (flexure) at the outboard end of the fixed brace, and a large tension load on the inboard of the two tension bolts attaching the side brace fitting to the trap panel. Evidence of flexural distress of the fixed brace was observed in parts taken from both the China Airlines and FedEx-Newark accident aircraft. The fixed brace from the China Airlines aircraft failed completely (Figure 24). The fixed brace from the FedEx-Newark aircraft was bent and suffered a stress corrosion fracture (Figure 25). The stress corrosion fracture is attributed to residual stress resulting from a high flexural load. Note also in Figure 25 the evidence of local contact with the side brace fitting.

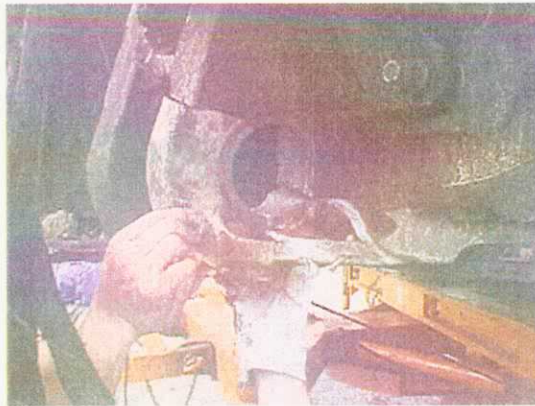
Figure 29. Wing fitting lugs that support the MLG forward trunnion [left]

In the case of the China Airlines accident the markings indicating contact between the right main landing gear strut and the wing attach fitting are slightly different (and not quite as clear). This is primarily due to the fact that the forward trunnion connection was partially failed (See Section 5.0) before the strut rotated outboard. The contact area for the forward trunnion was therefore very localized, and quickly resulted in the fracture of the remaining connection (the aft lug). See Figures 29 and 30. The two lugs that support the *aft* trunnion, the forwardmost still connected to a large piece of the wing fitting, also

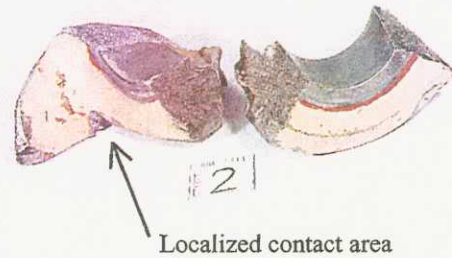
Figure 30. Separated pieces of the aft wing fitting lugs that support the MLG forward trunnion [right]

cracked off as a result of the gear rotating outboard (Figure 31). This separated the right main landing gear from the aircraft. The contact area on the aft trunnion arm is shown in Figure 32. A photograph of the wing fitting, showing the mating area for the two aft trunnion support lugs, is included as Figure 33.

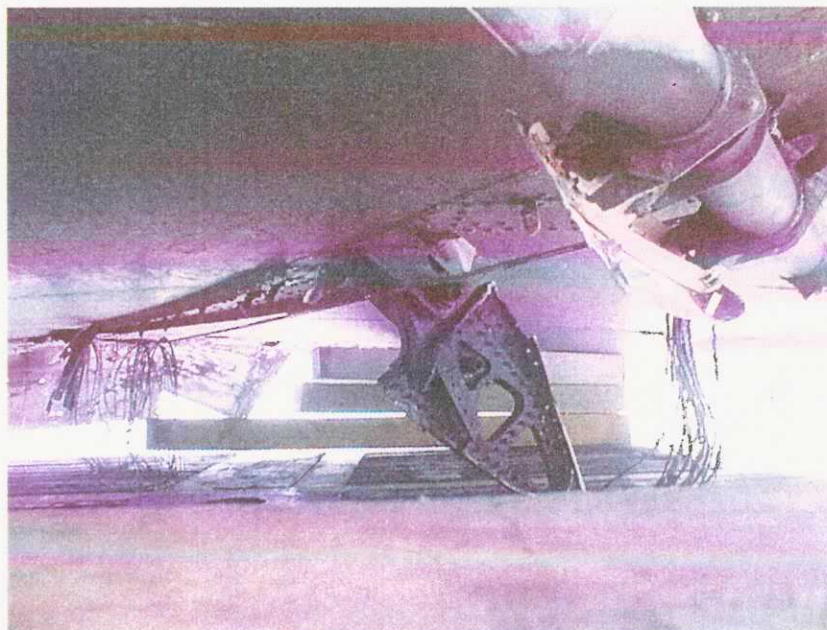
Figure 37. Right engine pylon aft-attach bulkhead still attached to the right wing

Figure 37 shows that the right pylon failure mode was different for the China Airlines accident aircraft; the right engine pylon aft-attach bulkhead is still attached to the right wing. Figure 38 shows the right engine pylon. The observed failures suggest that the loads on the nacelle included a significant sideways

component. This is thought to have occurred because the outboard wing, as the failure progressed, began to sweep further and further aft.

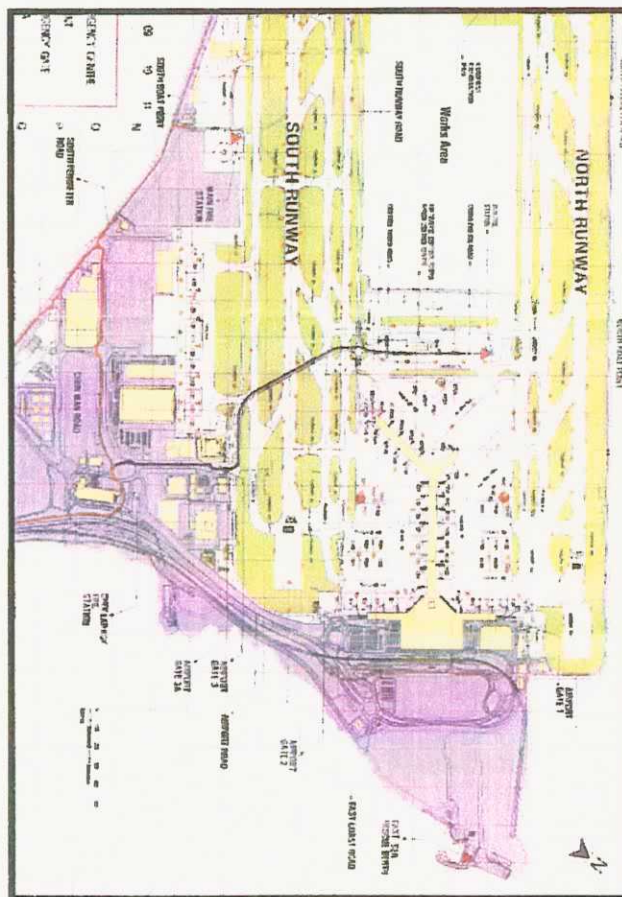
Figure 1. Runway 25L approach area in the lee of the Passenger Terminal Building

- a) The Hong Kong draft Final Report minimizes the significance of the absence of high capability wind shear warning detection system at Chap-Lap-Kok Airport. The improvement of wind shear detecting system is a major challenge confronting the world aviation industry.
- b) The Hong Kong draft Final Report also minimizes the finding of the three very valuable simulator lessons tested at Boeing facility, Long Beach, California.
- c) The Hong Kong draft Final Report does not adequately address the RWY 25L and 25R wind difference analysis attributed from passenger terminal building. It should be considered in that context. See Figure 1 below.
