**AIRCRAFT ACCIDENT REPORT 1/2005**

**Report on the accident to  
Airbus A330-342 B-HYA  
Within the Manila Flight Information Region  
on 18 July 2003**

Operator : Hong Kong Dragon Airlines Limited

Aircraft Type : Airbus A330-342

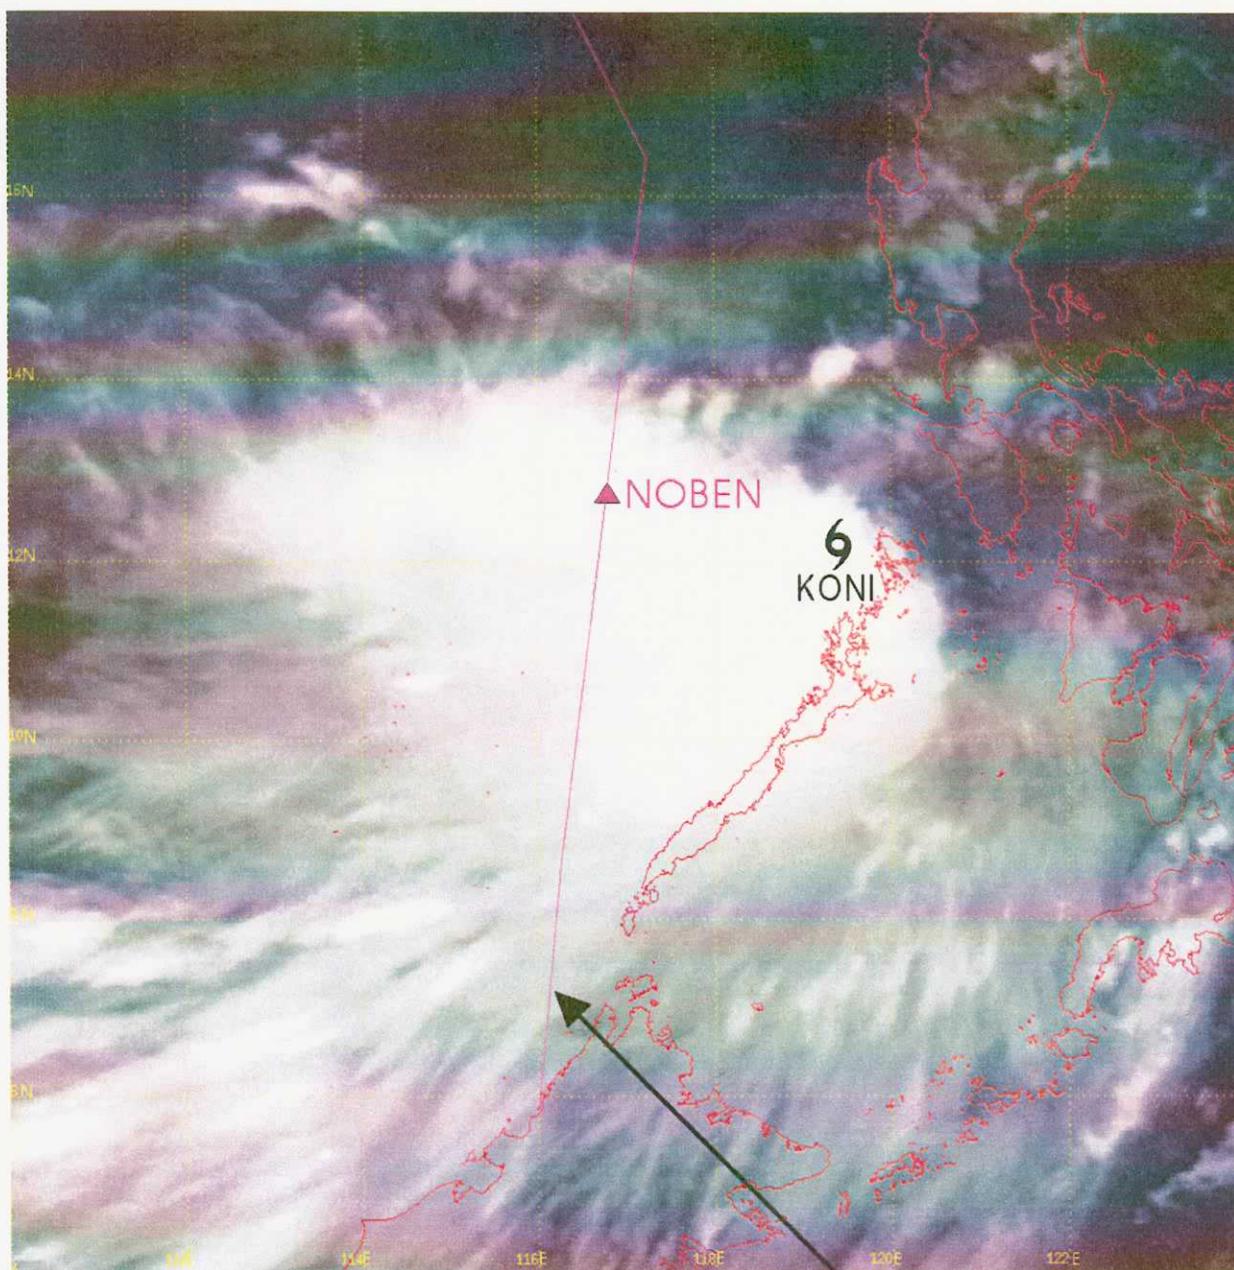
## GOES-9 INFRA-RED SATELLITE PICTURE

0525 UTC 18 July 2003

Flight Plan Track of HDA060

The satellite imagery was captured with GOES-9 operated by the joint effort of Japan Meteorological Agency (JMA) and United States National Oceanic and Atmospheric Administration National Environmental Satellite Data and Information Service (US NOAA NEDIS). Position of “KONI” is a post-analysis position for 0600 UTC 18 July 2003.
